FEASIBILITY STUDY FOR THE OURAY COUNTY COURTHOUSE

OURAY, COLORADO

MARCH 2017

CHARLES CUNIFFE ARCHITECTS

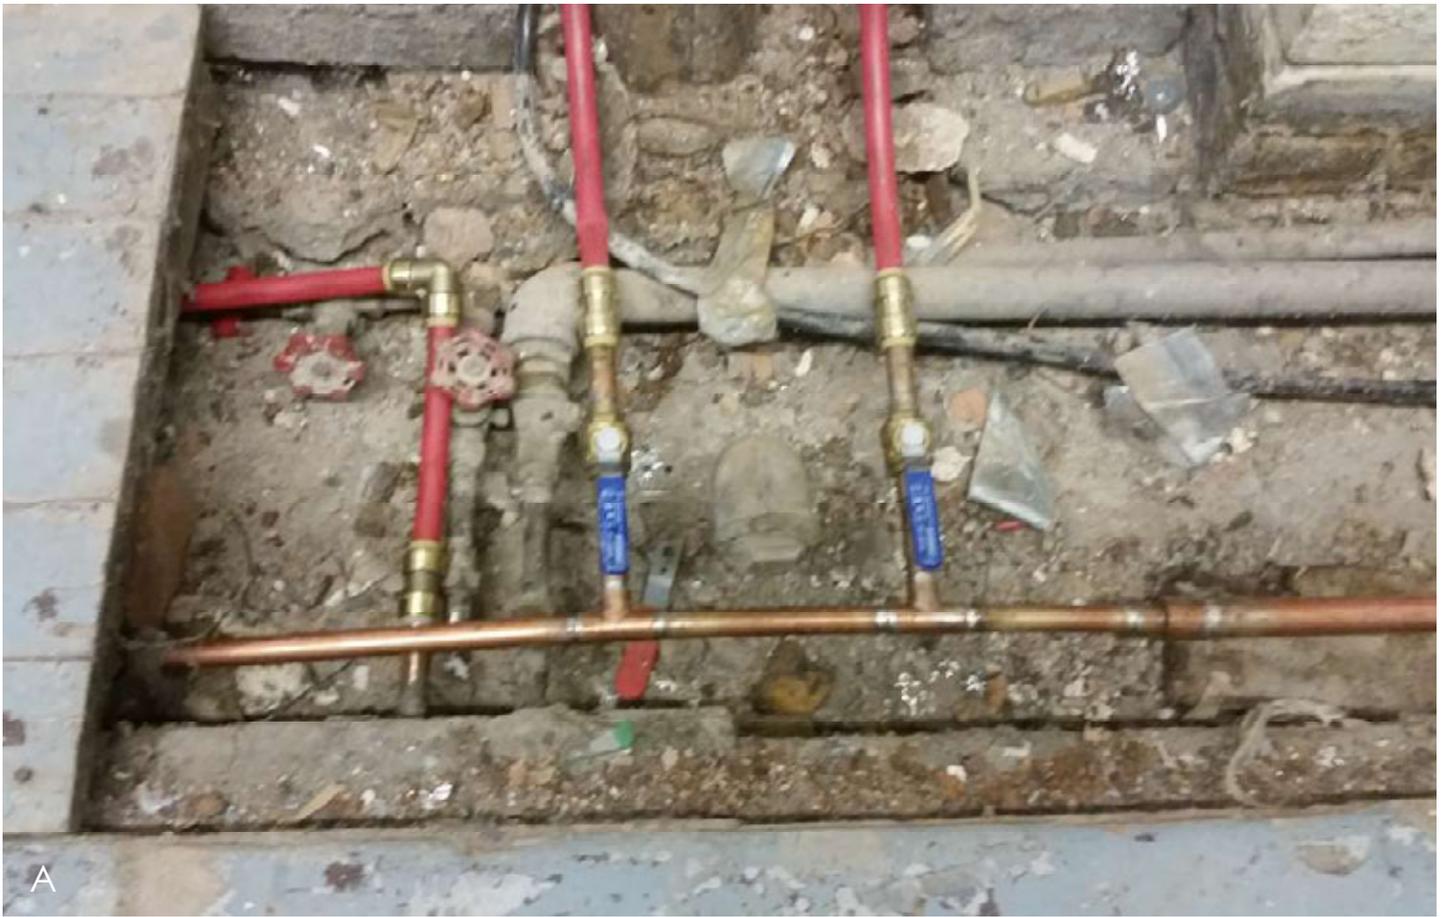
Exhibit A - Exposed plumbing is left in the basement hallway following a recent plumbing leak on the second floor.

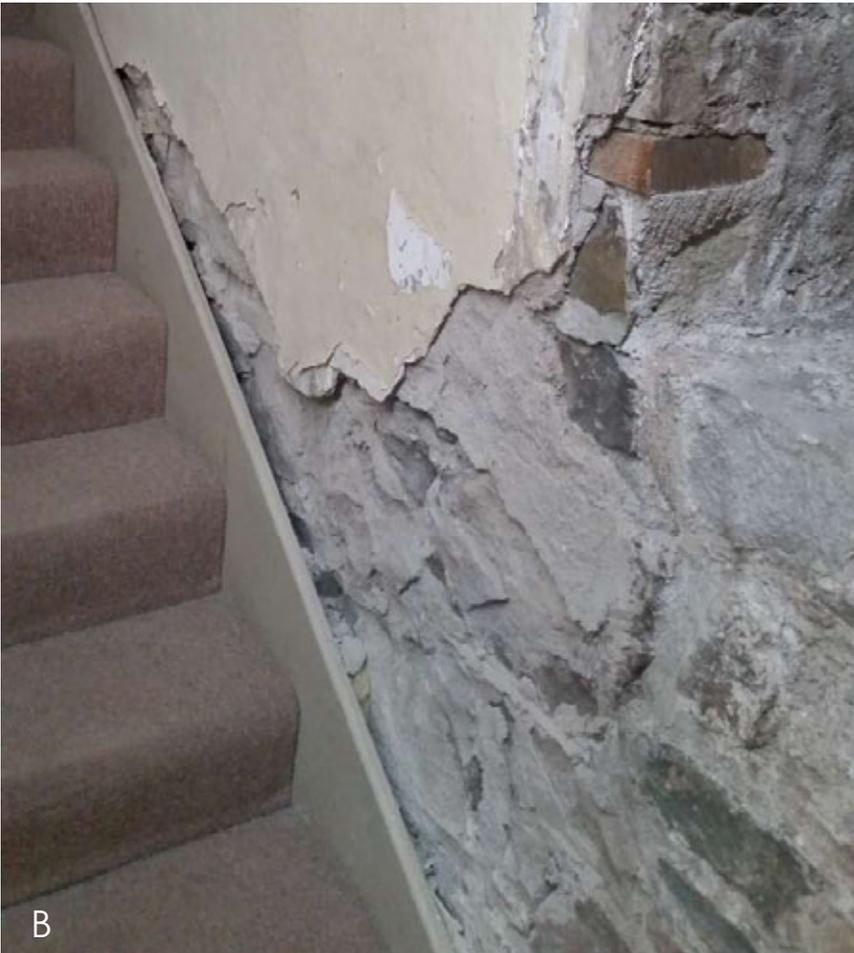
Exhibit A shows exposed electrical wires, plumbing, and insulation in the basement hallway ceiling. Exhibit B outlines the extent of exposed and cracking plaster/drywall along the stairwell. The historic brick is exposed but not properly protected. Exhibit C shows the updated building systems in a historic building and how better integration and concealment is needed.

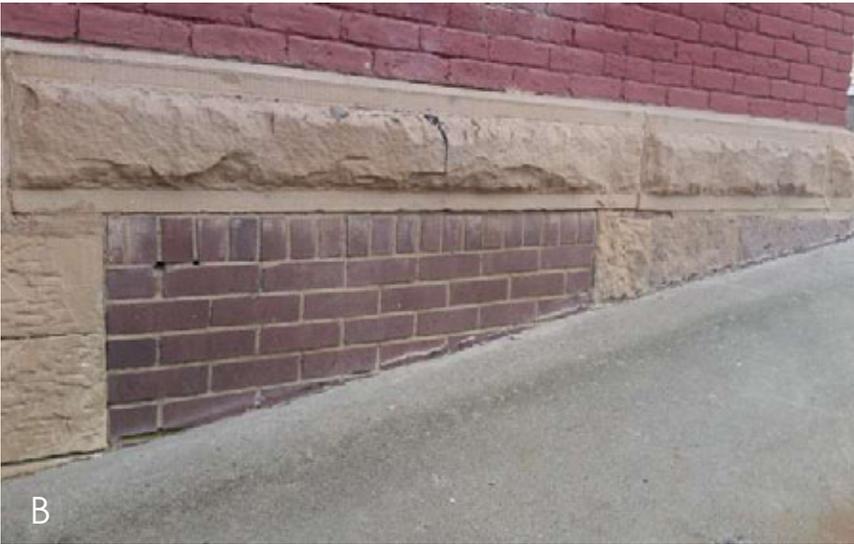
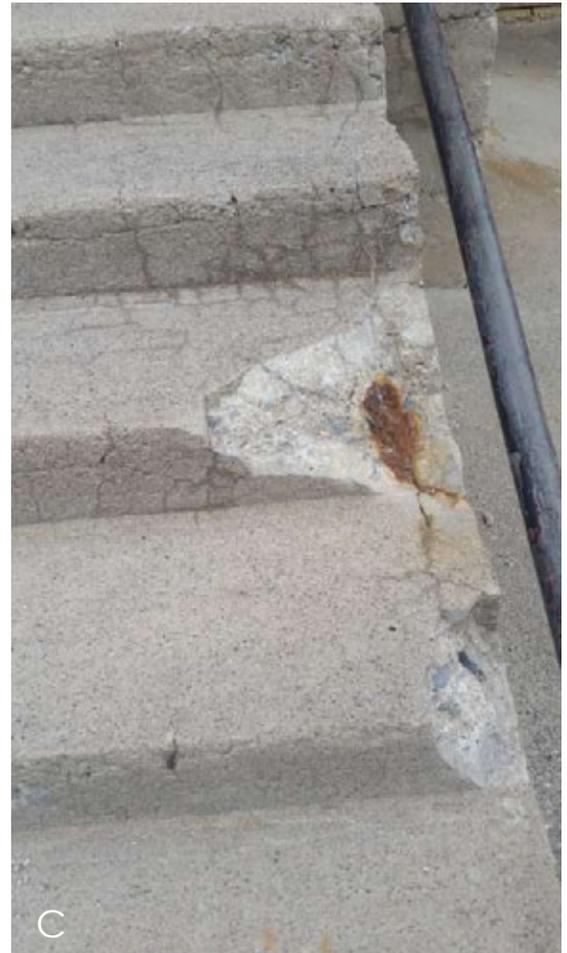
Exhibit A, B, C - The front entry steps have cracking and splitting concrete at step edges. Exposed masonry units are losing mortar, and discoloration is evident along the stair landing and stone base. Exhibit B illustrates the basement level window and moat that has since been infilled with brick.

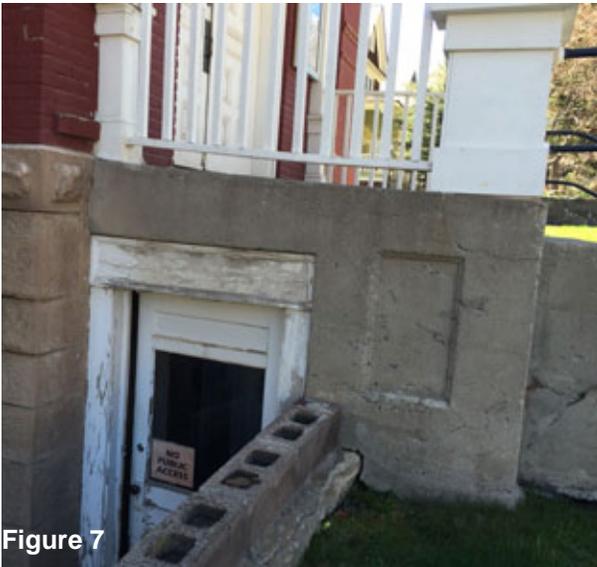
Figure 7

Deteriorating concrete steps at front entry, exposed CMU-topped retaining wall.

Retaining wall that is falling over and missing a cap.

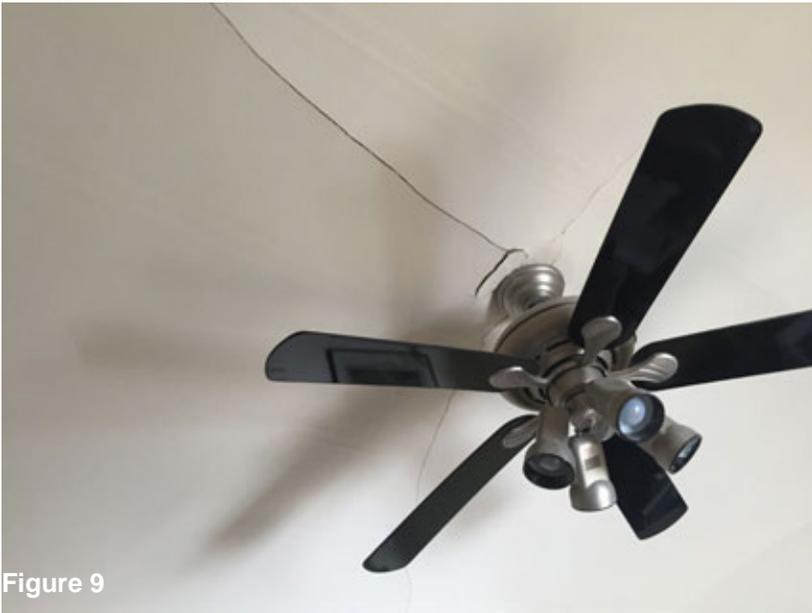
Figure 9

Cracked and peeling paint on the ceiling in the Sheriff's office.

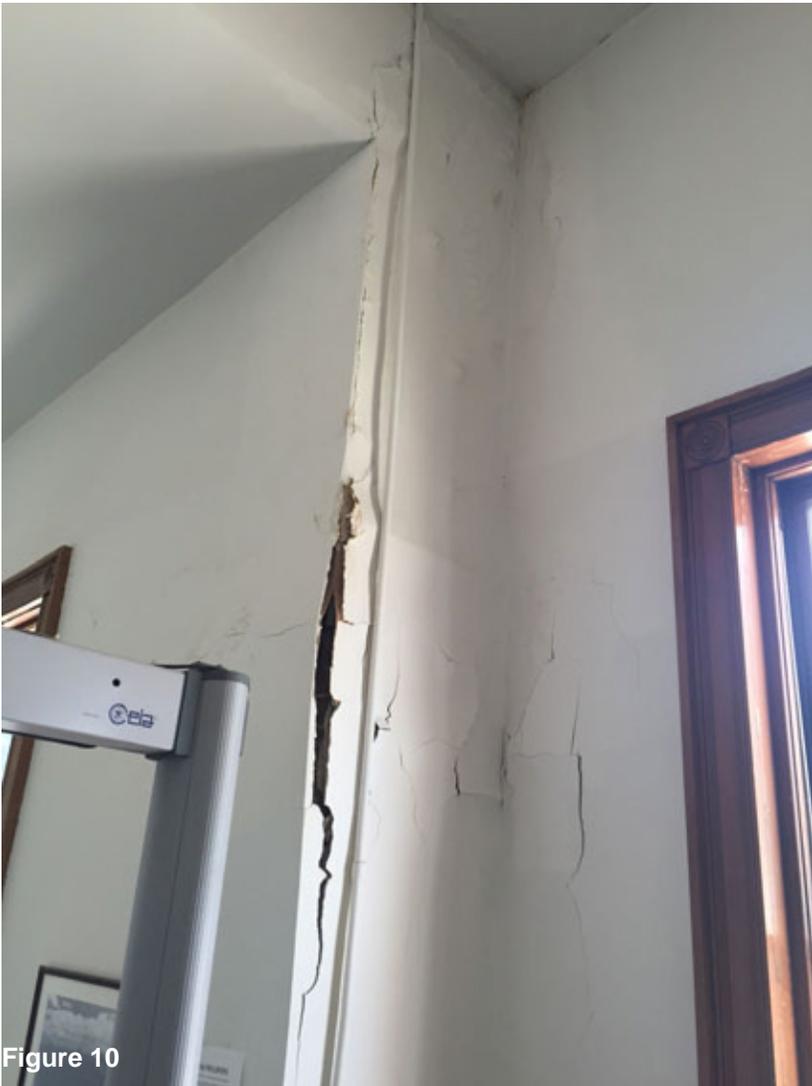
Figure 10

Cracked and peeling paint and drywall in the entry of the Courthouse by the entry stairwell.

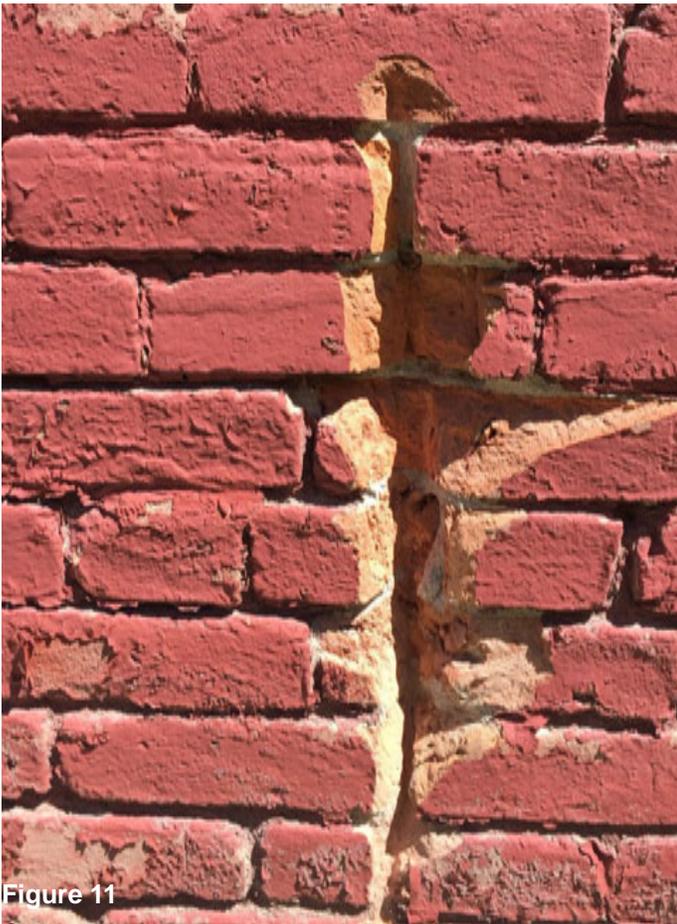
Figure 11
Cracks and damage to historic brick facade.

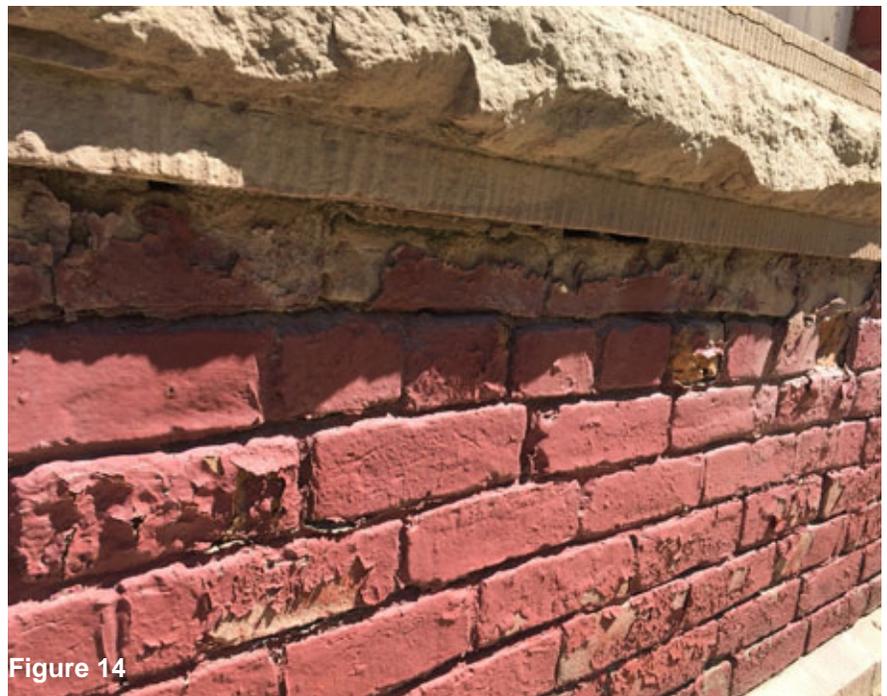
Figure 14

Concrete sidewalk cracking at the edge of the Courthouse limestone base. Paint is peeling off of the bricks in various locations over the building. Window sills are in need of repair.

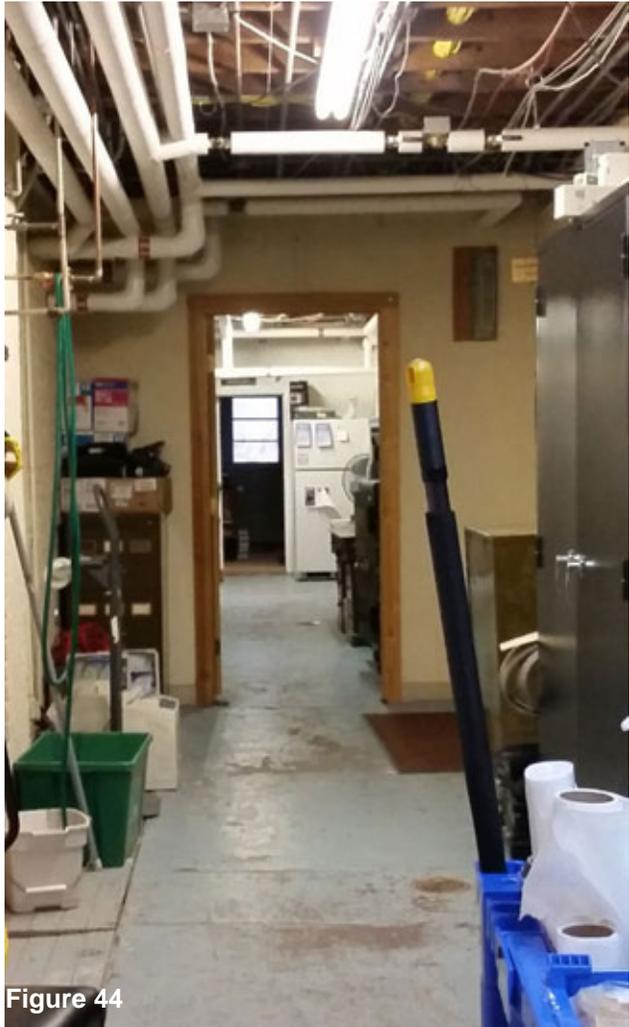
Figure 44

The condition of the basement has worsened over the years of use and floods. Storage vaults are utilized to full capacity, mechanical and plumbing is exposed in the ceiling, and mold is evident in a few of the damaged vaults.

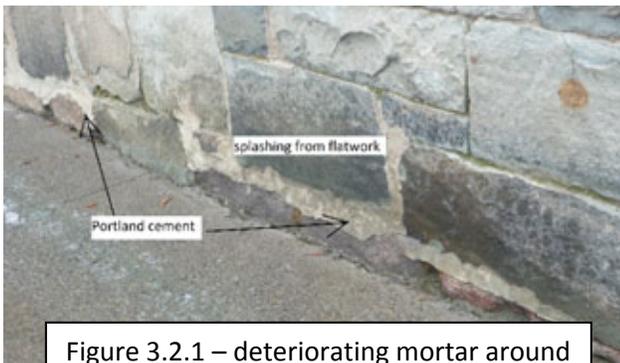
Figure 3.2.1 – deteriorating mortar around flatwork and Portland cement in-fill

The original lime mortar is deteriorating in all locations easily approachable on perimeter walls, including both interior and exterior surfaces. It is deteriorating to a greater degree where the walls are in regular contact with moisture and weather in such places as the building exterior on the exposed North side, and around ground level near concrete flat work on the North, West, and South sides of the structure (Figure 3.2.1). In places, a covering of unsightly and mostly ineffective Portland cement was applied at some point in the past, assumedly in an attempt to slow deterioration

On the North side of the building where the foundation is mostly exposed, a removal of the poorly placed Portland cement (Figure 3.2.1) should be followed with a professional re-tucking of lime mortar to match the original. Where concrete flatwork will remain, it is advisable to

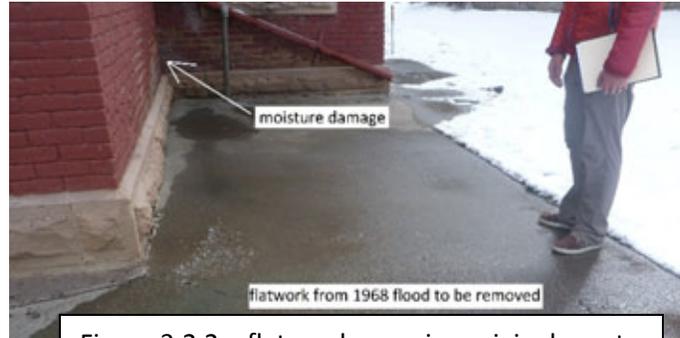
Figure 3.2.2 – flat work covering original moat

basement. It would also allow for a more thorough evaluation of the foundation, the placement of a waterproofing membrane, and would restore the building to its original configuration. The bottom of the moat should be covered in a well-draining gravel to shed moisture, and should be underlain by a foundation drain which flows to a drywell. Continued evaluation will be required as the excavation takes place to determine if different measures are needed. The moat should be surrounded with positive drainage so as to achieve a 6” drop in grade within the first 10’ around the perimeter in accordance with modern standards. This drainage should at least end in a sloped swale which would drain to the sewer or other convenient location, but the swale could also include an infiltrator drain which diverts excess water to a new onsite drywell. Such a drywell could be used for drainage throughout the site, as the condition of original drainage systems and storm sewer piping is very uncertain, as it is buried and likely built of tile.

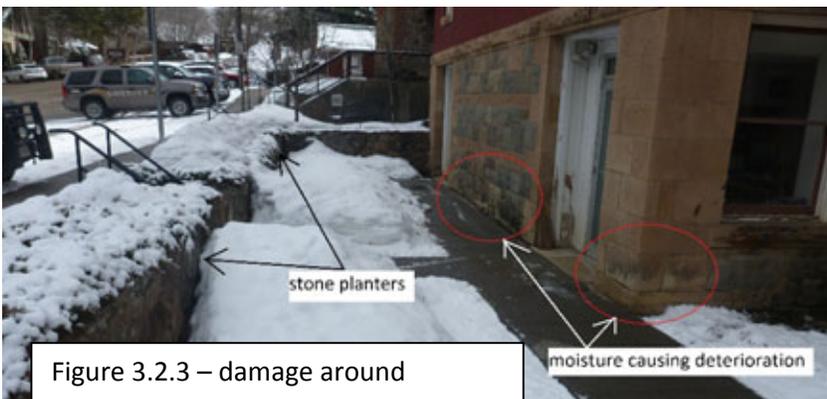
Figure 3.2.3 – damage around flatwork on the North side

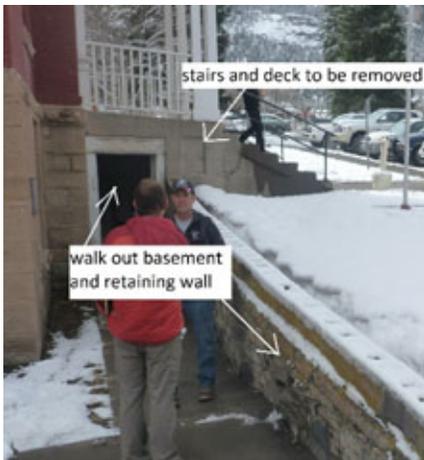
Figure 3.2.5 – retaining wall and front entrance

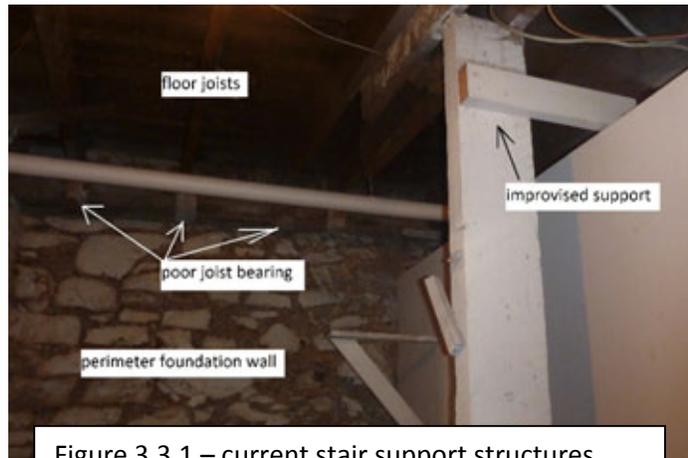
The original stairway to ones right as he/she enters the courthouse from the West (front) entrance is experiencing large deflections, and elements such as railings and stair treads are developing gaps and bending due to the stairs' poorly supported base, seen in Figure 3.3.1 at right and described below. The floor joists below these stairs are highly inadequate in their size, number, and the way in which they are supported and connected. Currently, there are small (roughly 2x6) joists spaced at approximately 16" supporting the East side of the above stairwell, and larger (roughly 2x10) joists below the heavier West side. In some places, joists are badly spliced in the middle with a few nails and seem almost useless. There are non-original posts placed under these joists in an attempt to add support, but they are only a temporary fix, and were not placed or constructed with permanence in mind. The floor joists bear on the foundation through un-secured bricks as shown. These bricks look to be extra on-site building material from original construction which were hastily placed under the above floor joists.

Figure 3.3.1 – current stair support structures

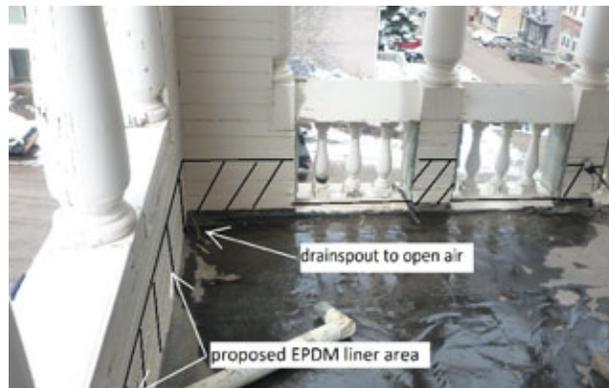
Much more concerning is the support structure underneath the cupola. The drainage system in the cupola is highly ineffective (Figure 3.3.2). There are some poorly-overlapping layers of waterproof membrane on the floor and a slight slope to the Southwest corner, where water is supposed to drain through a pipe in the wall and directly out into the open air below (Figure 3.3.3). However, the floor slope is not great enough, the waterproofing is deteriorating, and water easily comes in contact with the wood framing around the cupola perimeter

Figure – 3.3.2 – Current condition inside cupola

This failed system has caused regular periods of standing water in the cupola (Figure 3.3.2), which is open to weather and gathers both snow and rain. This precipitation cannot drain out as it should, and water damage to the floor system (Figure 3.3.4), underlying brick, and internal wall finishes has resulted as water has penetrated deep into the courthouse top floor (Figure 3.3.5). The partially-effective drain pipe dumps water onto the outside brick wall as seen in Figure 3.3.3, and is causing efflorescence and deterioration of the lime mortar in that area of the wall.

failed drain in the Southwest corner (Figure 3.3.2). The drain should be well repaired or replaced with a watertight pipe that flows to the gutters of the structure and follows a designated channel all the way to the ground instead of pouring out into the open air. Also, a clear Plexiglas™ could be inconspicuously installed between the cupola railing and the floor to partially prevent moisture from entering the room at that level. Of course, this Plexiglas™ could be continued to the ceiling in order to completely close in the room, but that would likely take away from the historic feel of the courthouse.

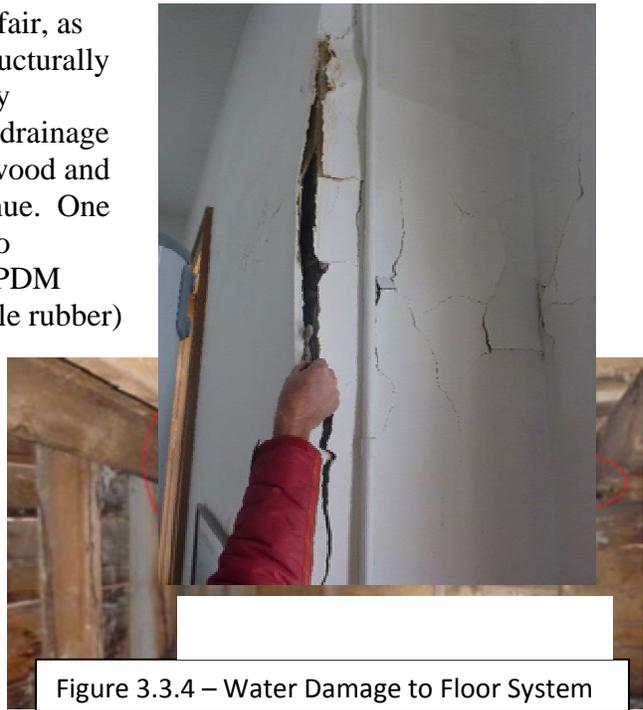
Figure 3.3.4 – Water Damage to Floor System

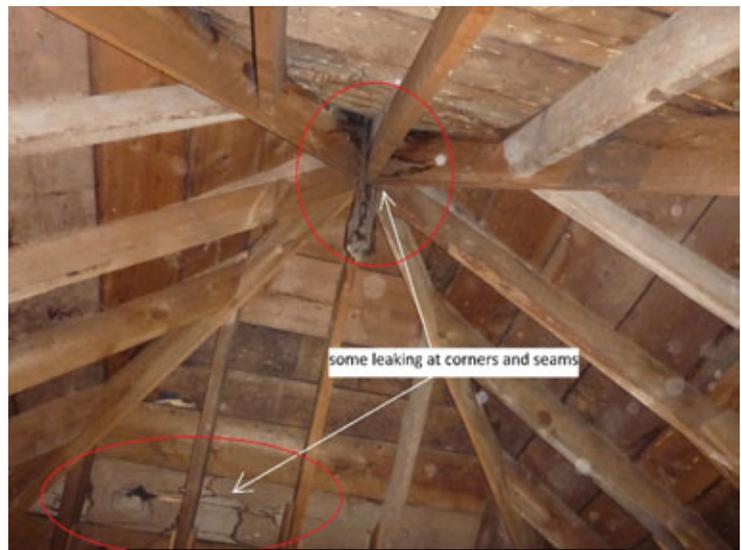
In the Southeast portion of the roof, which is above the courtroom, there was a fire at some point in the past. The timbers of the roof were not burned deeply, and the damage looks to be mostly superficial and mostly from smoke. There is no need for repair in the foreseeable future.

Figure 3.5.1 – the roof structure is in good condition (cupola roof shown)
