Ouray County Courthouse & Jail

Historic Structure Assessment & Restoration Plan

Issued: December 19, 1999

Prepared by:
CHARLES CUNIFFE ARCHITECTS

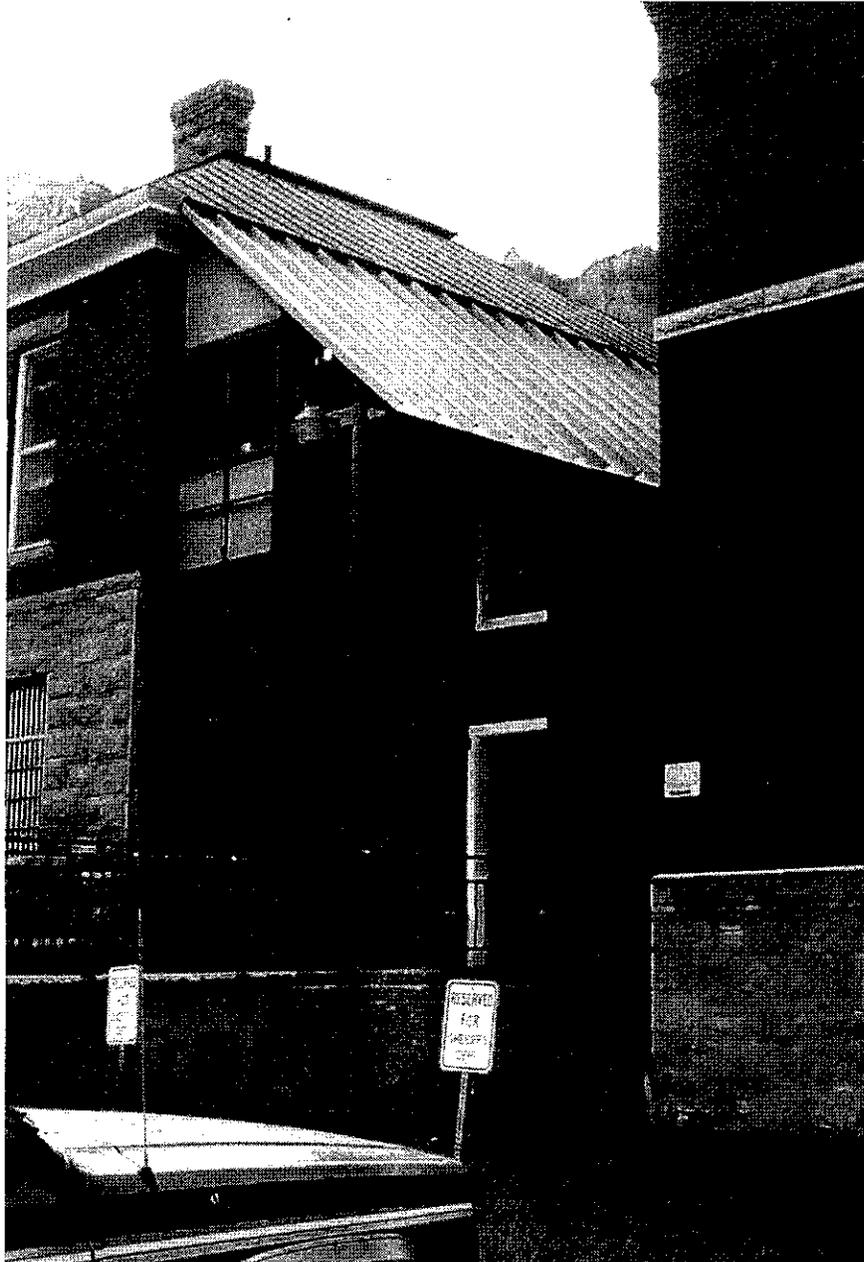
H - Photograph of Existing Shed Link

This photograph shows the current state of the shed addition between the two buildings.

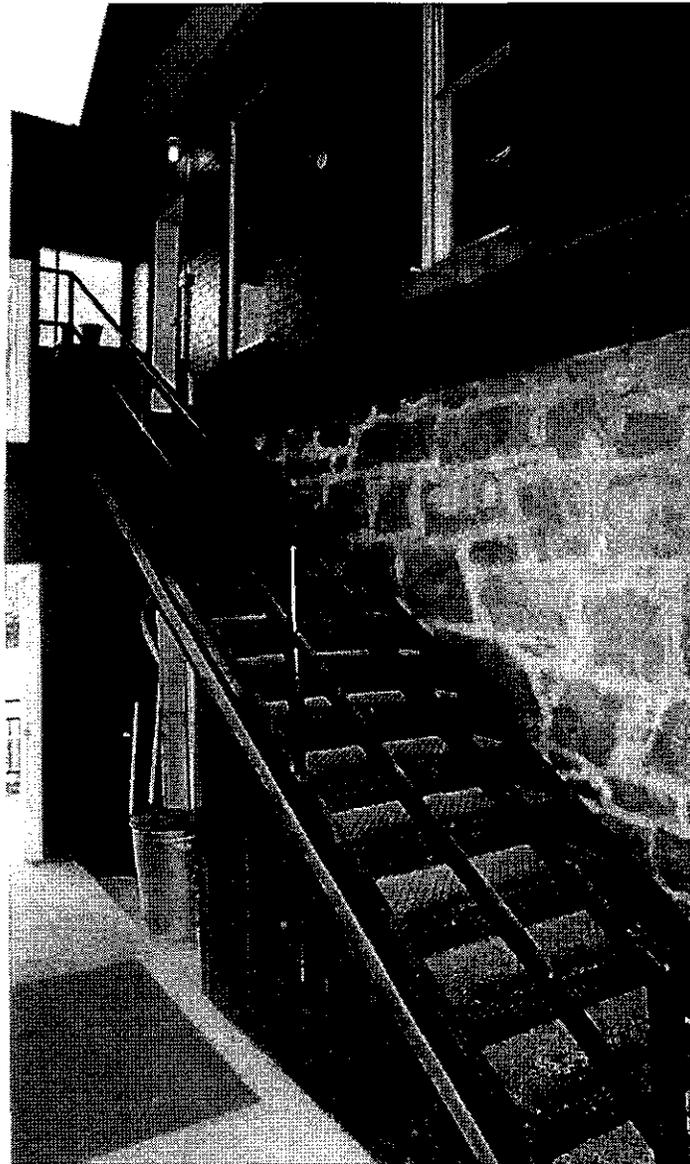
I - Photograph of Interior of Shed Link

This photograph shows the current state of the interior of the shed addition between the two buildings. This is the staircase to the Sheriff's office.

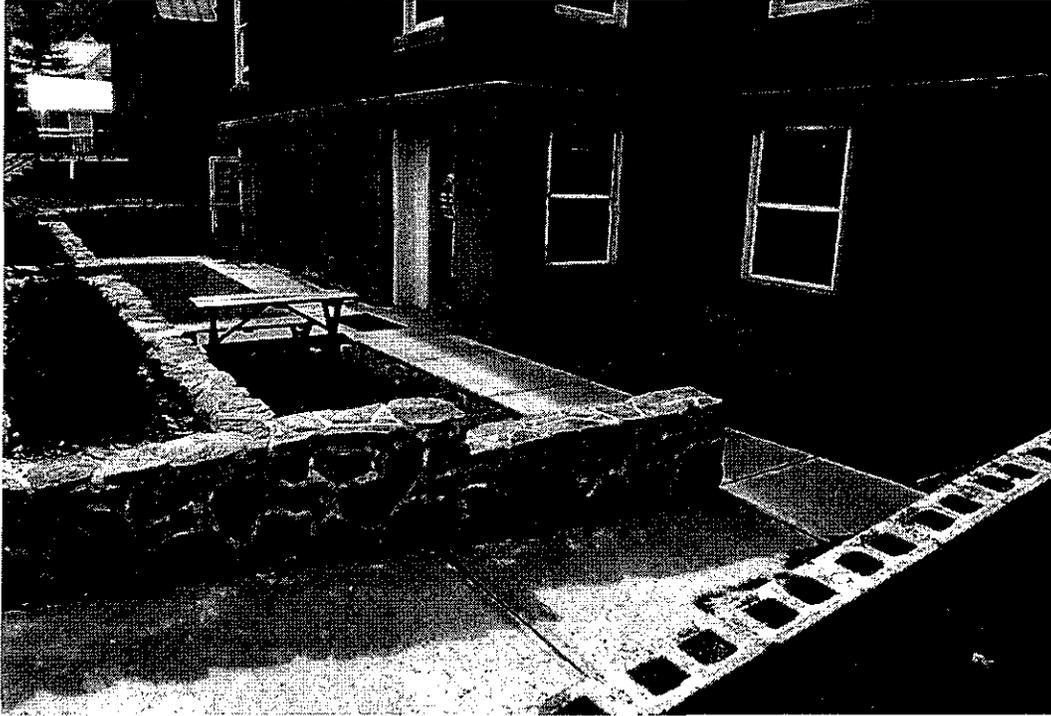
J - Photograph of Existing North Side Retaining Walls

This photograph illustrates the inappropriate masonry added to the north side of the Courthouse.

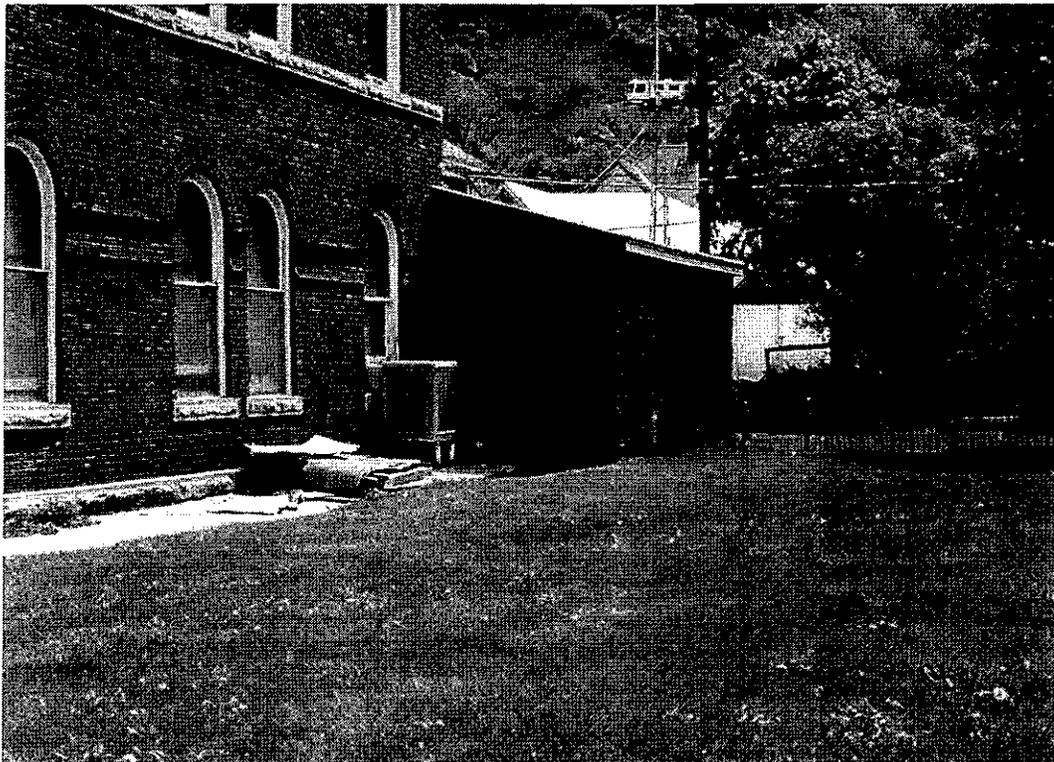
K - Photograph of Existing South Side Vault Addition

This photograph illustrates the current state of the vault addition.

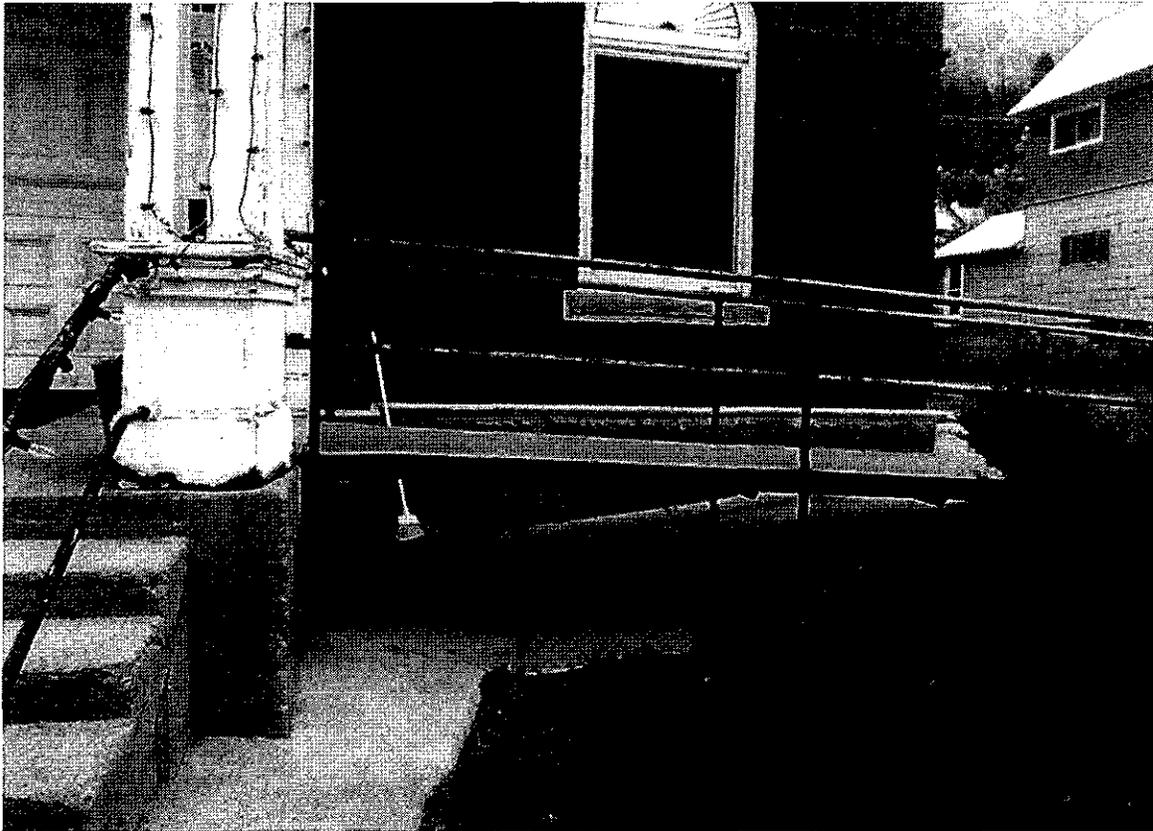
L - Detail Photograph of West Side of Courthouse

This photograph illustrates many of the problems at the Courthouse entry area. Specifically note:

- The concrete bridge and steps below the portico.
- The deterioration of the portico base.
- The steel guardrails and wheelchair ramp.
- The filled in moat and bricked window opening.

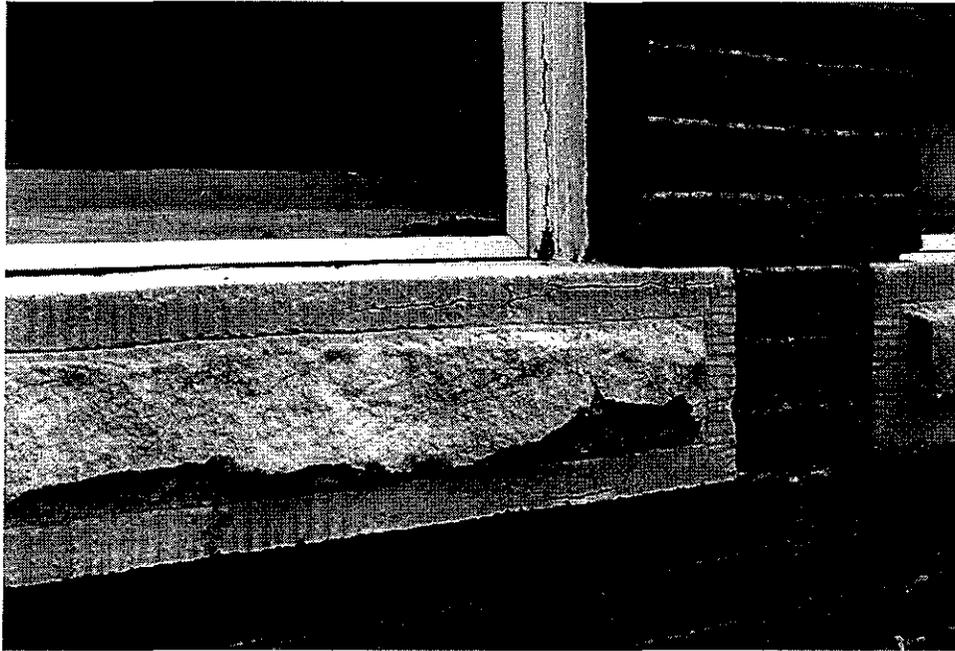
M - Photograph of Typical Stone Sill

Photograph shows typical sill fractures.

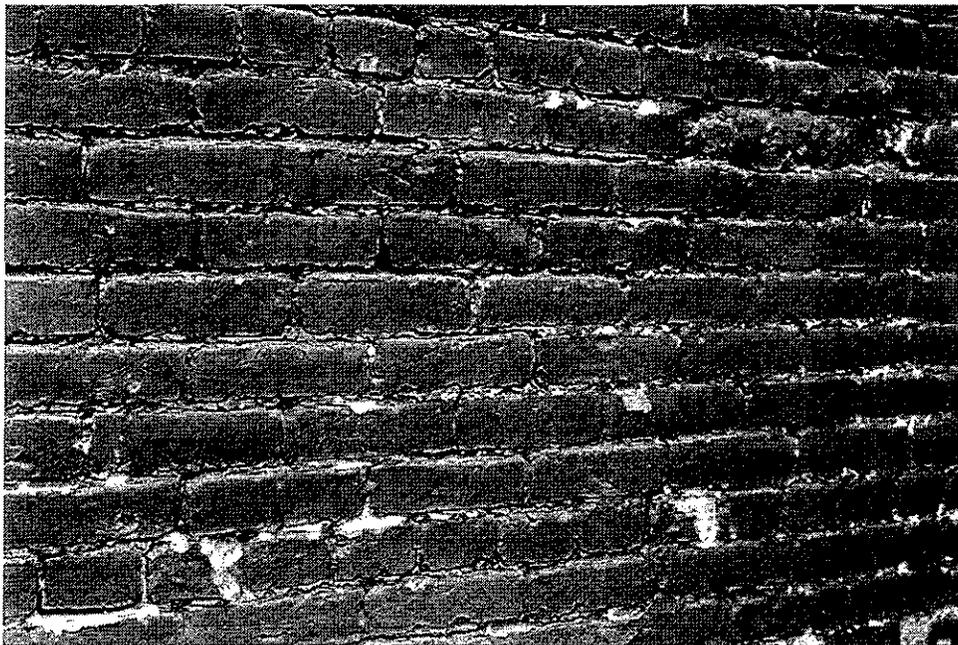
N - Photograph of Typical Brick Masonry

Photograph shows deterioration typical to most painted masonry.

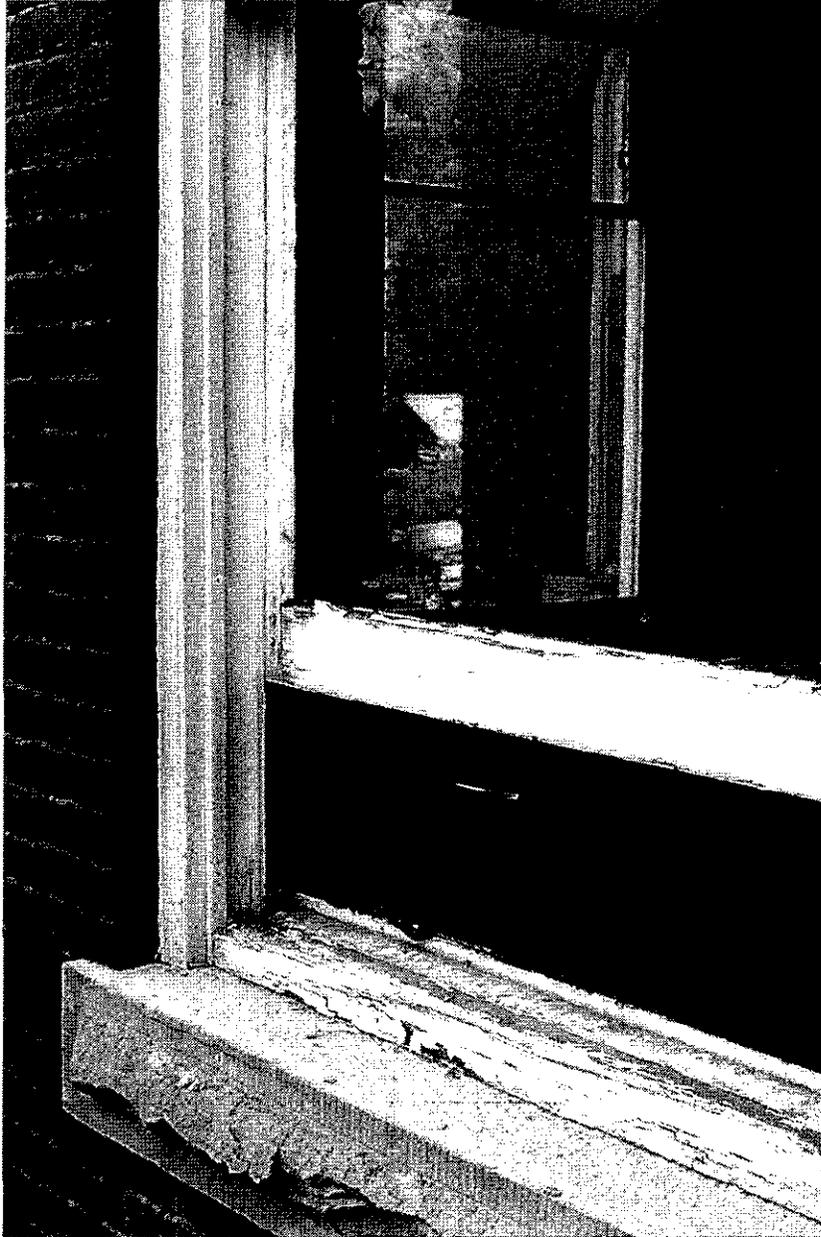
O - Detail Photograph of Typical Courthouse Window

Photograph shows typical condition of existing windows.

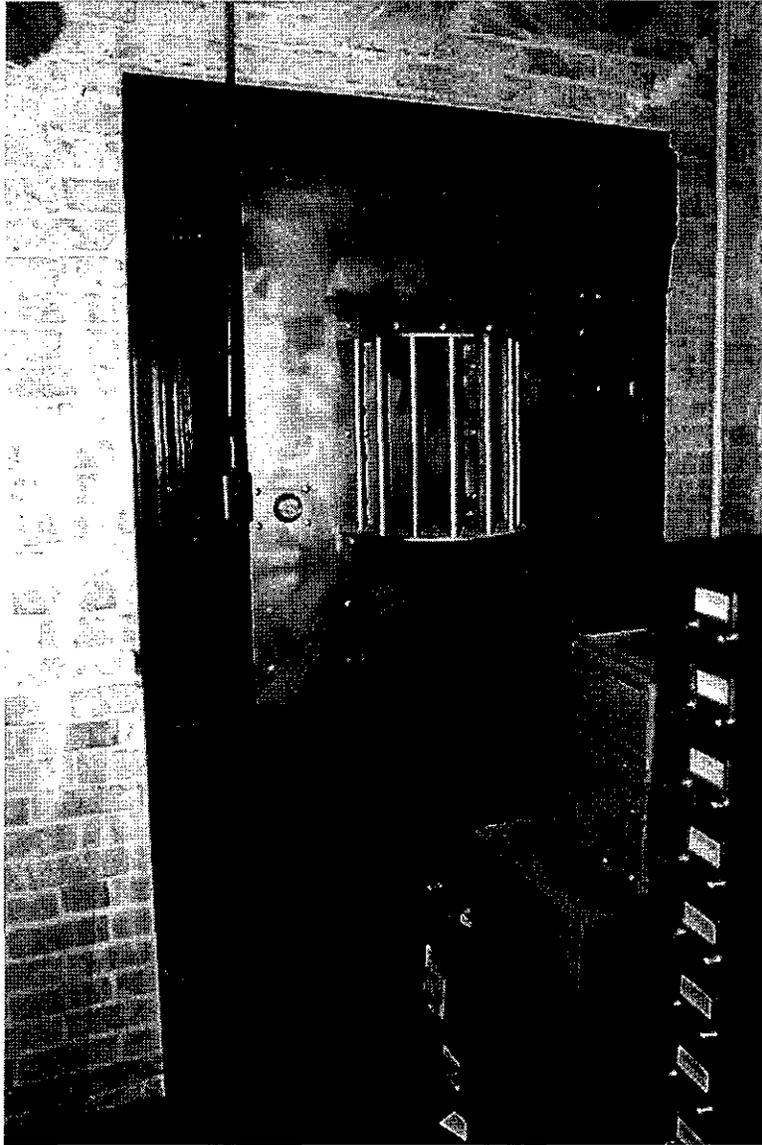
P - Photograph of Original Jail Cell Door

This photograph shows one of the original jail doors to be retained in the Jail building.

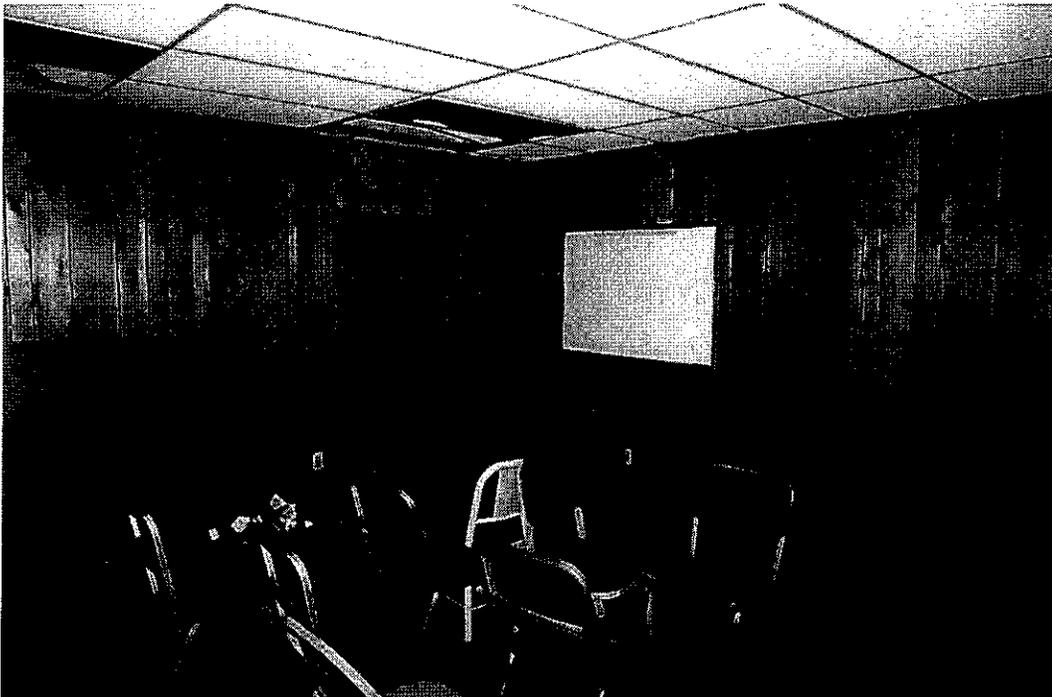
R - Photograph of Existing Room in Jail Building

This photograph shows the condition of some rooms in the Jail building ground floor. Paneling and suspended ceiling are to be removed.

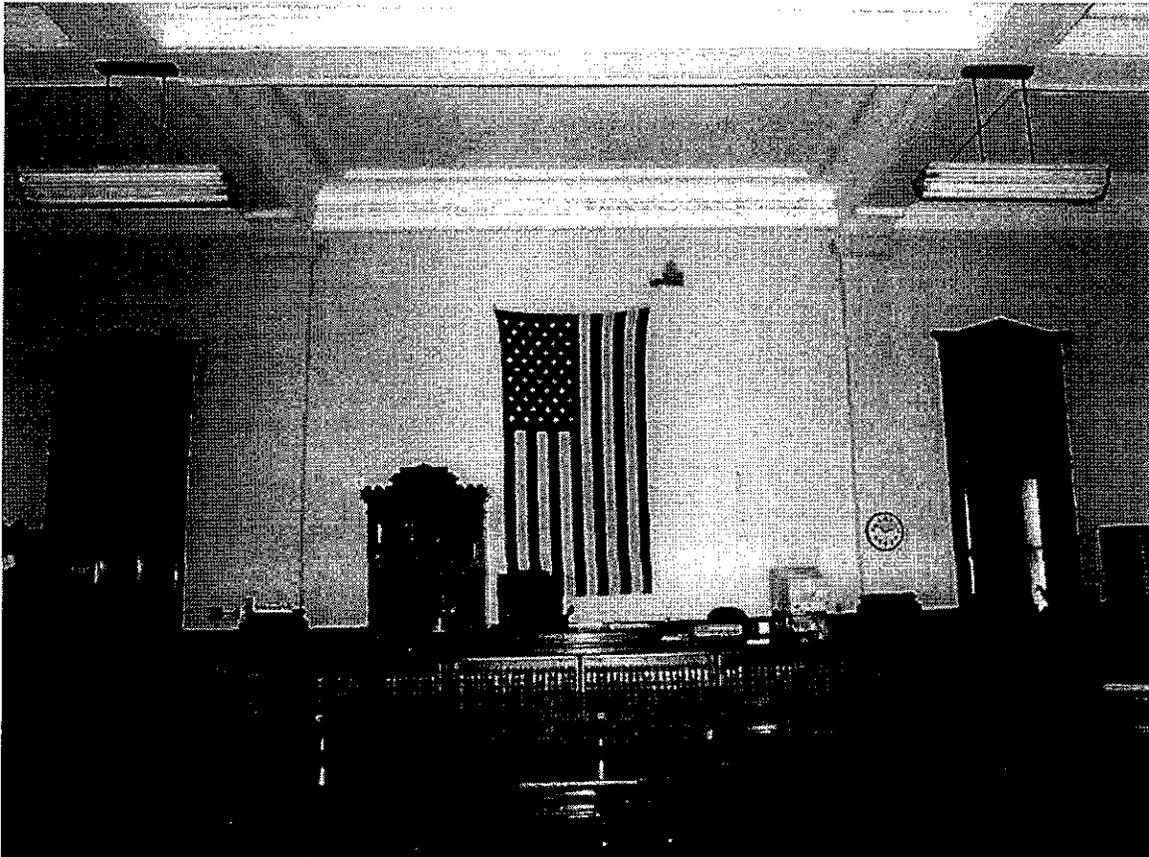
S - Photograph of Courtroom Interior

This shows the current state of the Courtroom interior. Note the judges desk obscured by book cases and poorly executed casework. The existing light fixtures are to be replaced. Visible near the ceiling is a small portion of exposed decorative frieze. (See inset detail below.)

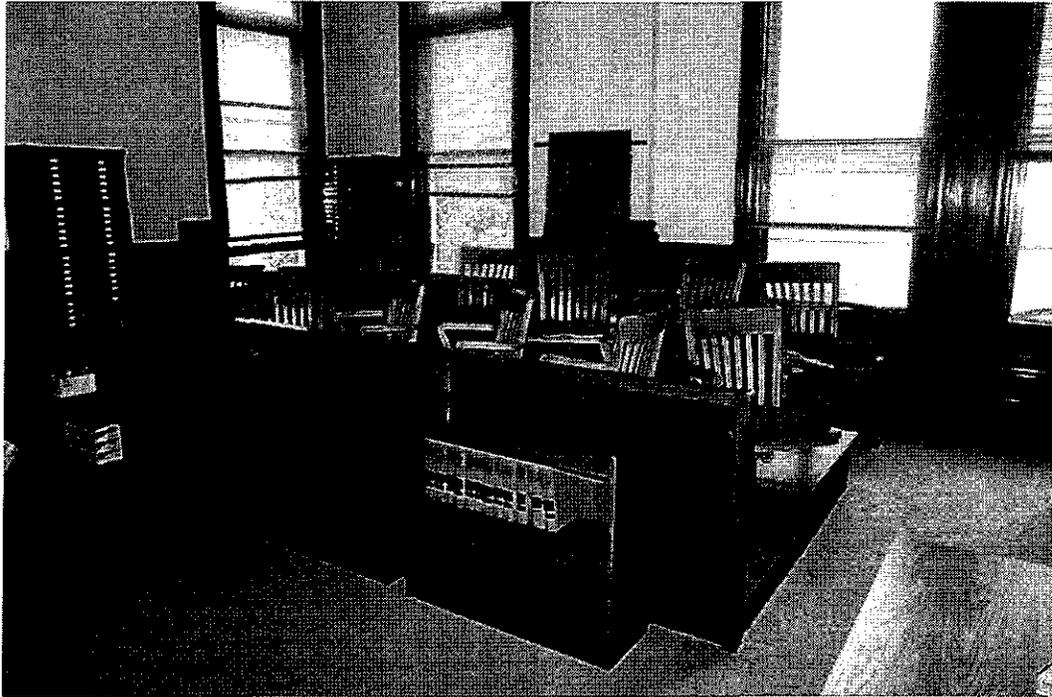
T - Photograph of Courtroom Jury Box

This photograph shows a closer view of the inappropriate casework added to the Courtroom.

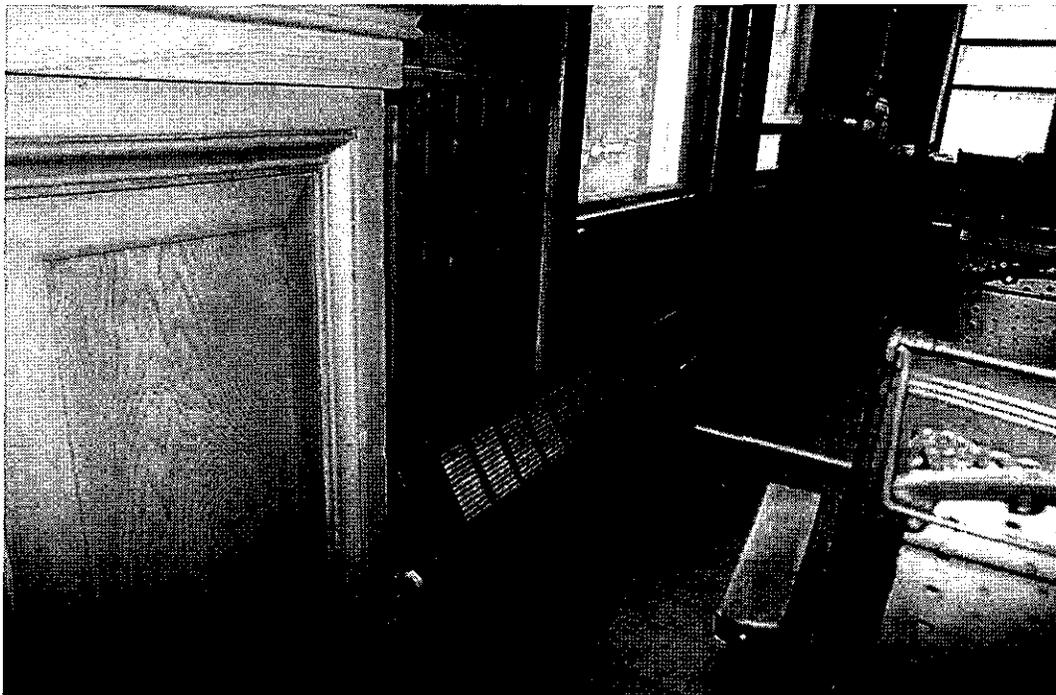
U - Photograph of Courtroom Heaters

This photograph shows how the existing radiators obscure the original woodwork. Note the quality of the faux oak graining on the pine wood.

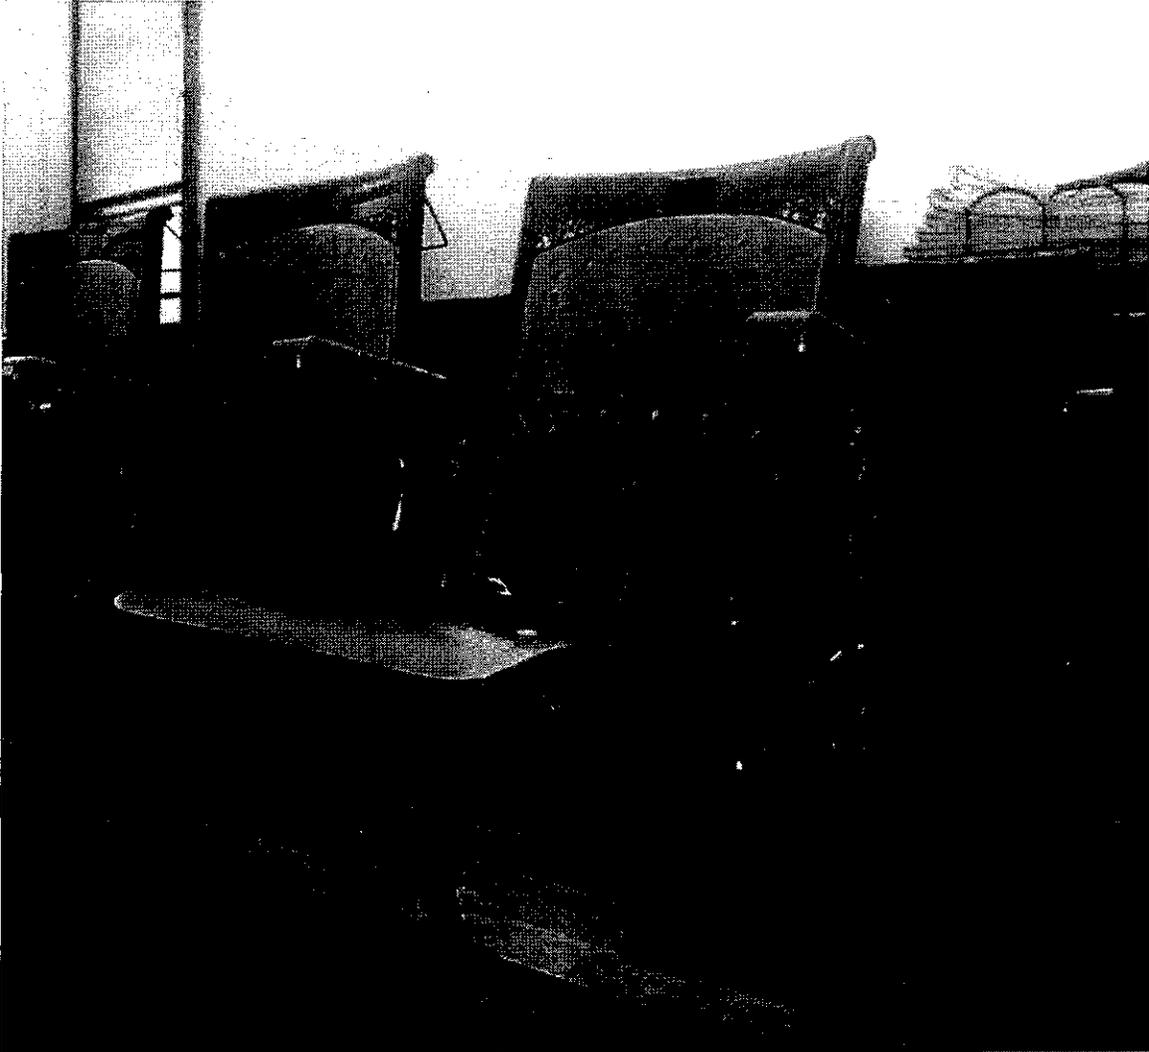
V - Photograph of Courtroom Seating

This photograph shows the original Courtroom seating that is still in use.

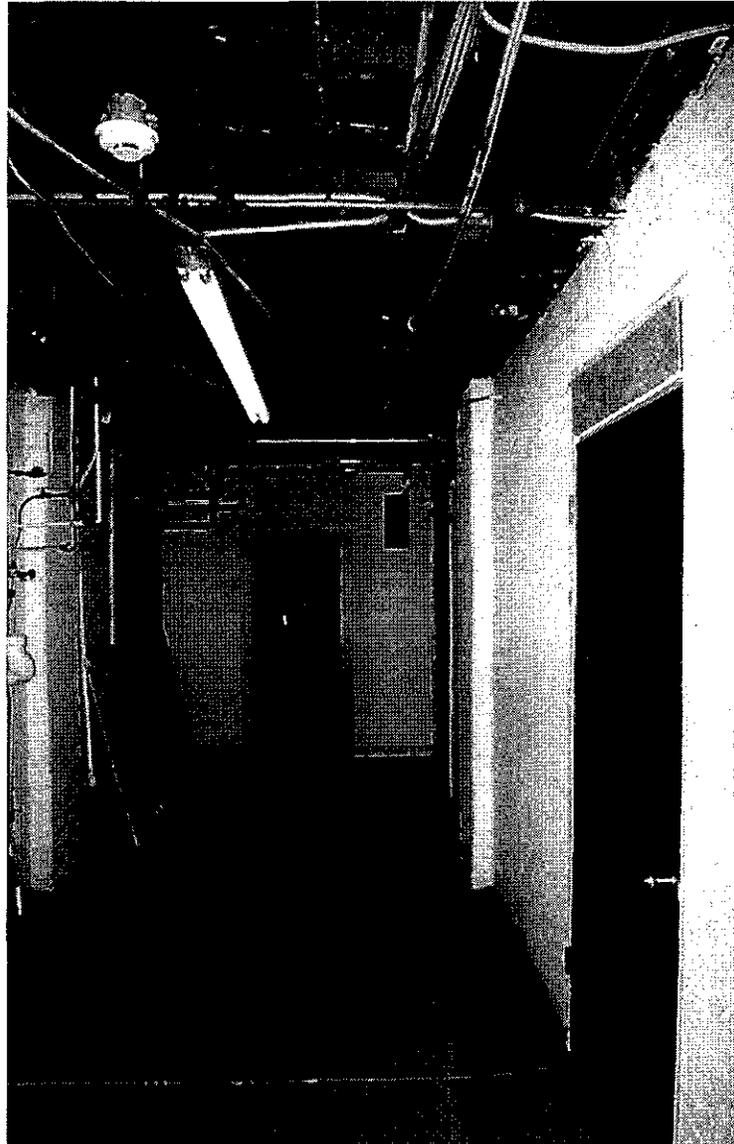
W - Photograph of Courthouse Basement

This photograph shows the existing condition of the ceiling in this area. Note the unprotected exposed joists.
