FEASIBILITY STUDY FOR THE OURAY COUNTY COURTHOUSE

OURAY, COLORADO

MARCH 2017

CHARLES CUNIFFE ARCHITECTS

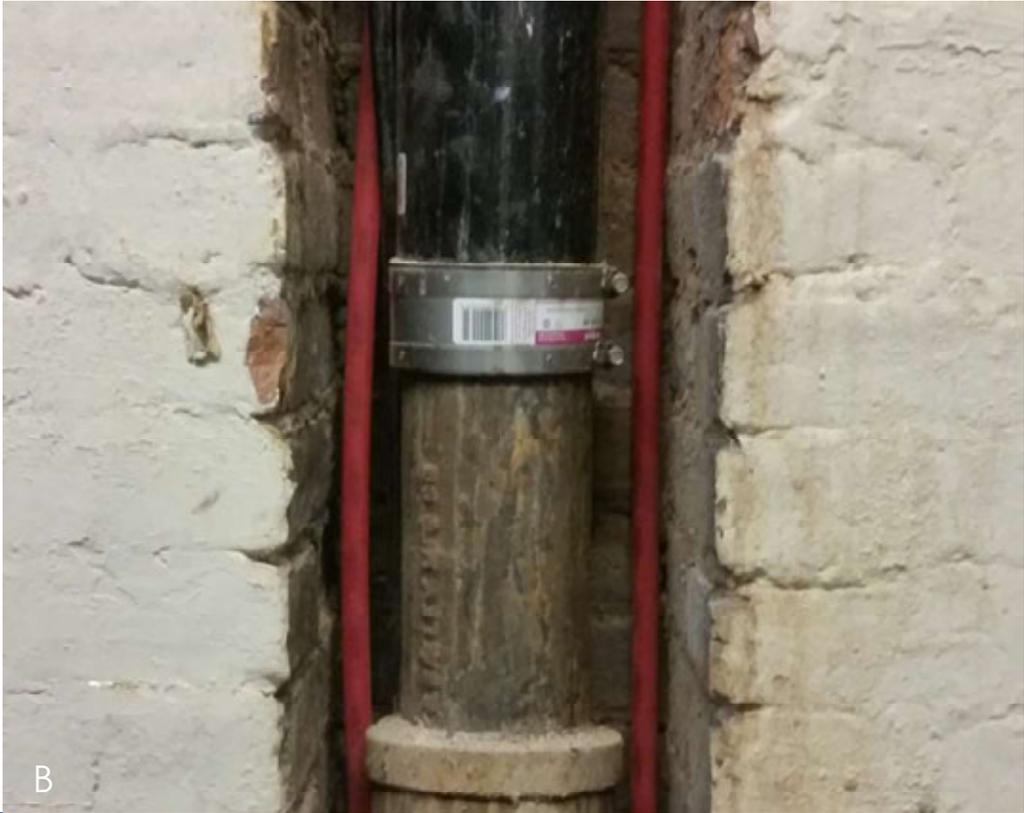
B

Exhibit B, C - Newly retrofitted pipe in brick wall to fix plumbing leak. Pipe has been left exposed in masonry wall.

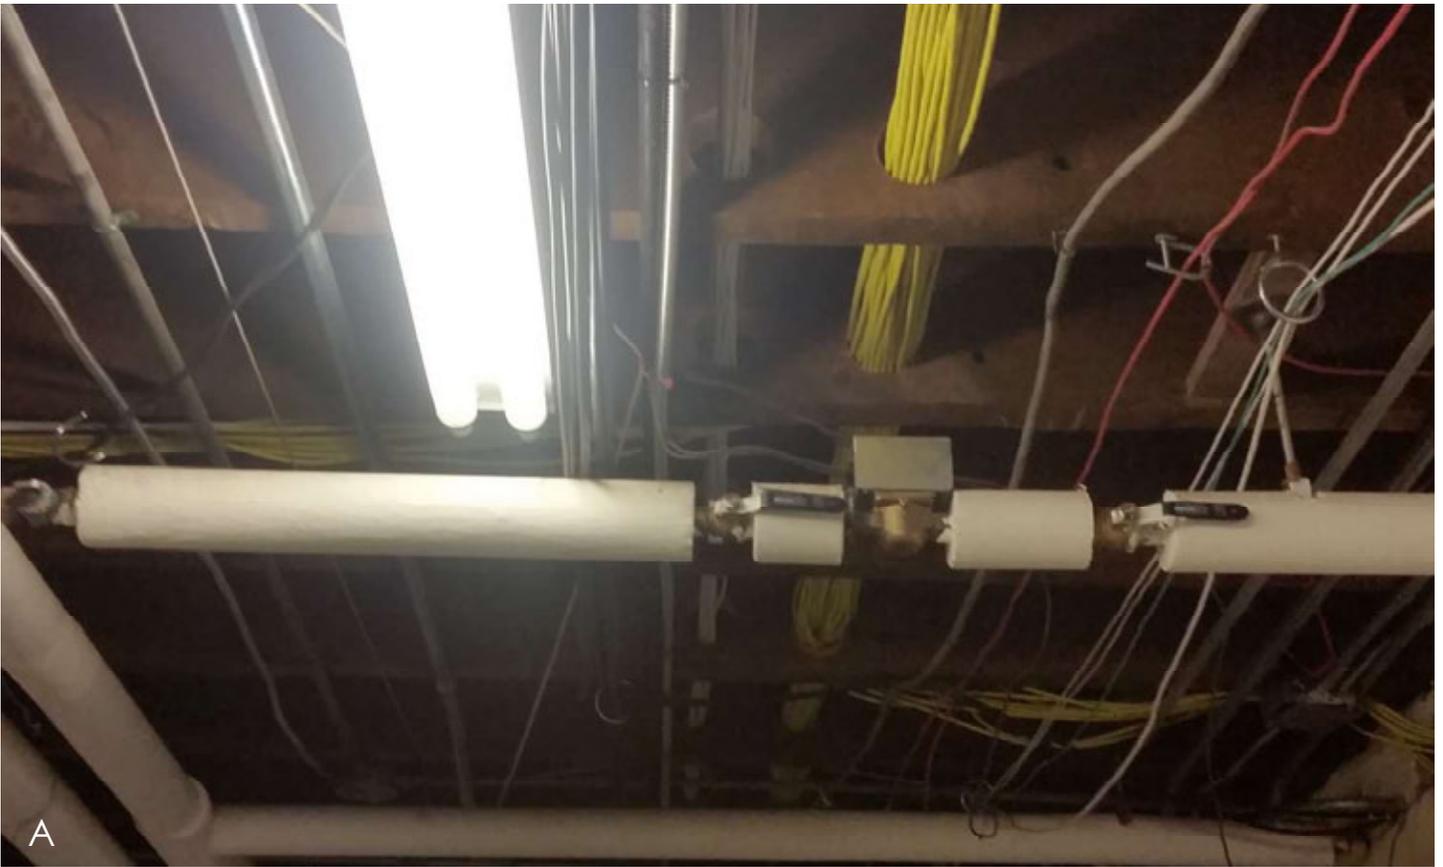
Exhibit A - Exposed plumbing is left in the basement hallway following a recent plumbing leak on the second floor.

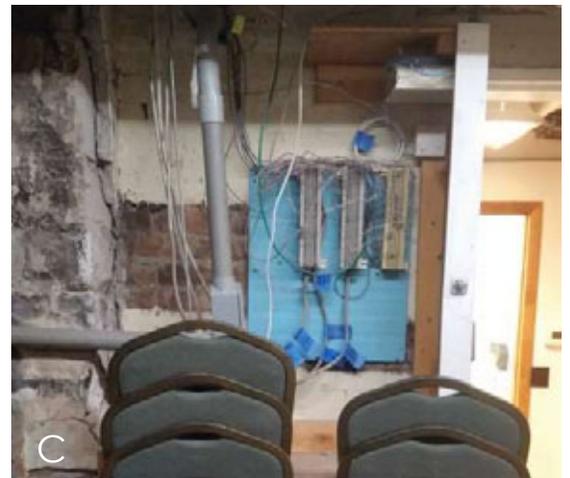
Exhibit A shows exposed electrical wires, plumbing, and insulation in the basement hallway ceiling. Exhibit B outlines the extent of exposed and cracking plaster/drywall along the stairwell. The historic brick is exposed but not properly protected. Exhibit C shows the updated building systems in a historic building and how better integration and concealment is needed.

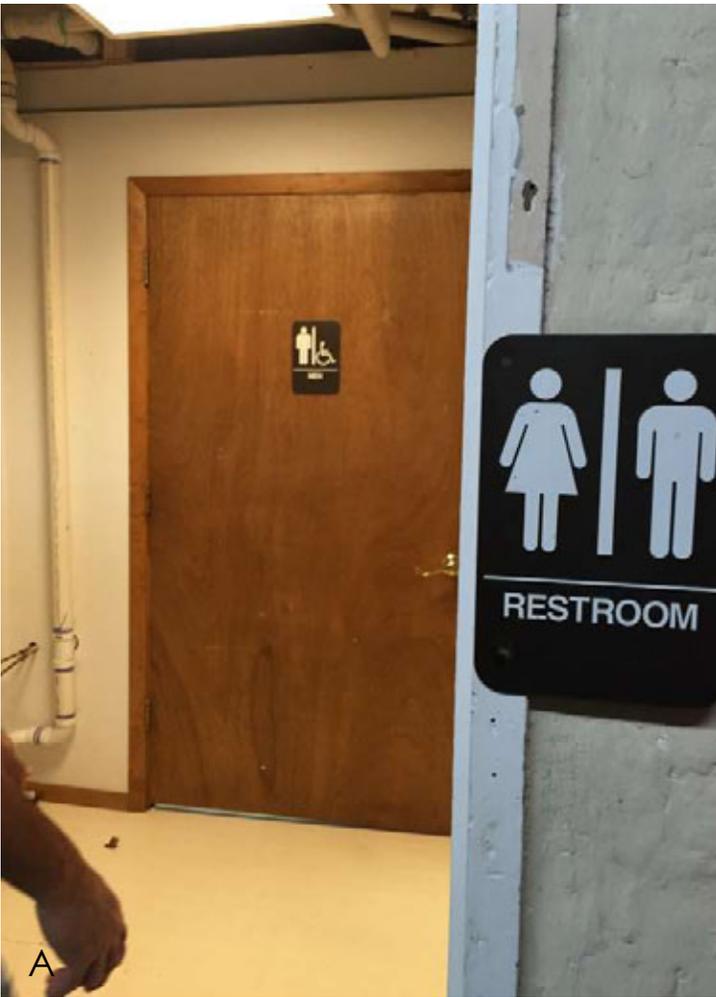
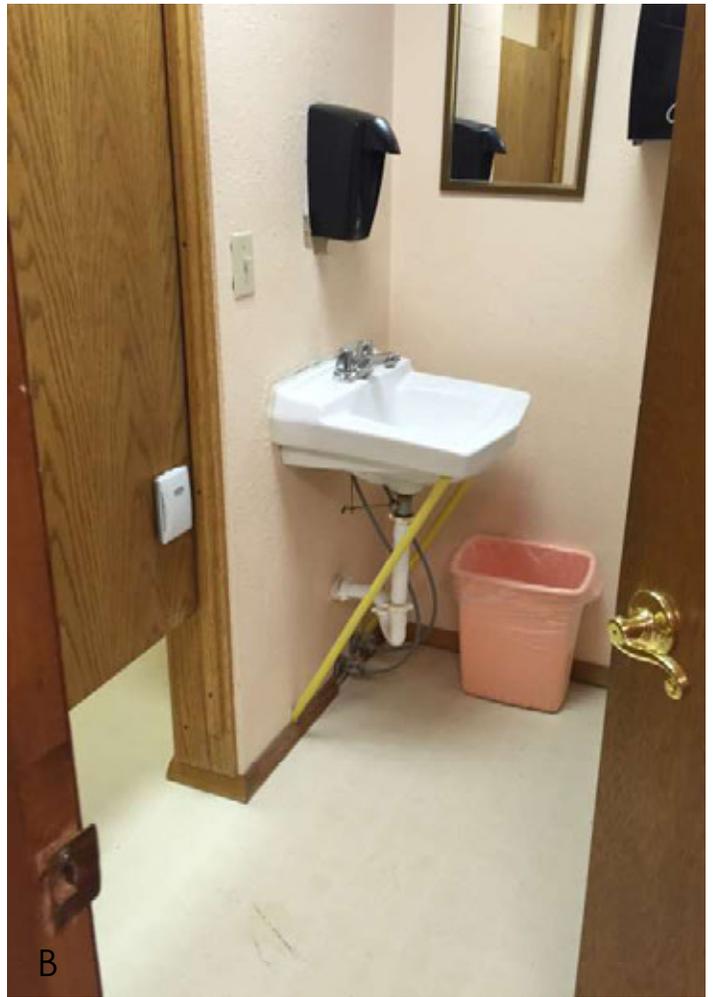
Exhibit A, B - The only public restroom in the Courthouse is located in the basement. These restrooms don't have the necessary number of fixtures, are outdated, and pose security problems by allowing Jurors to interact with the public. Exhibits C and D - Office and storage space is maxed out in the Courthouse leading to non-functional work spaces and unorganized storage.

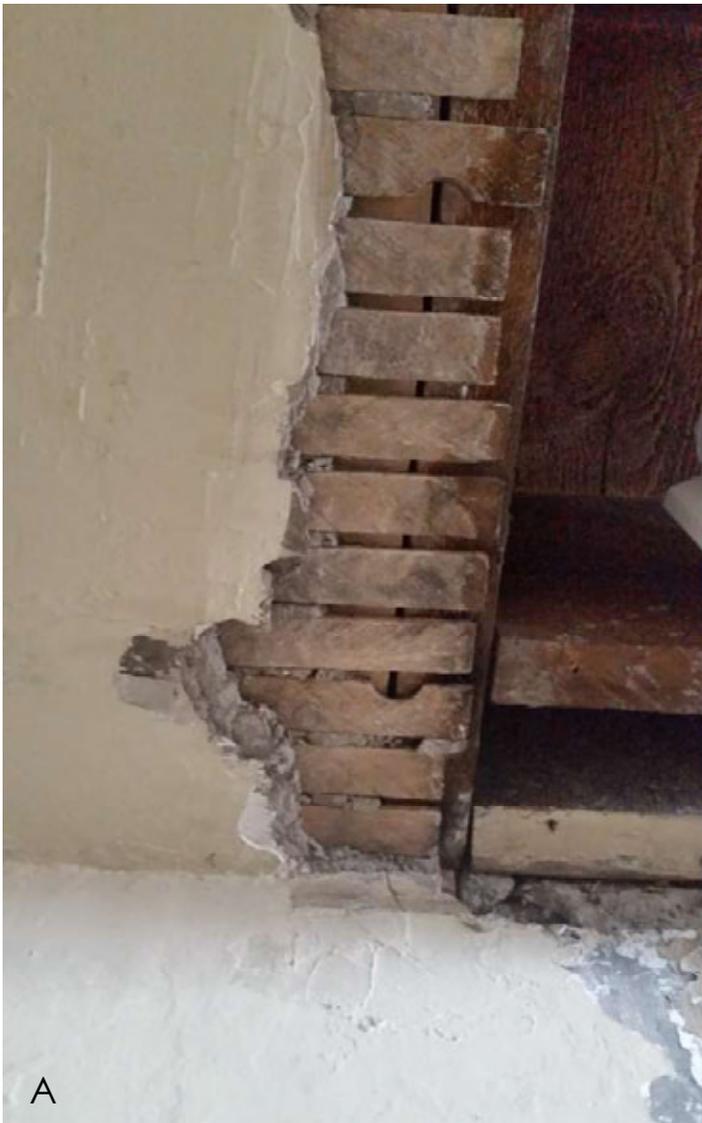
Exhibit A - Basement level stairwell with exposed ceiling structure, cracking plaster and drywall.

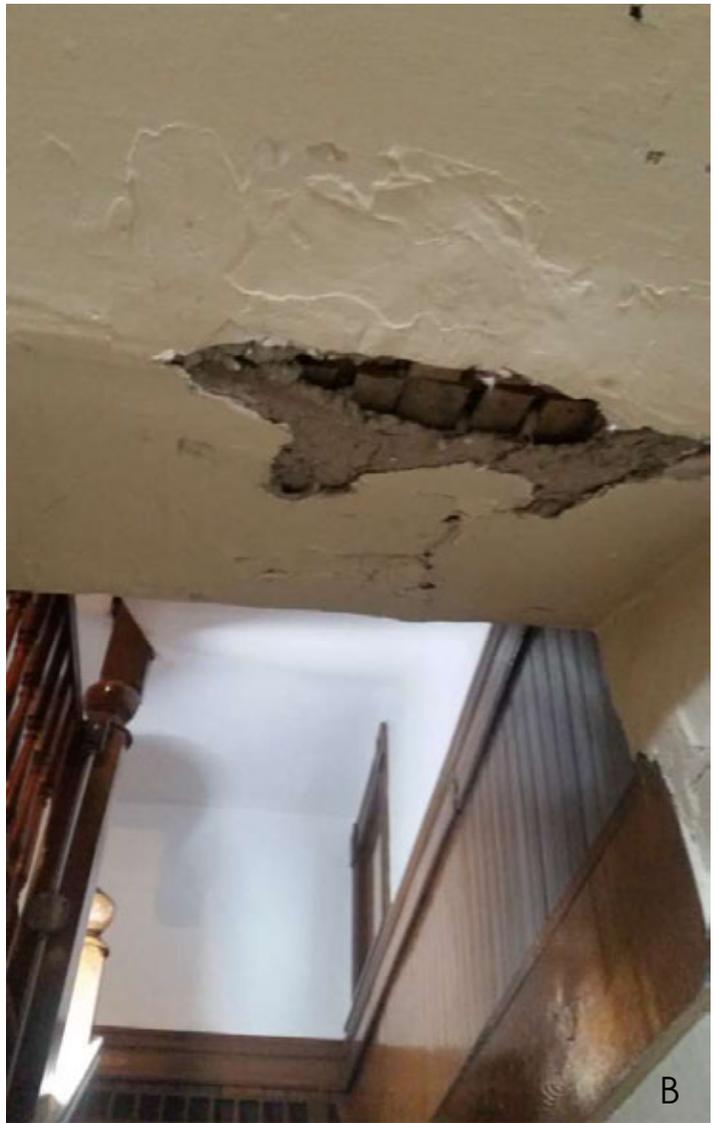
Exhibit B - View from stairwell up towards main hallway. Plaster and drywall is cracking, missing, and deteriorating further.

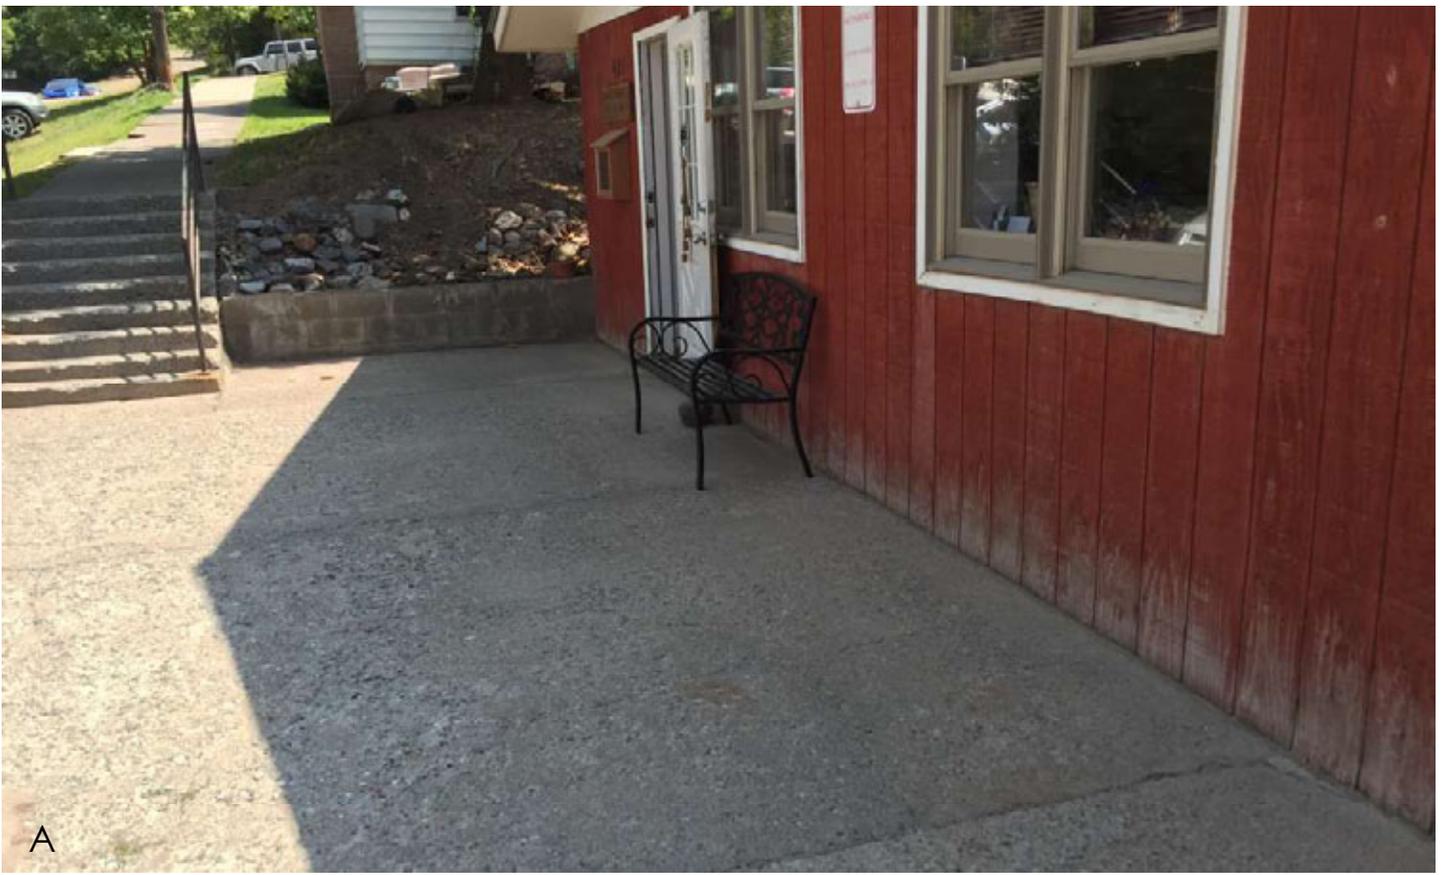
A

Exhibit A,B - Weathering and discoloration along the base of County Assessor building.

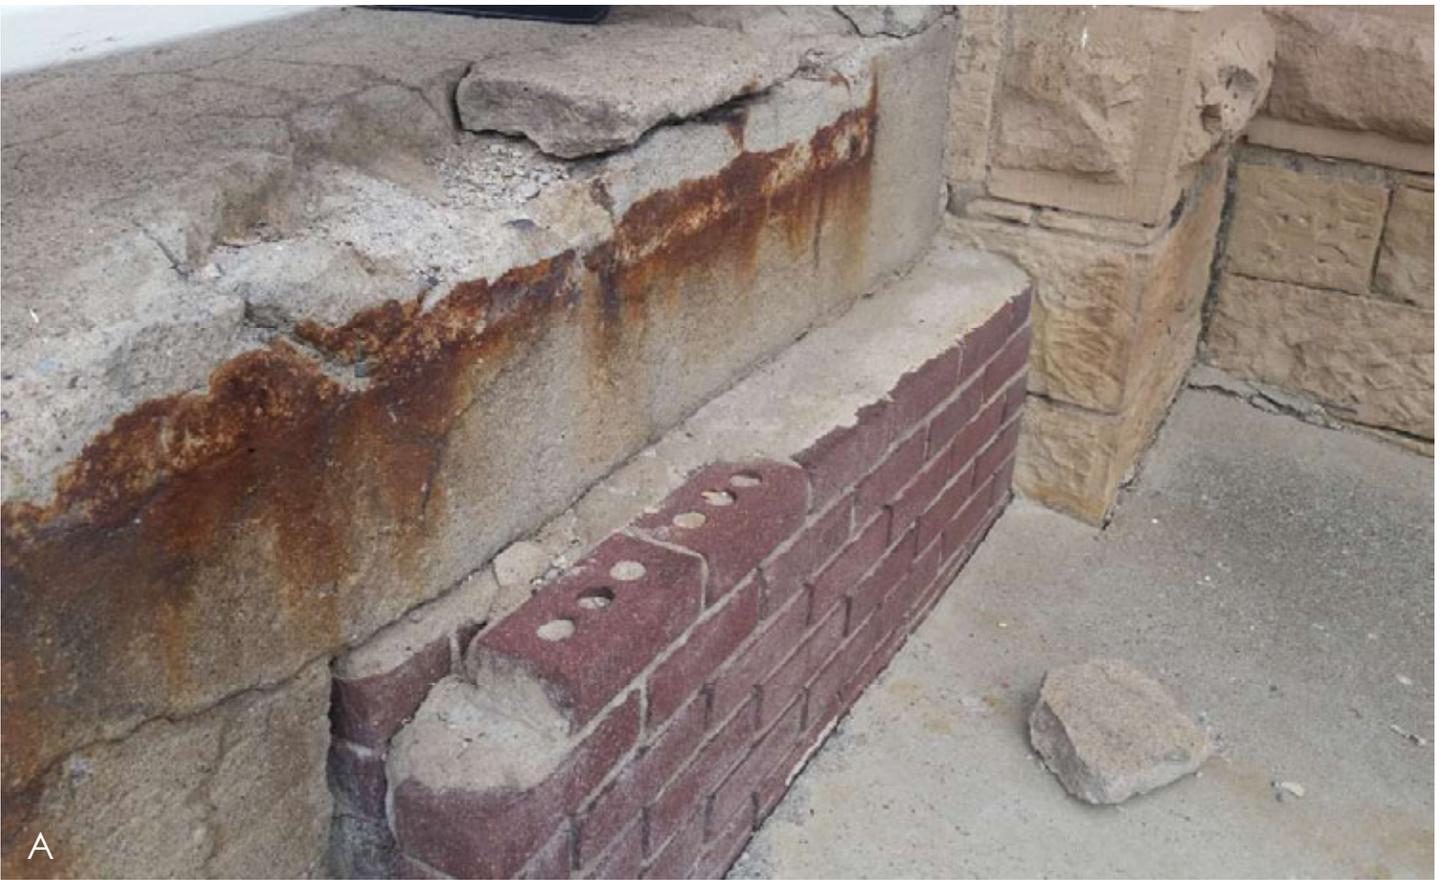
A

Exhibit A, B, C - The front entry steps have cracking and splitting concrete at step edges. Exposed masonry units are losing mortar, and discoloration is evident along the stair landing and stone base. Exhibit B illustrates the basement level window and moat that has since been infilled with brick.

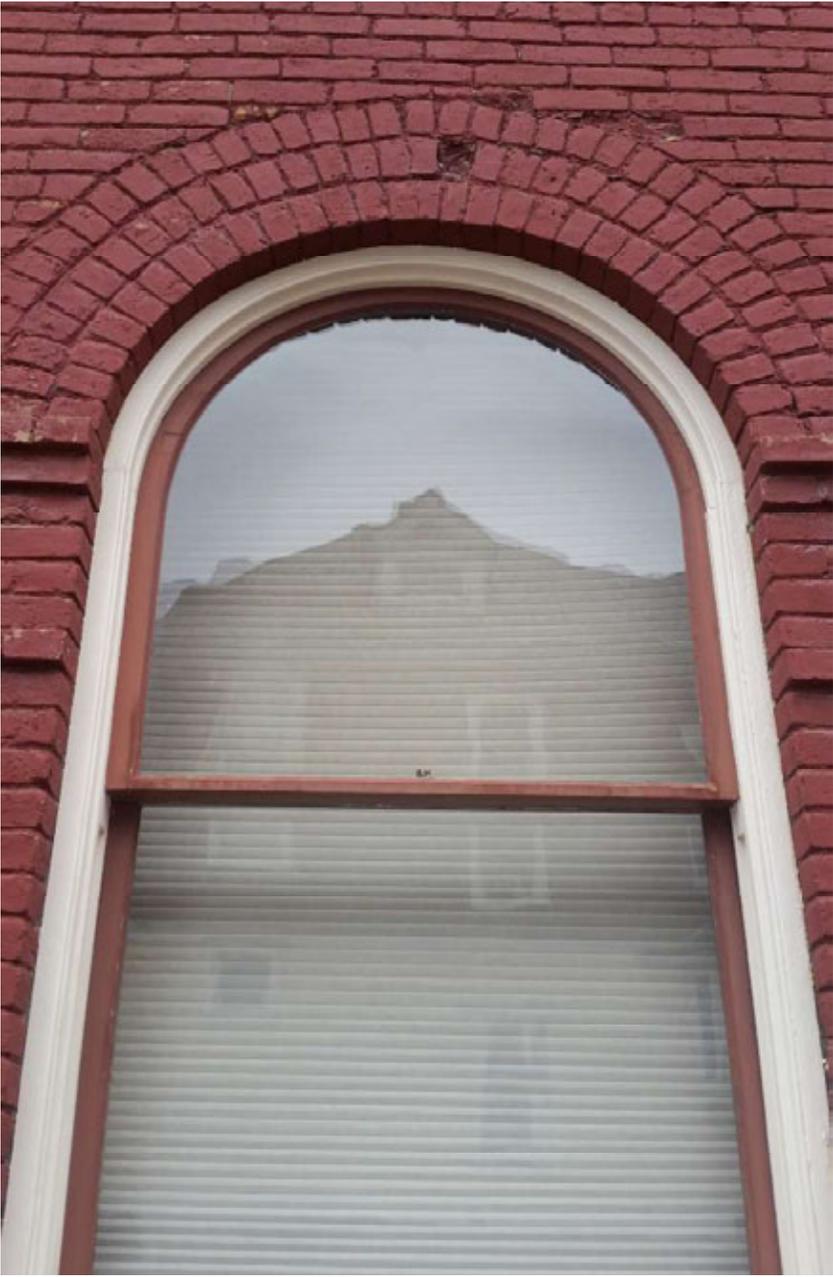
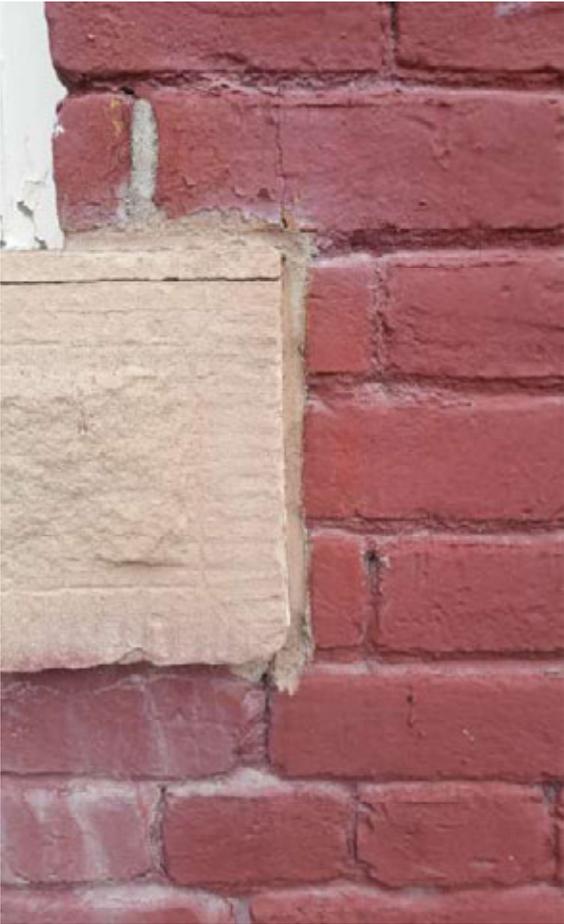
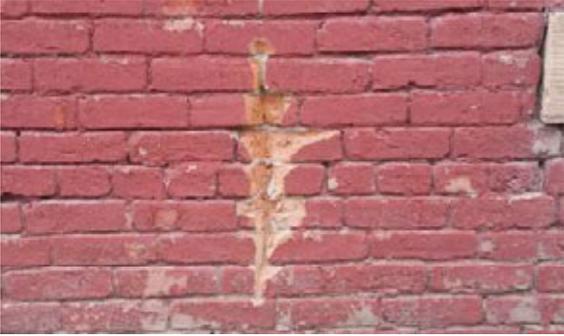
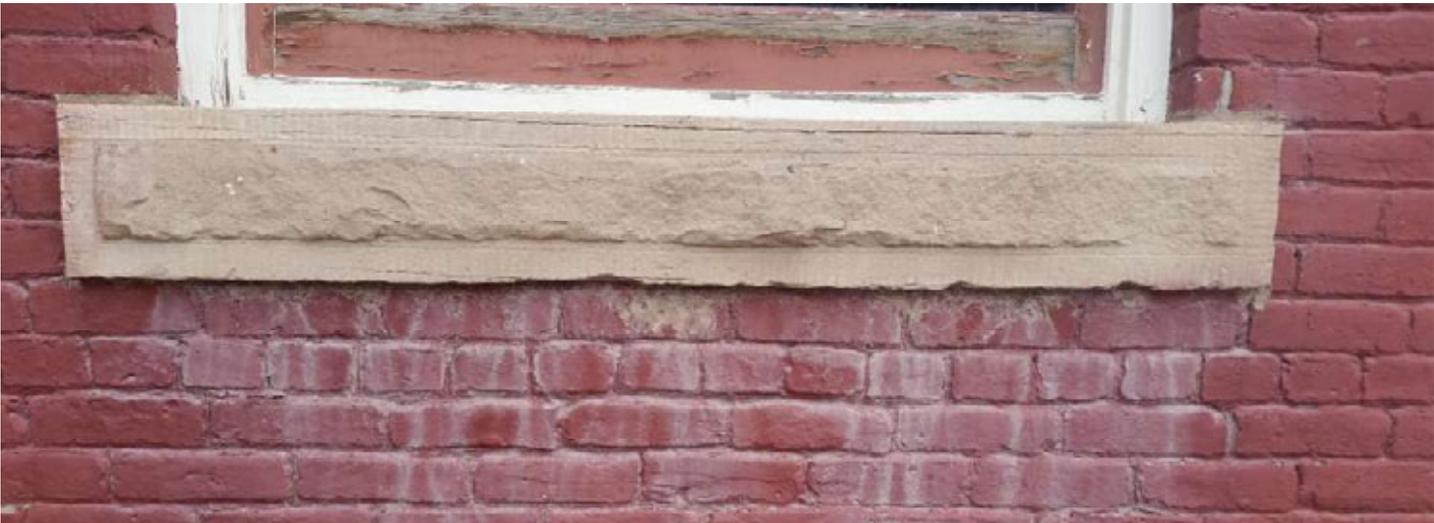
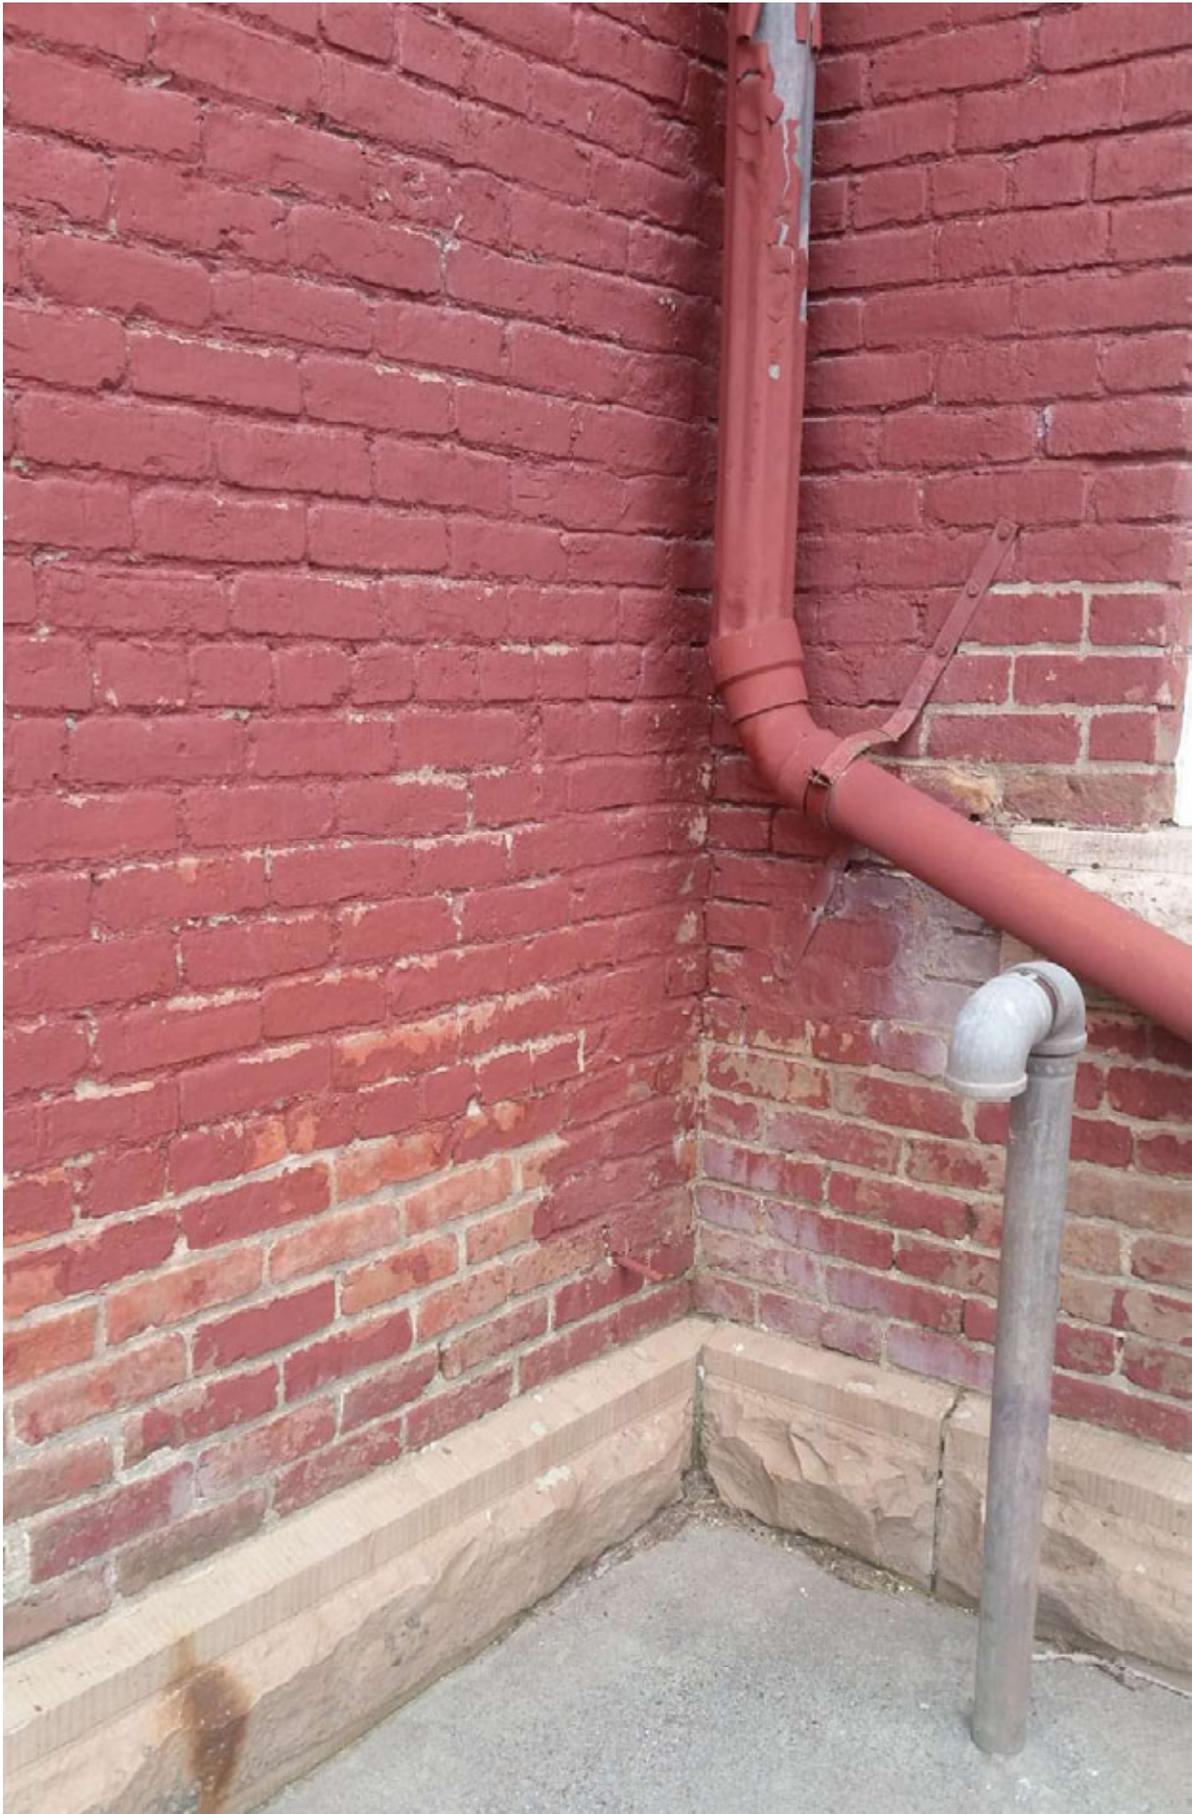
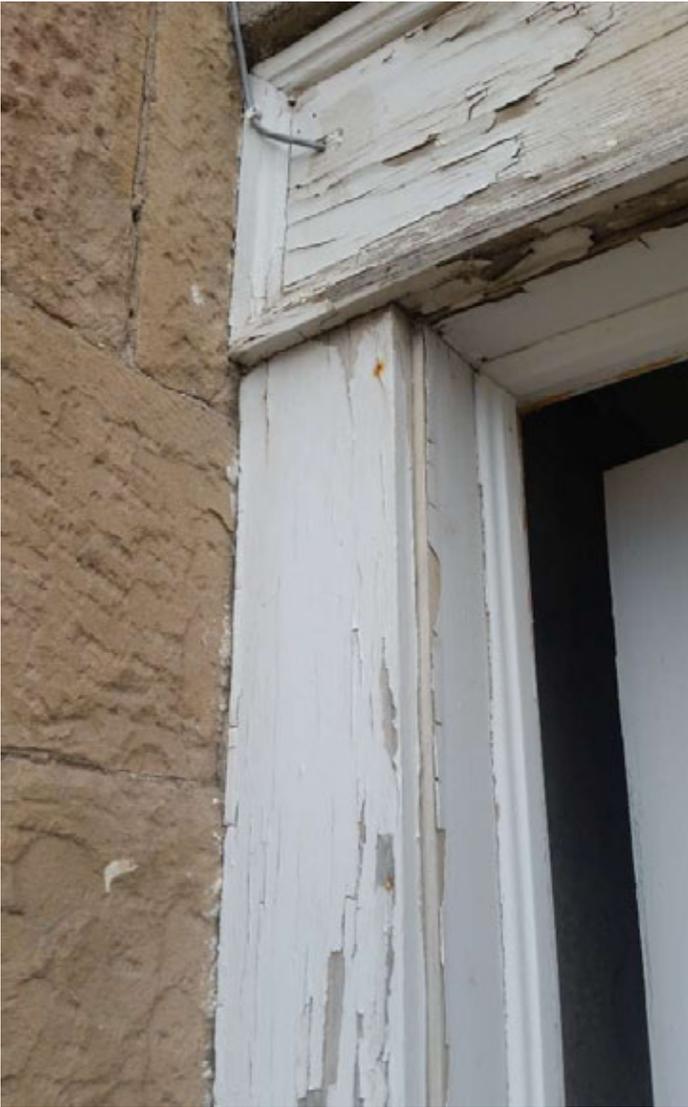
Exhibit A, B, C - The stone foundation wall at the basement level is not plumb, has many gaps between foundation stones, and is showing evidence of erosion at its base. The wood window sill outside of the existing EMS office at this level has chipped and peeling paint and weather damage. Exhibits D and E show staining and discoloration at the painted bricks and stone base. Exhibit F - The existing sidewalk along 6th Ave is not ADA compliant in its slope, and accumulates a dangerous amount of ice during the winter.

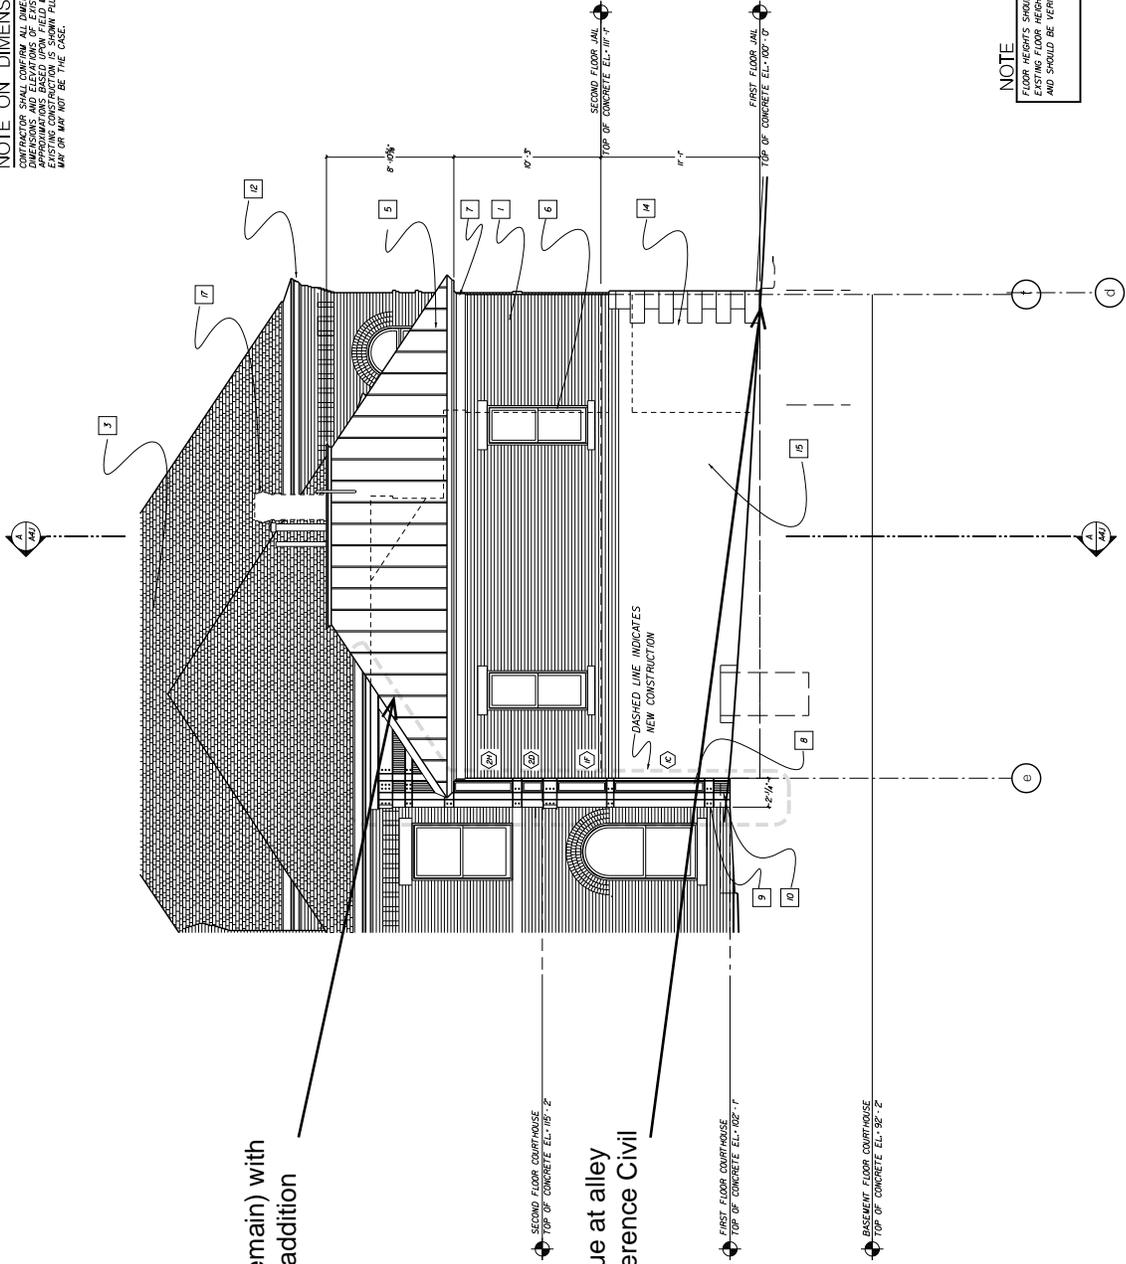
Jail building (to remain) with 2008 connection addition behind.

Address icing issue at alley and sidewalk; reference Civil Report.

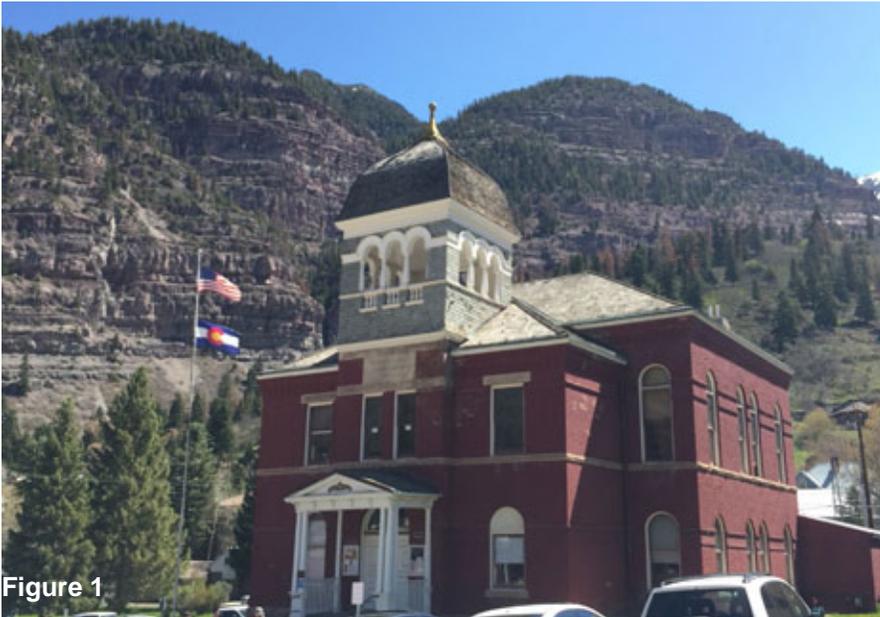
Figure 1

The Courthouse and Jail buildings do not meet current life safety codes, specifically with regard to fire protection as there is no fire suppression system. Decades of water and moisture infiltration at the perimeter of the building and into the below-grade space have created deterioration of mortar within the structural foundation. Water infiltration at the location of the roof and cupola has created deterioration of both the exterior masonry and interior wall finishes. The existing piping for domestic water and waste appear to have surpassed its useful life and needs replacement. The net result is that this jewel of a building with one of the strongest ties to Ouray County's past is in danger of becoming unfit for occupancy unless action is taken. Given the age and condition of all of the systems, and lack of building insulation, the utility costs are very high. Many exterior trims and joints have opened up permitting weather penetration that is accelerating the deterioration. Finally, the exterior masonry has been painted from its original state. The paint is in an extreme deteriorated state, and is not of historic origin. A more detailed description of existing conditions appears later in this report (Figures 1, 2, 3).

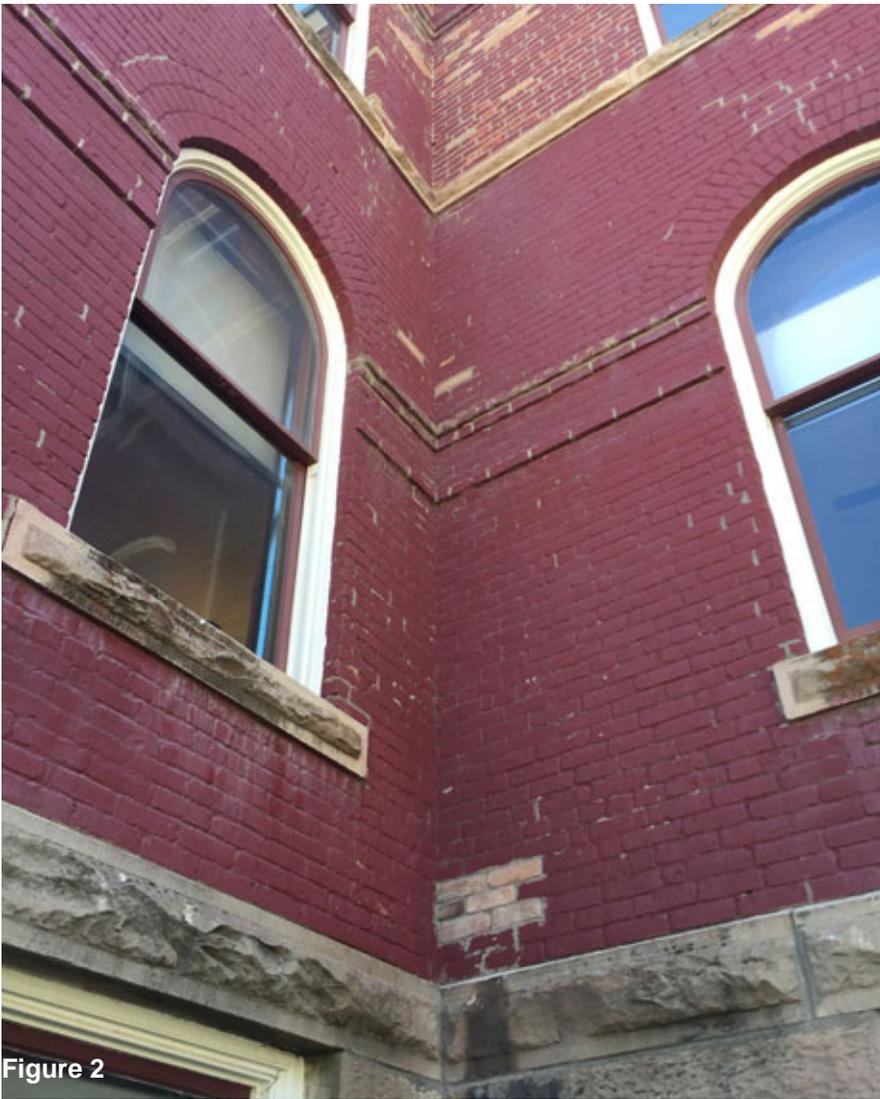
Figure 2

Exterior views of the Courthouse with its various locations of peeling paint, lichen on the limestone, and damaged bricks.

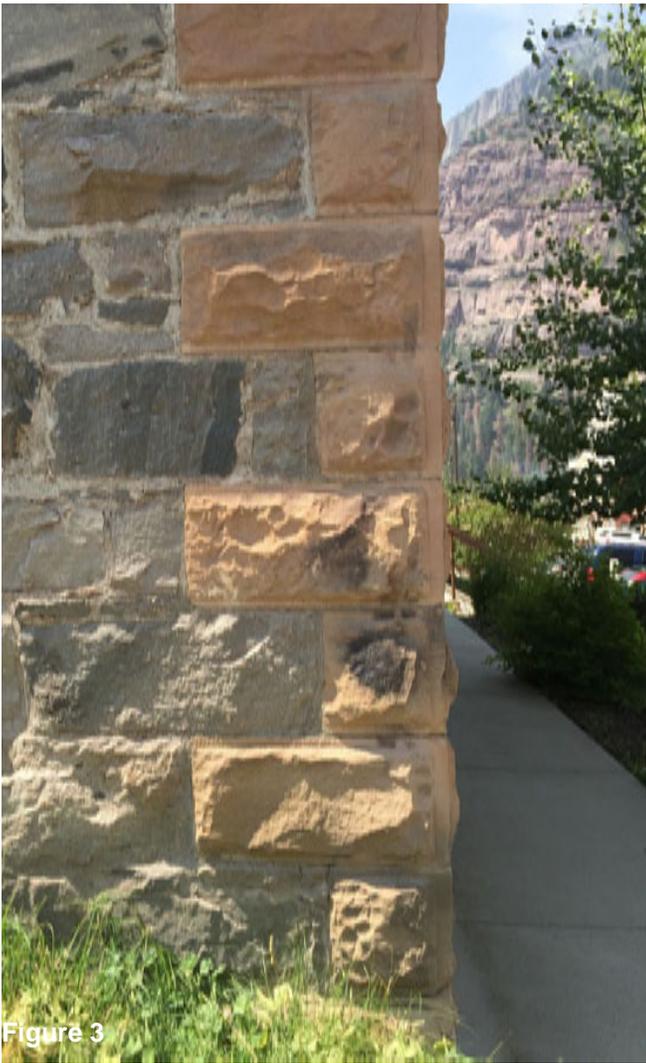
Figure 3

The base of both the Courthouse and the Jail building is a combination of sandstone laid in a random ashlar pattern and a dark green-gray quartzite in a random rubble pattern. Again, a dressed sandstone is used for lintels, sills and quoins around window and door openings (Figures 3, 13, 15, 21).

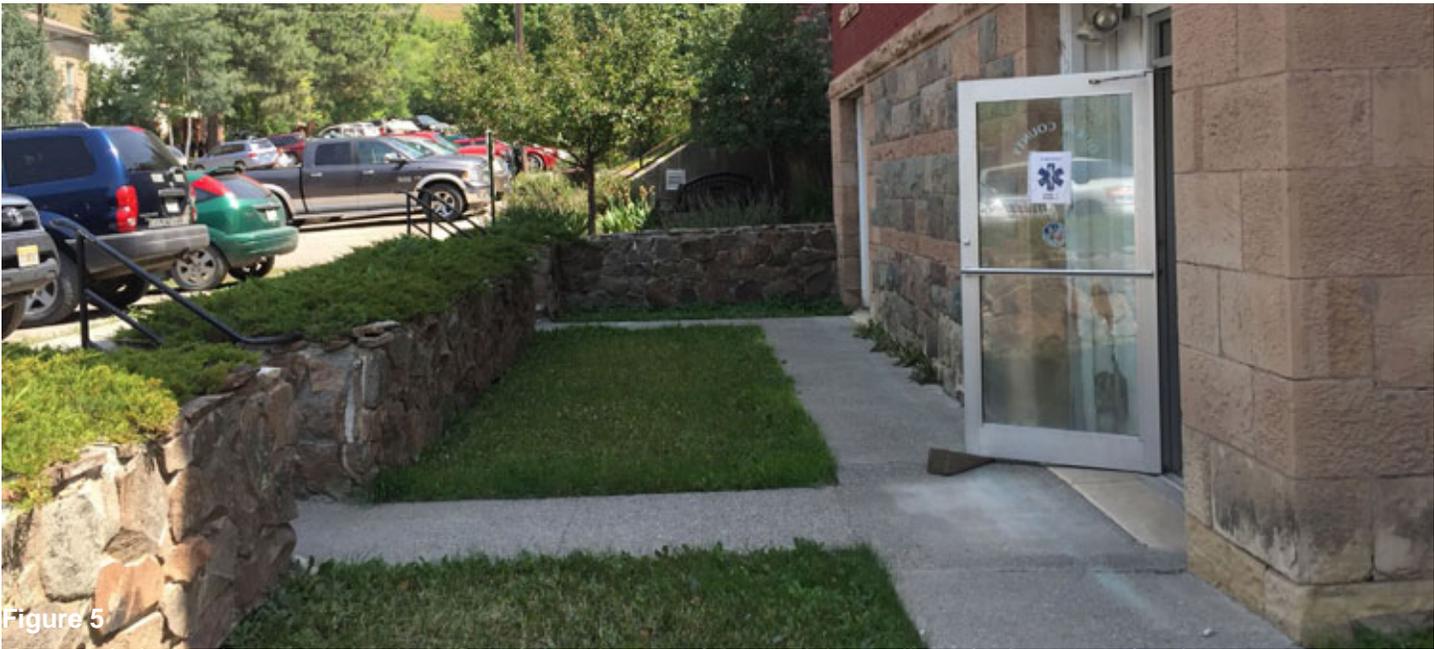
Figure 5

loose fit of the sash does not provide adequate insulation; removable storm windows have been installed within the wood frames on the north interior. A peculiar condition can be observed in comparing the main floor windows on both sides of the front entry porch. The left window is typical of others in the building with two sashes, the upper being an arch-top. The right window, however, consists of a large single sash and arched transom with a wood fan-shaped in-fill. Historical photos show this asymmetrical detail, and it may be an original solution to the conflict between the entry foyer stair soffit and the window head. Some changes have occurred to the original door and window patterns. Glazed aluminum doors have been installed in the north basement openings (Figure 5). A few basement window openings have been in-filled with brick and horizontal sliding metal windows.

Stone coloring and appearance along Courthouse base and the retaining walls at the basement level.

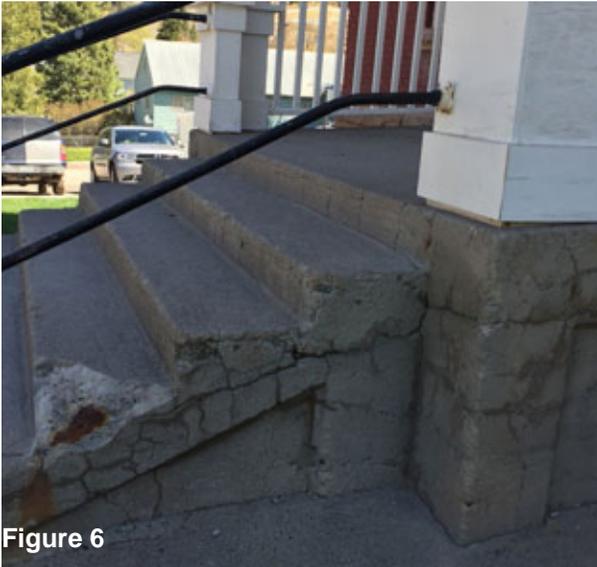
Figure 6

The wood entry porch is an important stylistic element of the building. The elegance of the shallow gable, the ornamental brackets, and the subtly tapered triple corner columns contrast with the substantial masonry mass of the Courthouse. The original architectural drawings do not include this feature, but it is clearly present in the earliest photographs of the completed building. Besides serving as a sheltered entrance, the portico also functions as a bridge across the moat originally surrounding the west side of the Courthouse. The wood base (bridge) originally constructed has since been replaced with a concrete deck and steps which appear incongruous with the rest of the wooden structure (Figures 6, 7, 8).

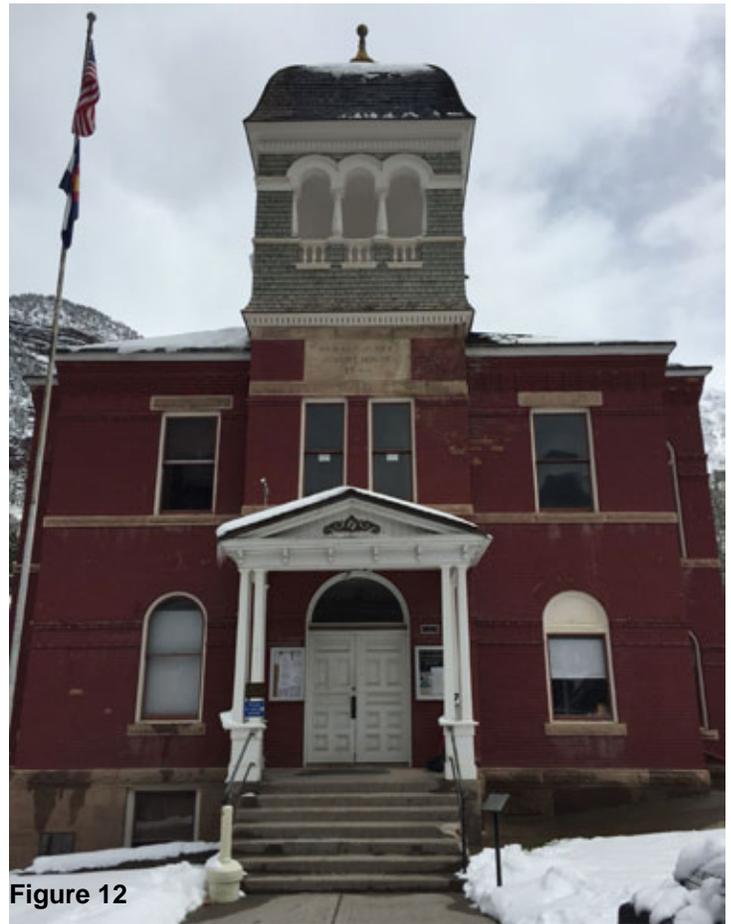
The exterior Courthouse walls are load bearing masonry construction (Figure 11, 12). The predominant exterior material on the upper floors is a locally manufactured common brick. A distinctive triangular “frog” has been impressed into the top of each brick. Most of the brickwork is four wythes thick in running bond with a head course every eighth course. Mortar joints are a nominal 3/8 of an inch. The brick is simply ornamented with arched headers at windows, projected belt courses, and a corbelled cornice. Dressed stone- primarily buff colored sandstone- has been used for belt courses, window lintels, and sills. The sandstone is probably of local derivation and has both tooled and split-face finishes.

The original double-leaf, paneled wood entry doors and wood windows remain in place (Figures 12, 88). Two types of counter-weighted double-hung windows are evident: arched-top and flat-top (Figure 1). The

Figure 12
Front view of Courthouse entry and cupola.

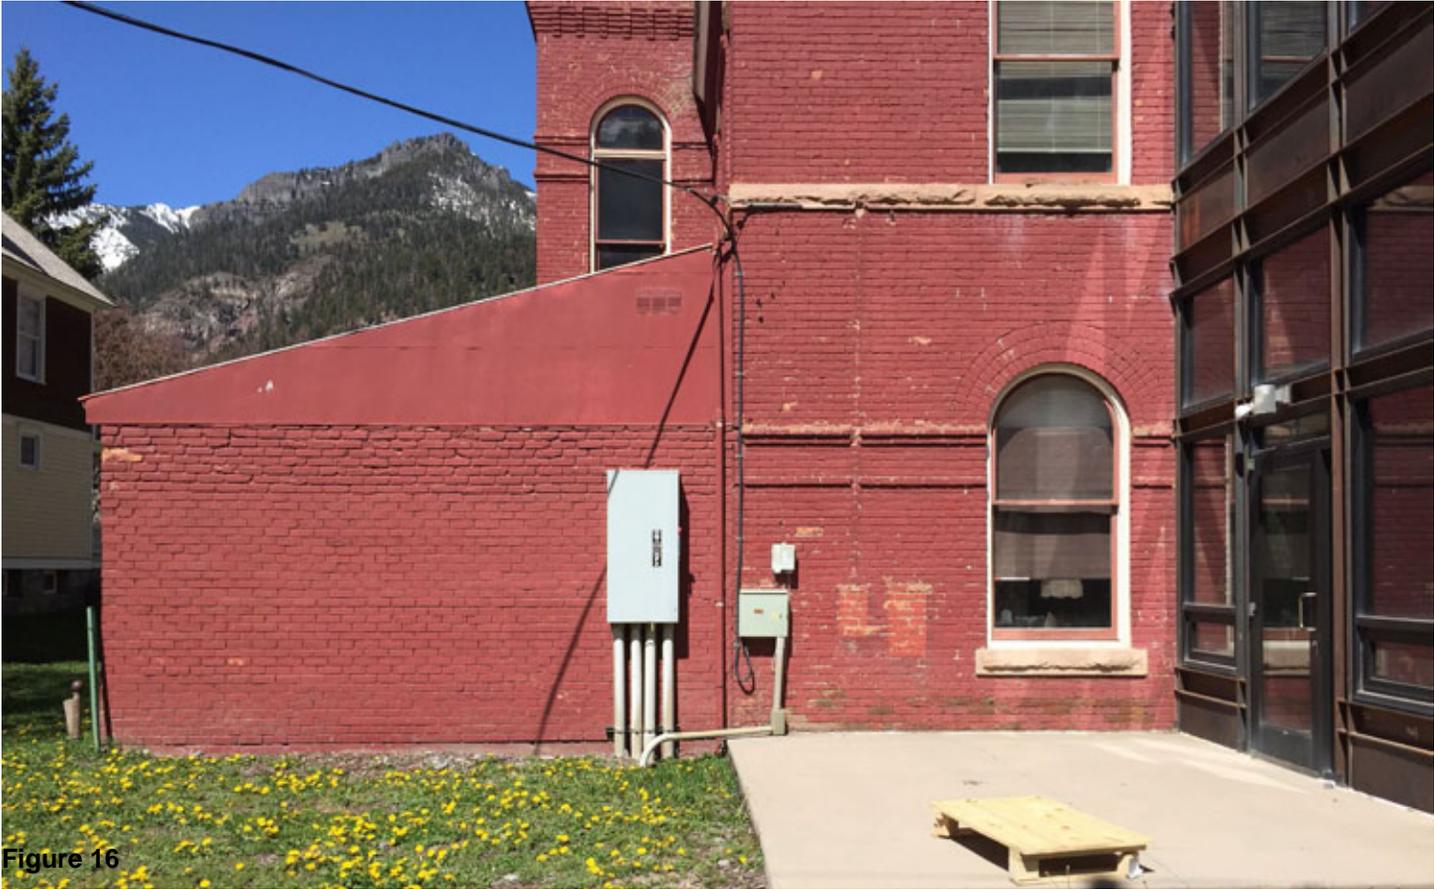
Figure 16

Additional modifications and additions to the exterior have been executed since the Courthouse was completed. Most of this work has been unsympathetic to the original character of the building. The shed roof and featureless brick walls of the 1976 Clerk's vault addition at the southeast corner are incompatible with the Courthouse roof forms and brick detailing. While in good condition, its appearance and appropriateness is historically detrimental. Similar contrasts are seen at the glass and metal in-fill connection between the Courthouse and the Jail building (Figures 16, 18, 19).

Non-historic, blank-faced brick storage addition looking west that is proposed to be removed.

The historic spaces and architectural elements in and around the building should be preserved. However, the addition of the non-historic Clerk's storage vault built of concrete masonry in a utilitarian fashion should be removed and the exterior of the courthouse in this location should be restored (Figures 16, 18, 20).

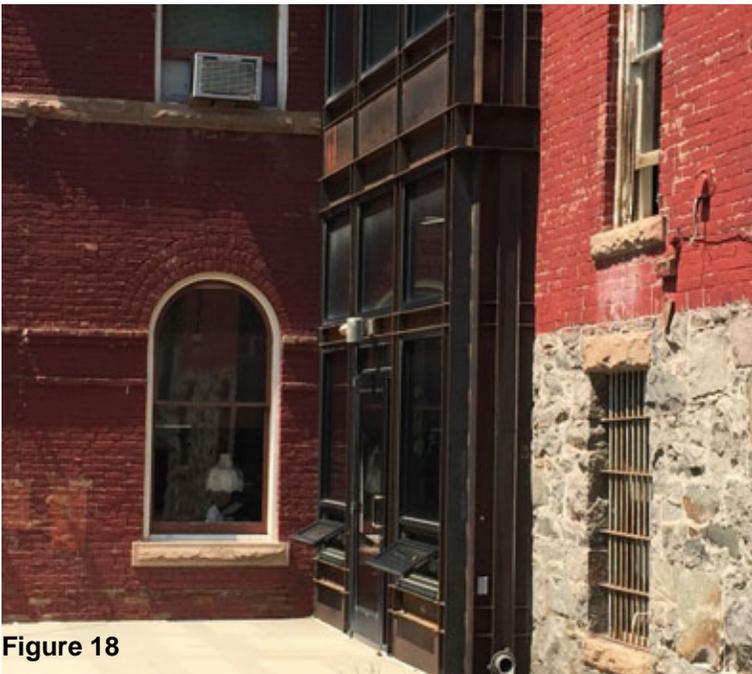
Figure 18

Existing masonry and window conditions shows next to the newer connection in steel and glass.
