FEASIBILITY STUDY FOR THE OURAY COUNTY COURTHOUSE

OURAY, COLORADO

MARCH 2017

CHARLES CUNIFFE ARCHITECTS

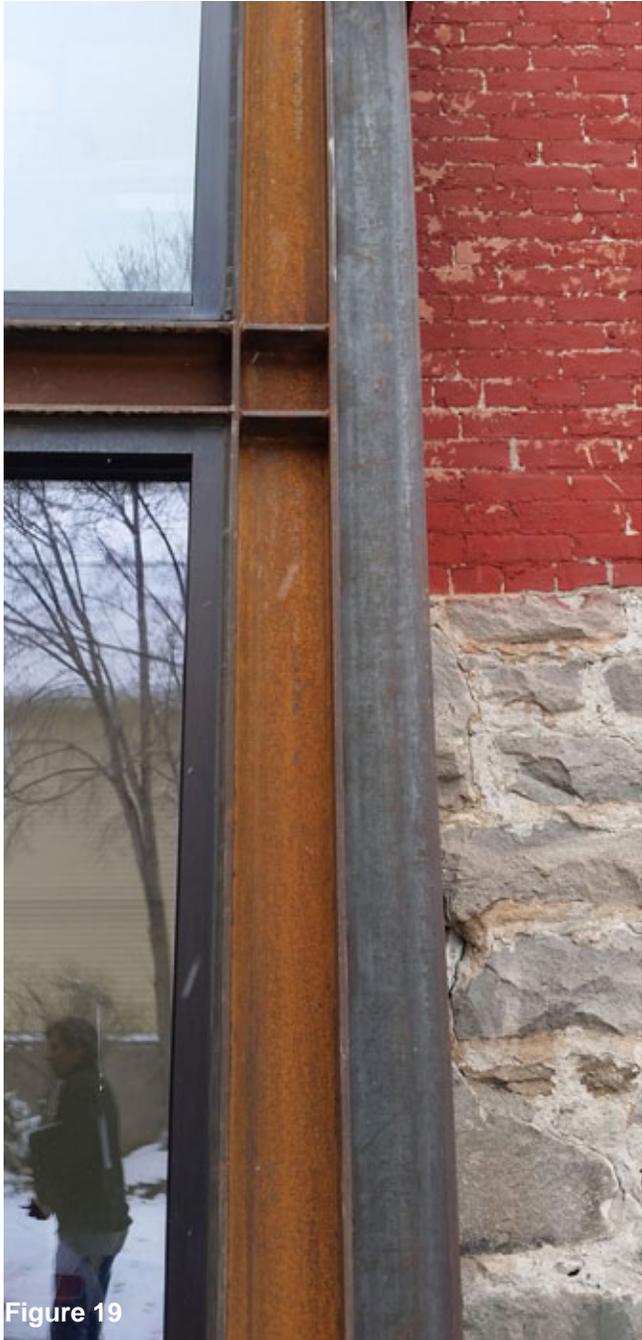
Figure 19

Additional modifications and additions to the exterior have been executed since the Courthouse was completed. Most of this work has been unsympathetic to the original character of the building. The shed roof and featureless brick walls of the 1976 Clerk's vault addition at the southeast corner are incompatible with the Courthouse roof forms and brick detailing. While in good condition, its appearance and appropriateness is historically detrimental. Similar contrasts are seen at the glass and metal in-fill connection between the Courthouse and the Jail building (Figures 16, 18, 19).

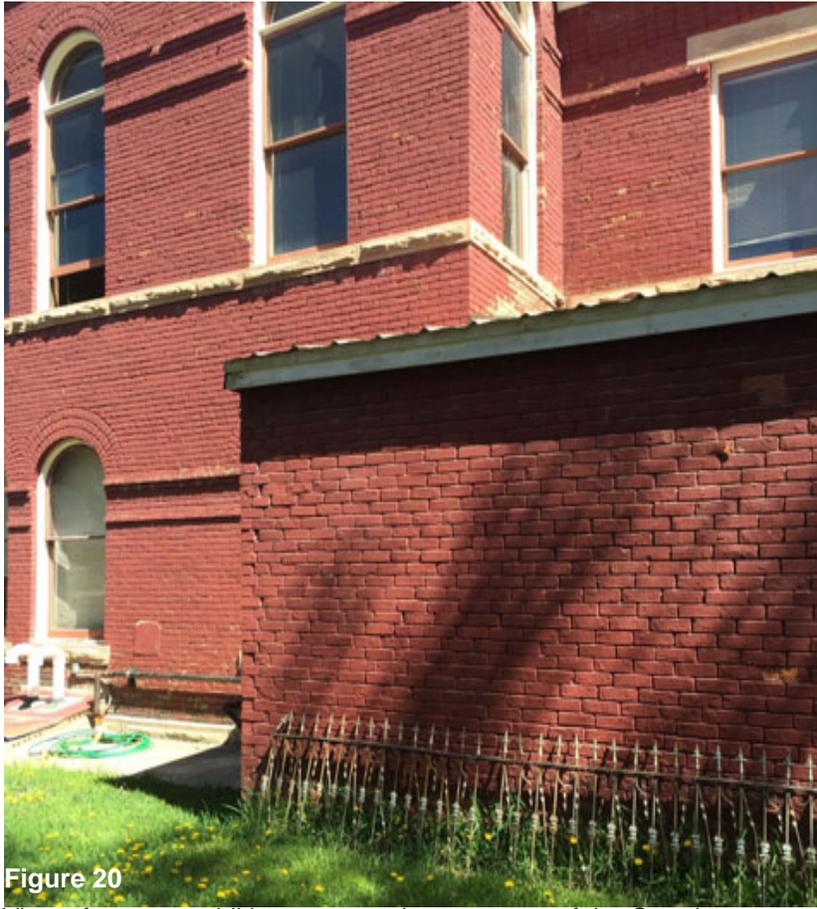
Figure 20
View of storage addition onto southeast corner of the Courthouse.

The historic spaces and architectural elements in and around the building should be preserved. However, the addition of the non-historic Clerk's storage vault built of concrete masonry in a utilitarian fashion should be removed and the exterior of the courthouse in this location should be restored (Figures 16, 18, 20).

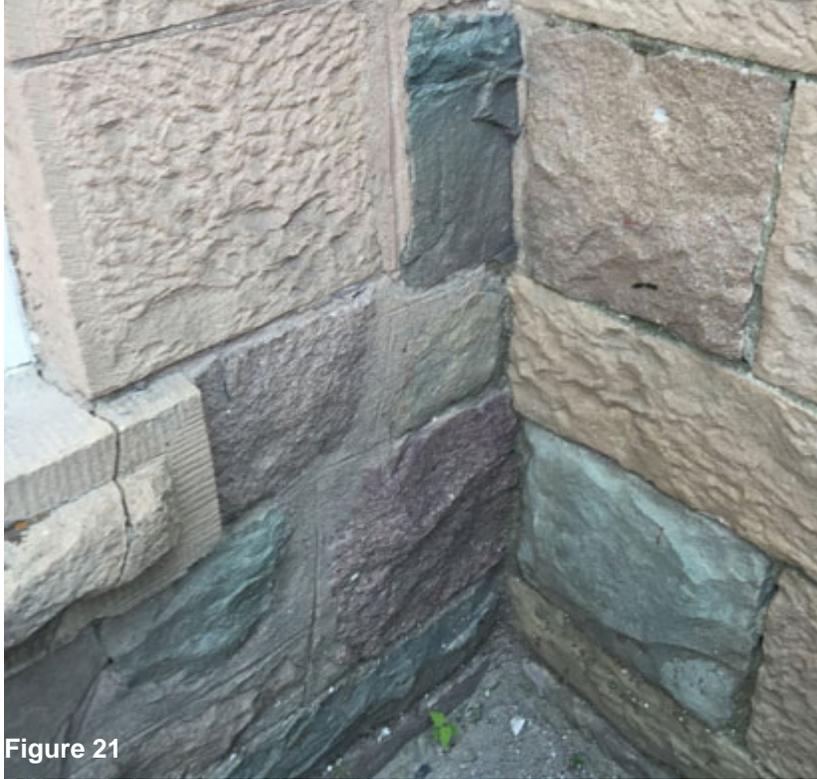
Figure 21
Differentiation in natural stone base color.

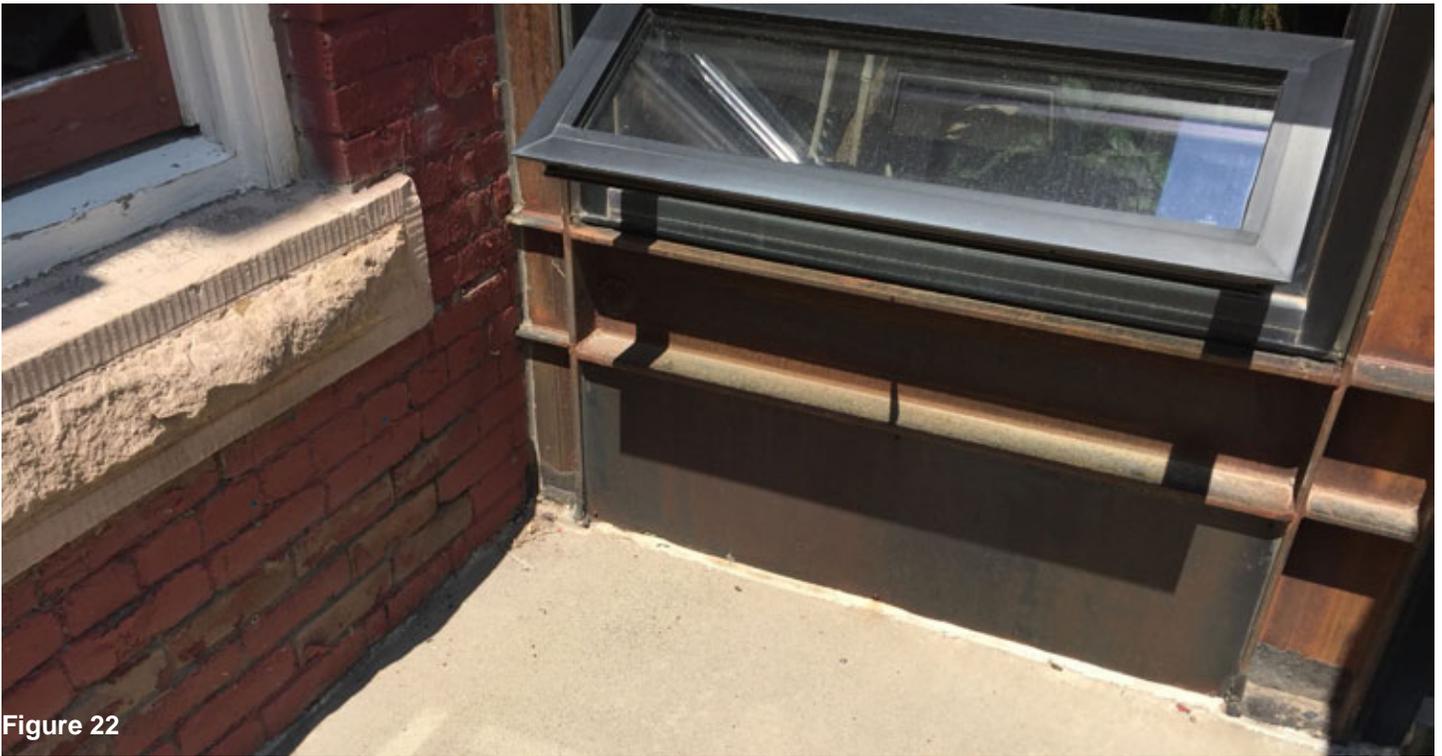
Figure 22

Connection between historic Courthouse and connection.

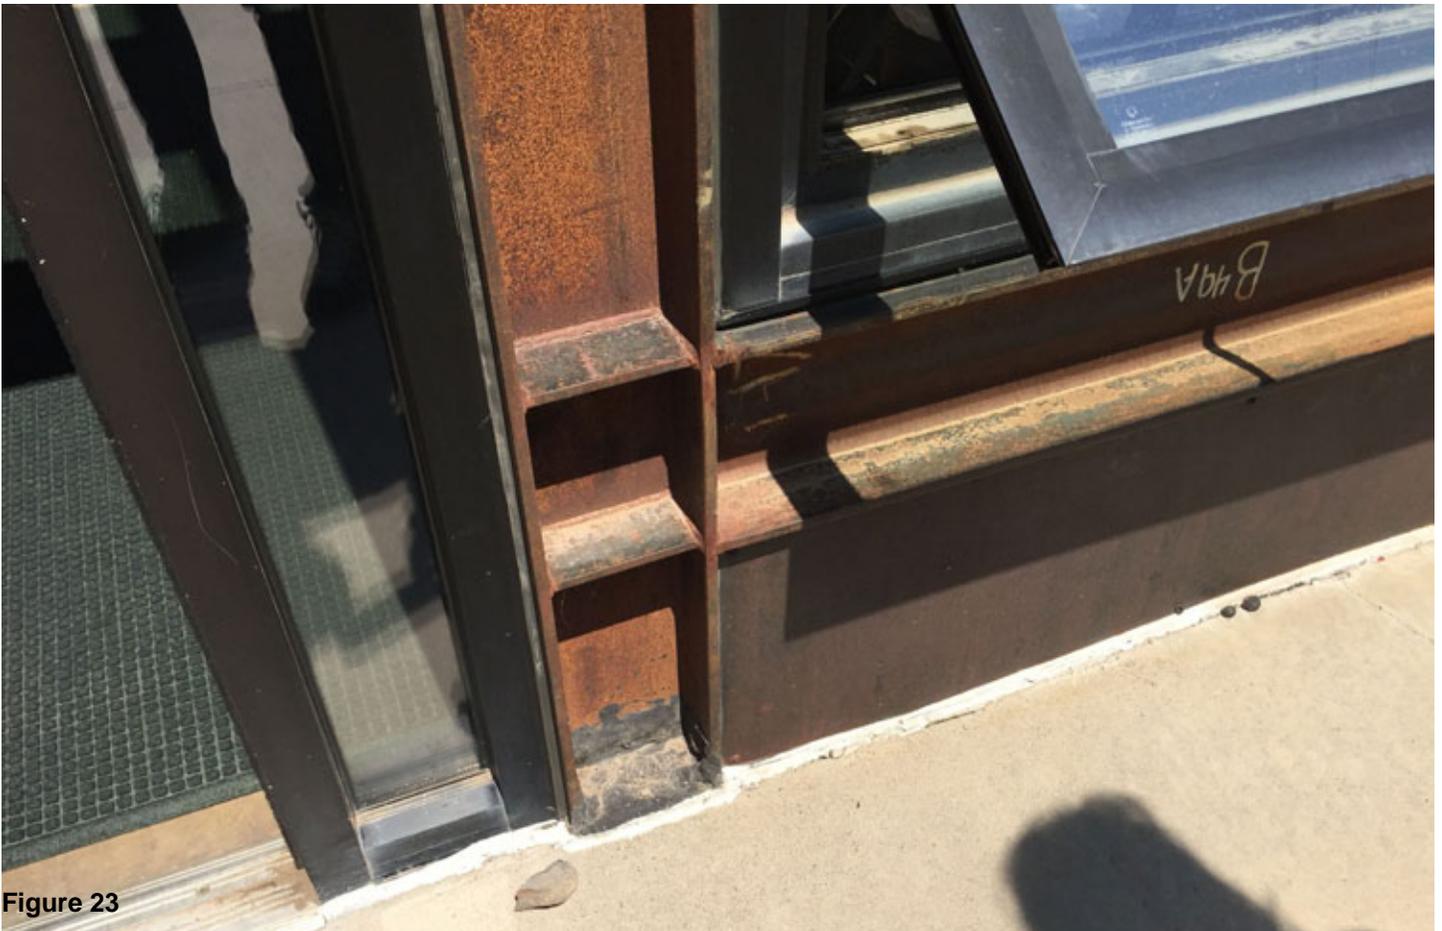
Figure 23

Material detail of connection between Courthouse and the Jail building.

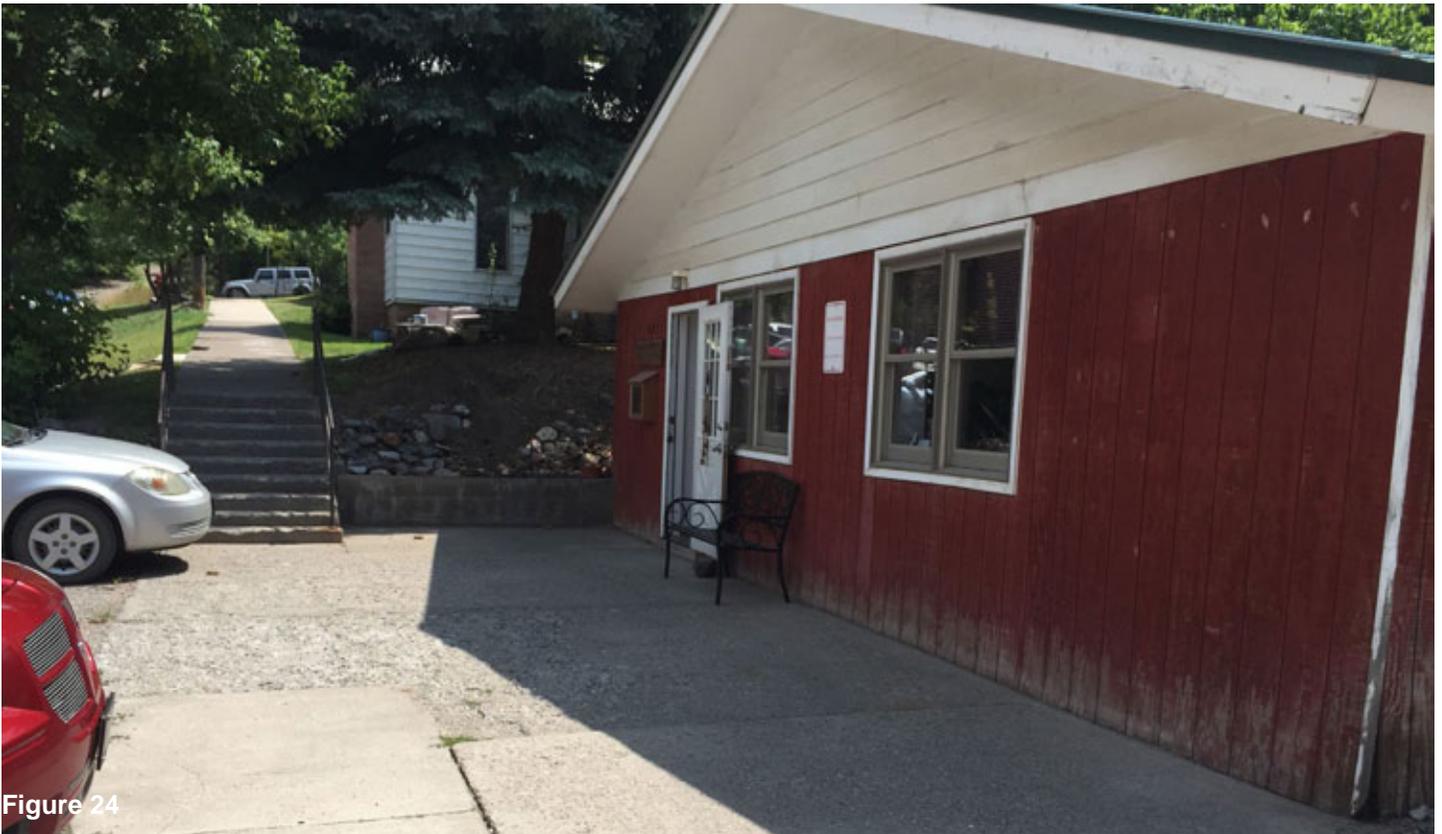
Figure 24

Vertical wood siding painted red cover the north, east, and west sides of the building. Discoloration and general wear and tear are evident on the lower portion of these boards as the paint is faded and the wood is splitting in some locations. The paint on the door and window trim is peeling and chipped off in some locations and will need repainting. Due to inadequate insulation in the exterior walls, the door on the west is never used by the occupants in order to keep the office a more comfortable temperature. The southern wall of this building is concrete masonry and is in good shape (Figures 24, 25).

Front of County Assessor's building.

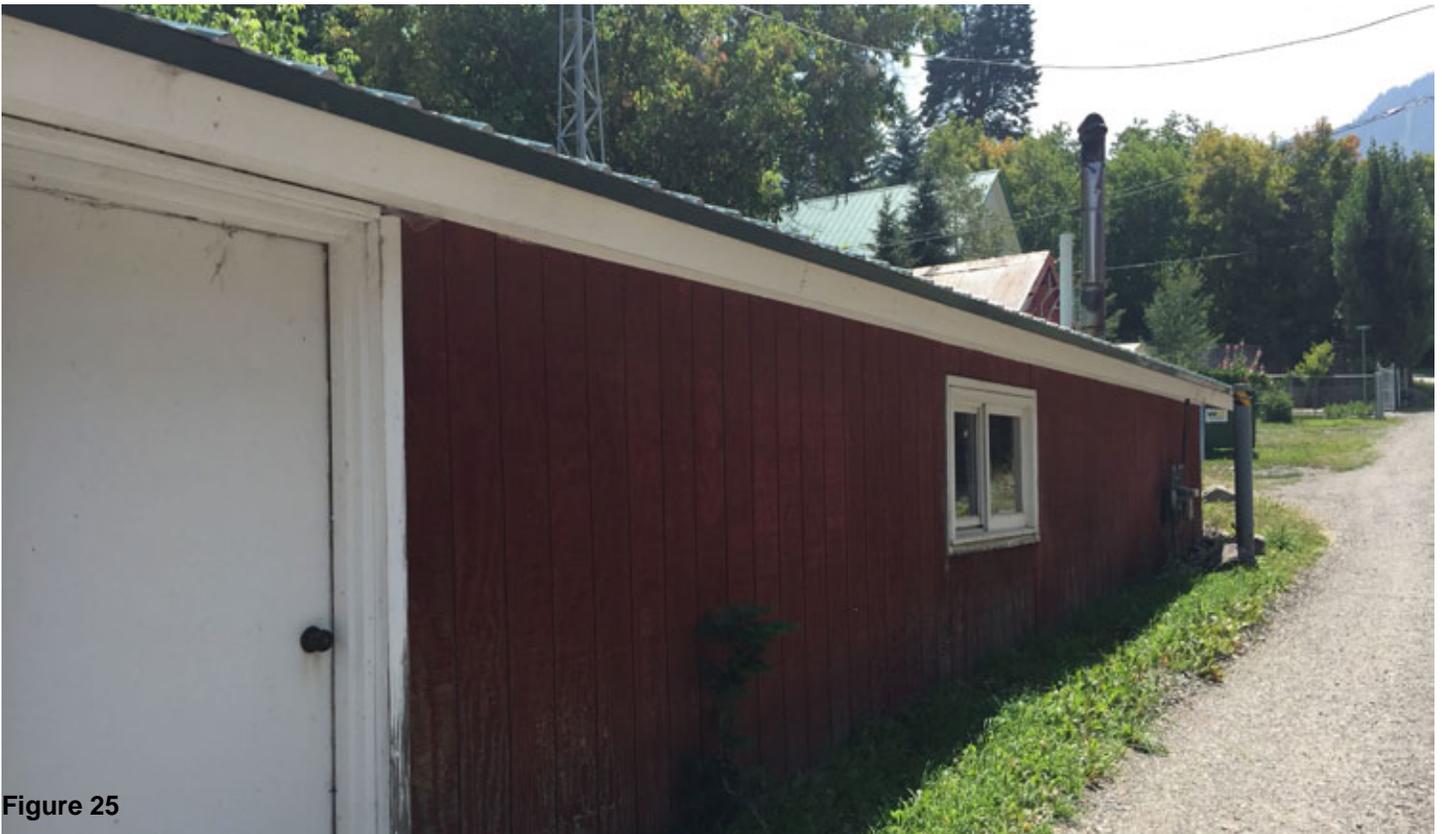
Figure 25

Alley view of County Assessor's building.

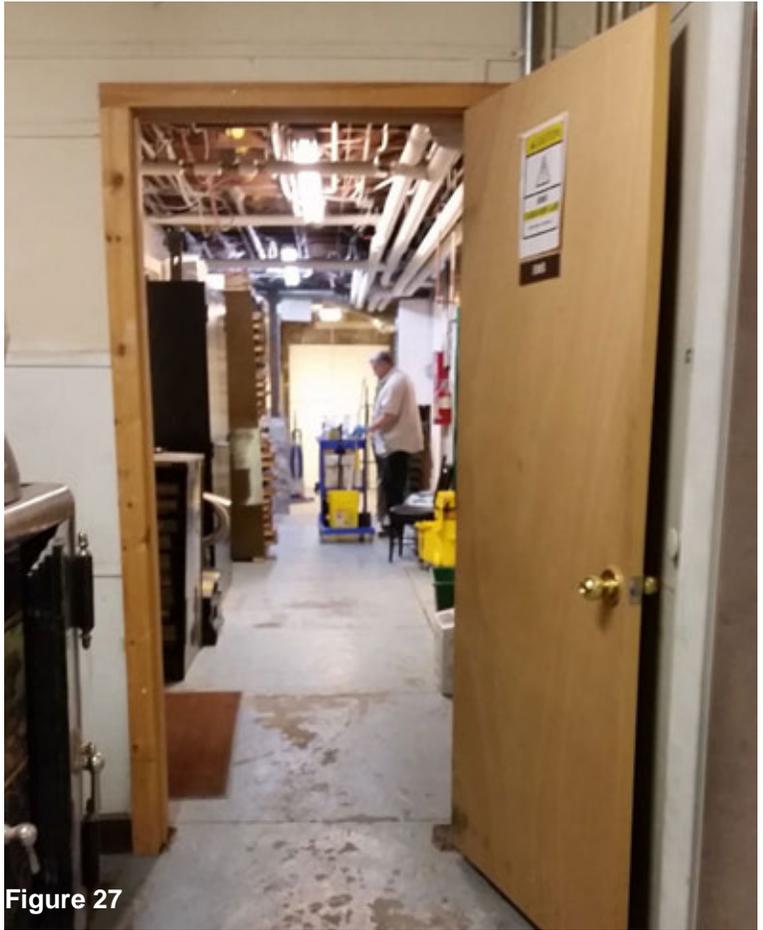
Figure 27

The lowest floor of both buildings is a concrete slab on grade (Figure 27, 44). The slab has been carpeted in some areas. After the flood of 1965, the basement floor is in need of repair. Where exposed and restored, the oak floor is in good condition. The carpet covering other areas is in poor condition. Some areas of the second floor Courthouse have not been carpeted and the exposed oak floor has not been refinished for some time. The concrete floors in other areas are in fair condition.

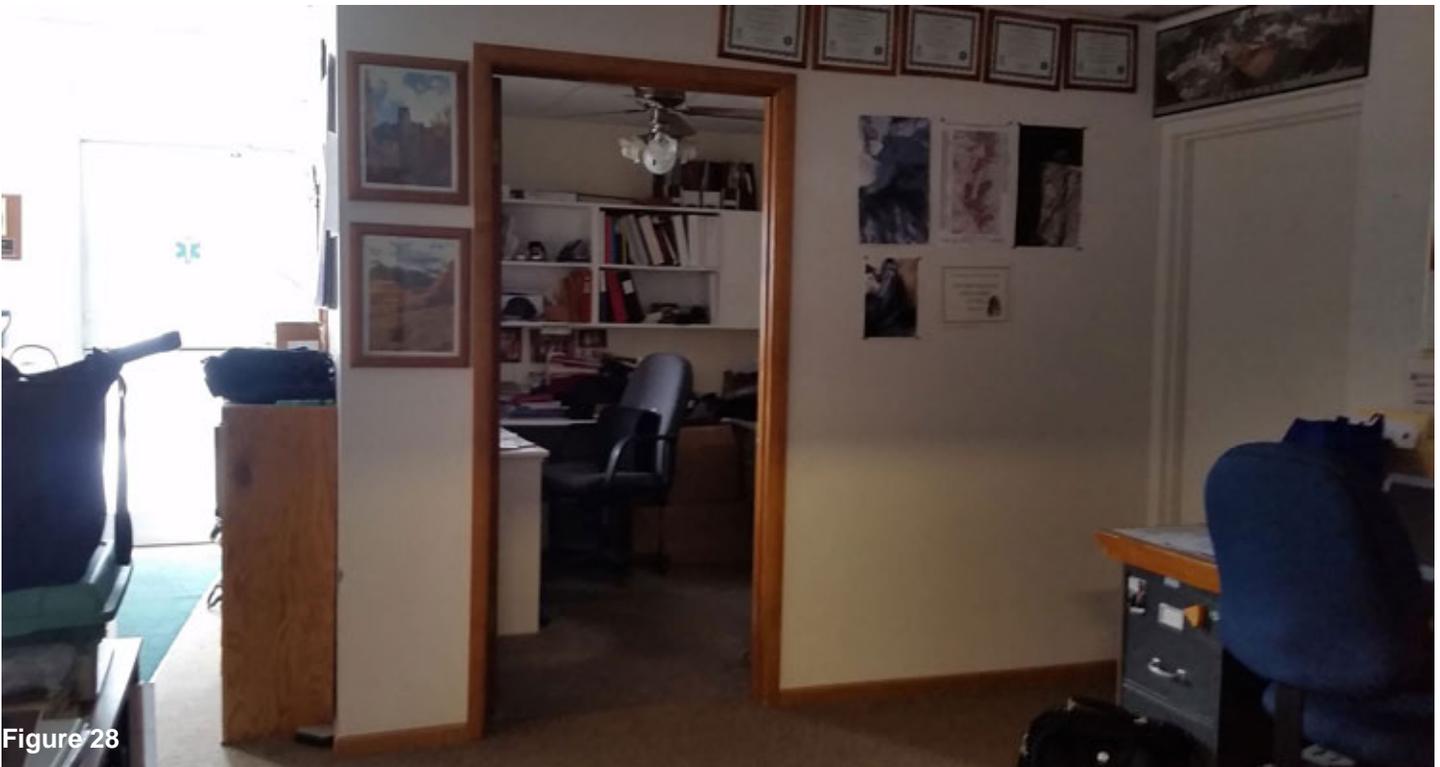
Figure 28

Layout of existing EMS office in the basement. The aluminum-framed door replaced the original historic door.

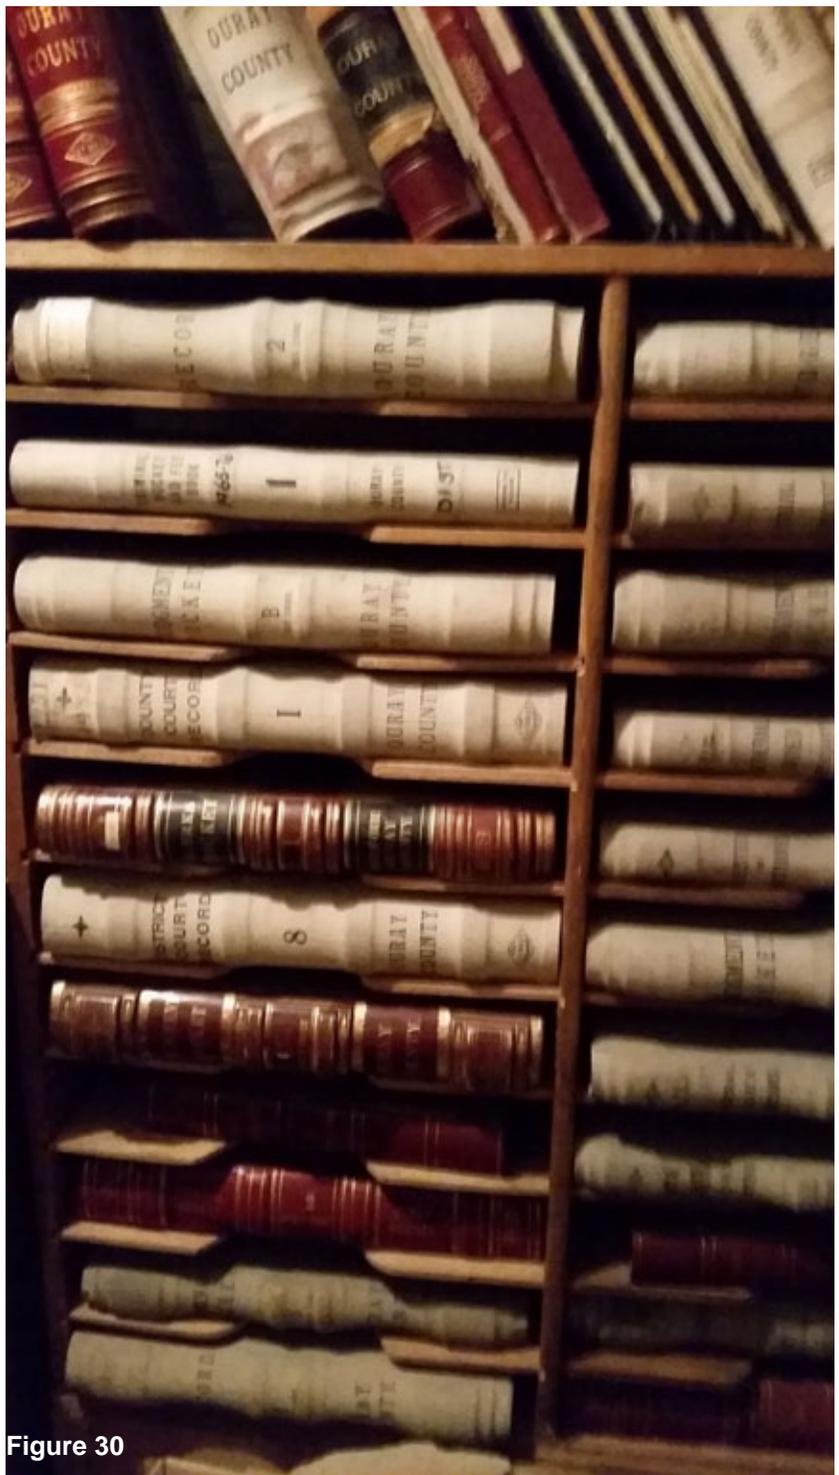
Figure 30

Additional record books stored in the basement and the catwalk with boxed up items. No temperature or humidity control in this storage room of important files.

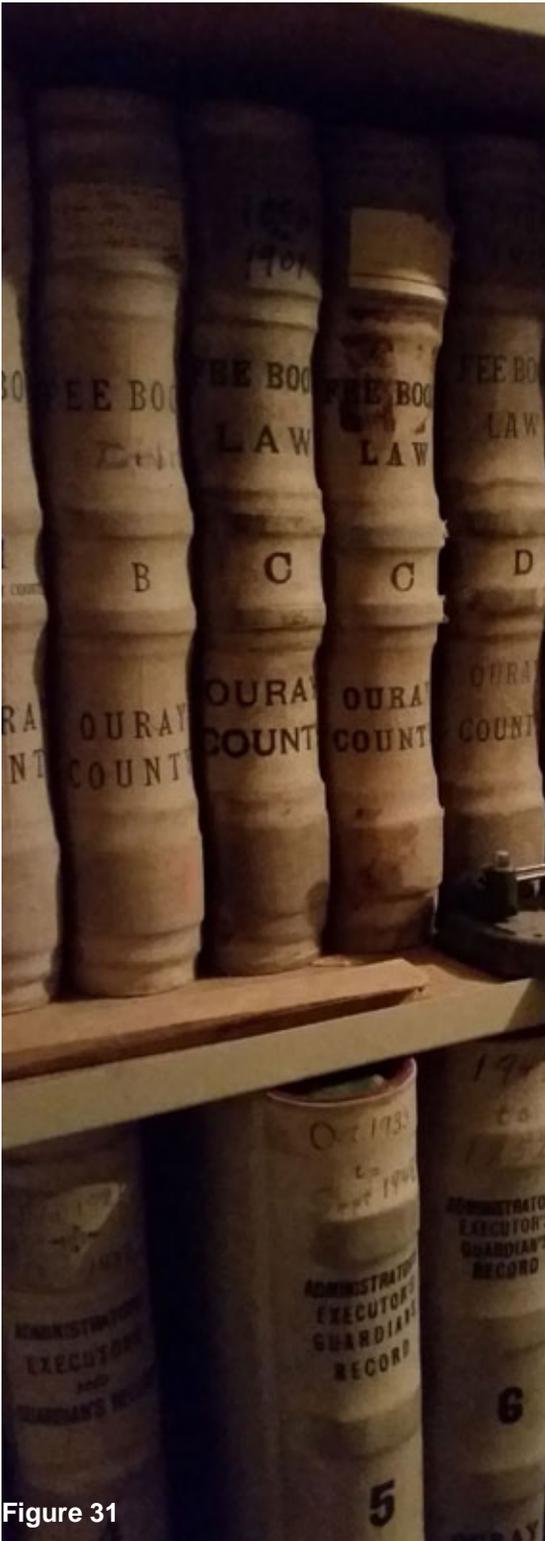
Figure 31

Old Court record books located in storage in the basement.

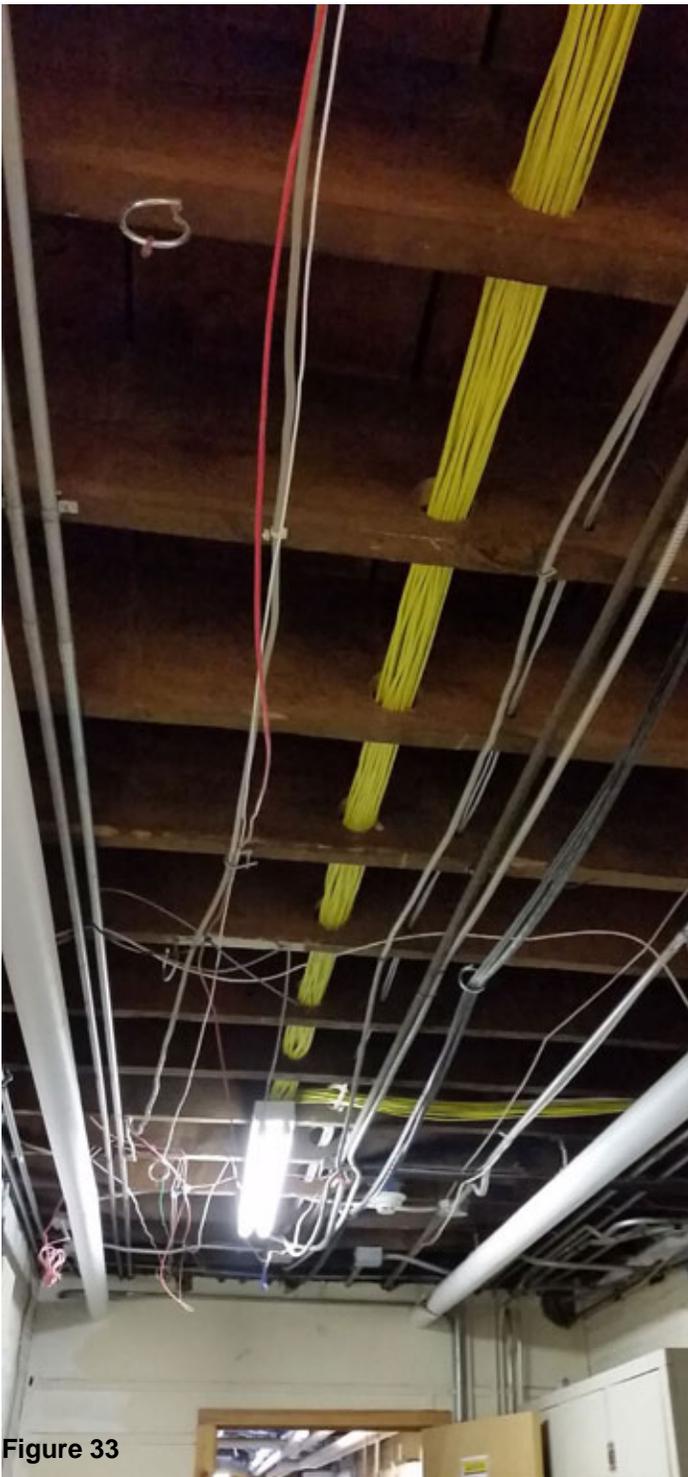
Figure 33

The original plaster ceilings are in good condition. Most fortunately, repairs have been made appropriately. The unfinished ceiling in the Courthouse basement constitutes a serious fire hazard (Figure 33). Plumbing and electrical conduits from several periods have been installed throughout this area and seriously detract from the otherwise attractive pattern established by this framing.

Ceiling wires exposed in the basement hallway.

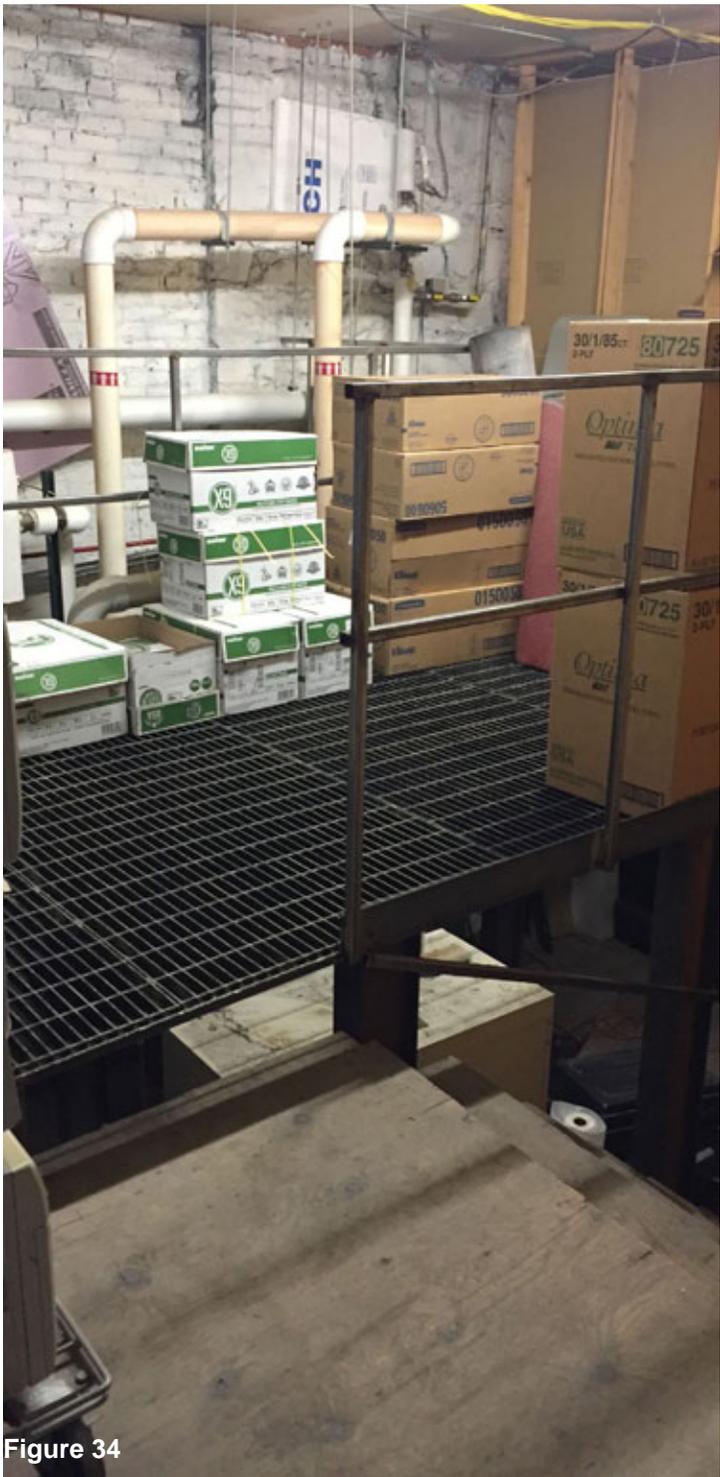
Figure 34

Storage boxes in the unfinished Court Clerk room. Two levels of storage with a grate cat-walk.

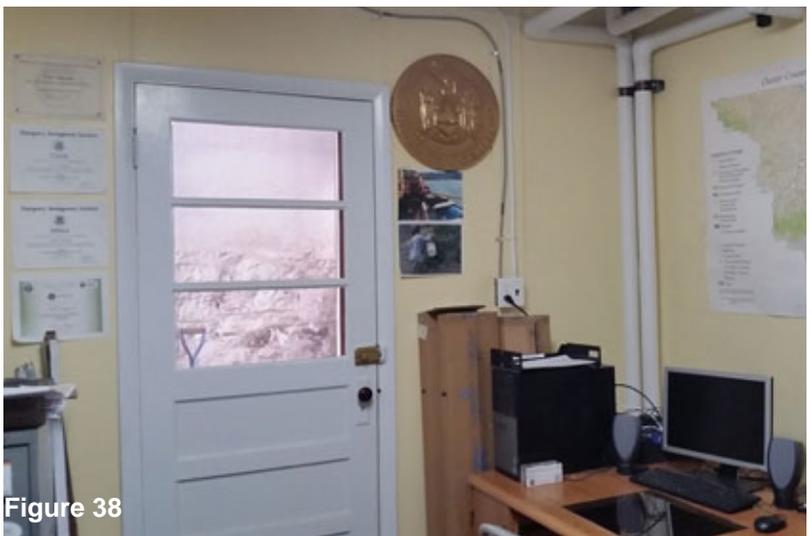
Figure 38

Inside of the Facility Manager's office in the basement and their storage vault.

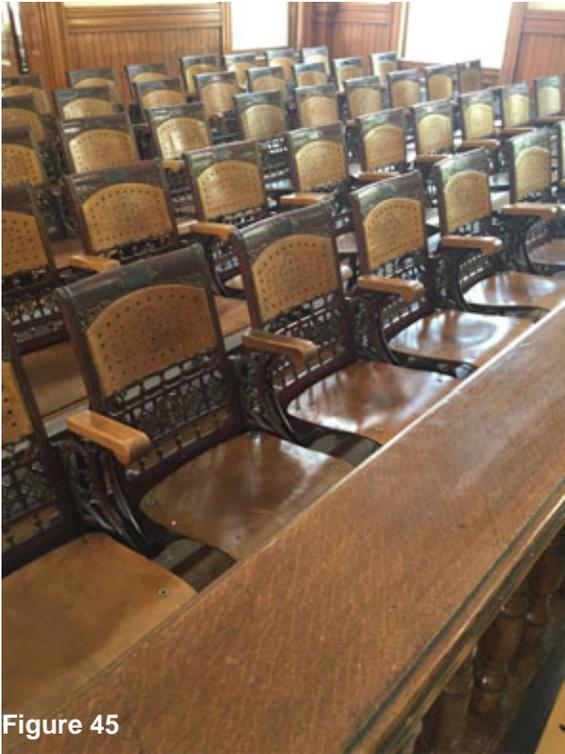
Figure 45

The “theater” style row seating in the Courtroom (Figures 45 & 46) is constructed with ornamental cast iron standards and backs, perforated bent wood back inserts, tilt-up bent wood seats, wire hat racks beneath each seat and wire coat racks on the seat backs. The seat rows are fastened to 2 x 4 runners but are not affixed to the floor. As the room was originally used for dances and other public events, it is likely that the seats have never been permanently attached to the floor so that they could be move aside. The seating is in generally good condition but some of the tilt-up mechanisms are broken and parts are missing here and there. The low level of maintenance and the lack of permanent attachments results in the generation of unacceptable levels of noise from squeaks, rattles, bangs and knocks when in use. The remainder of the courtroom furnishings, including the jury box and witness stand, are clearly from a later date and their inexpensive plywood construction is not compatible with the more elaborate dark oak original pieces. Their presence, along with other contemporary book shelves and desks, creates a chaotic look in the courtroom that significantly detracts from the dignity of the original architecture and furnishings.

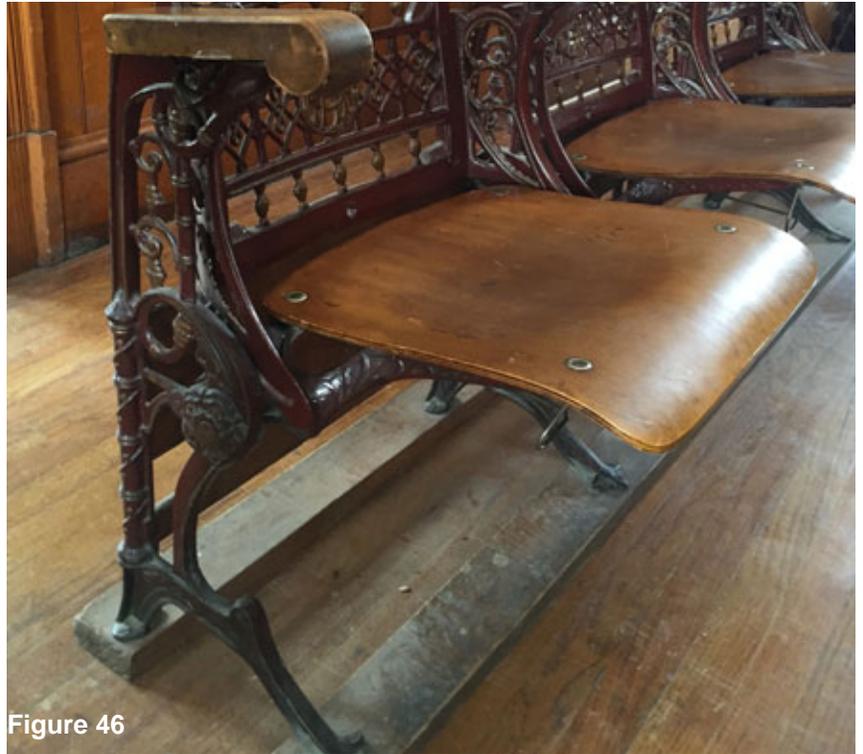
Figure 46

Original wood seating with metal hat and jacket holders at bolted into 2x4s but not the wood flooring itself.

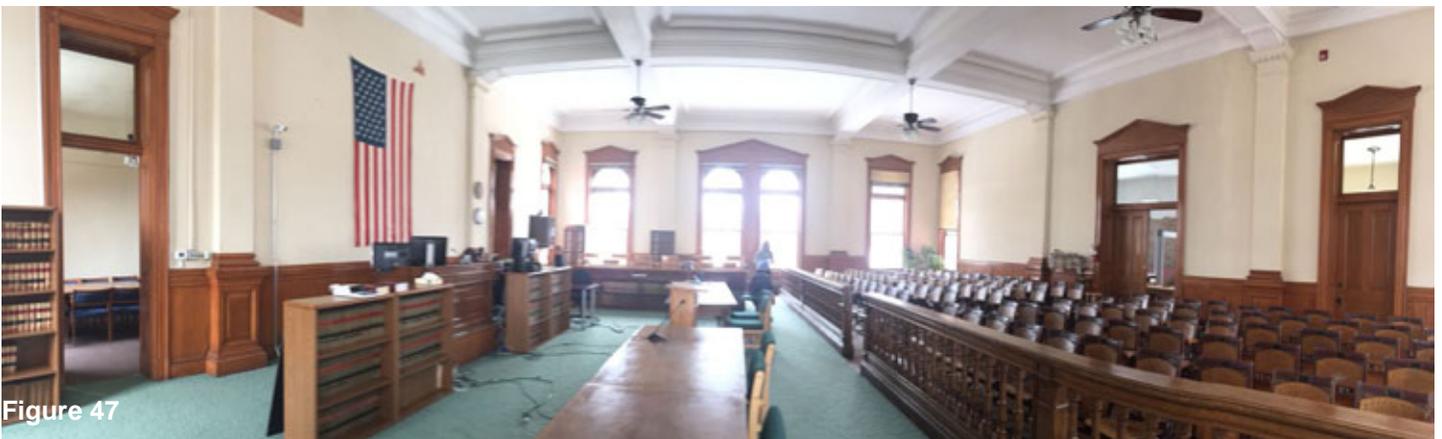
Figure 47

- The Courtroom bar is also original. Made of dark stained oak with ornate turnings and moldings, the bar has been moved from its original position to provide more room on the court side. The original gates have been lost. Nonetheless, the bar is in excellent condition and is still performing its function (Figure 47).

Panorama shot of the Courtroom.

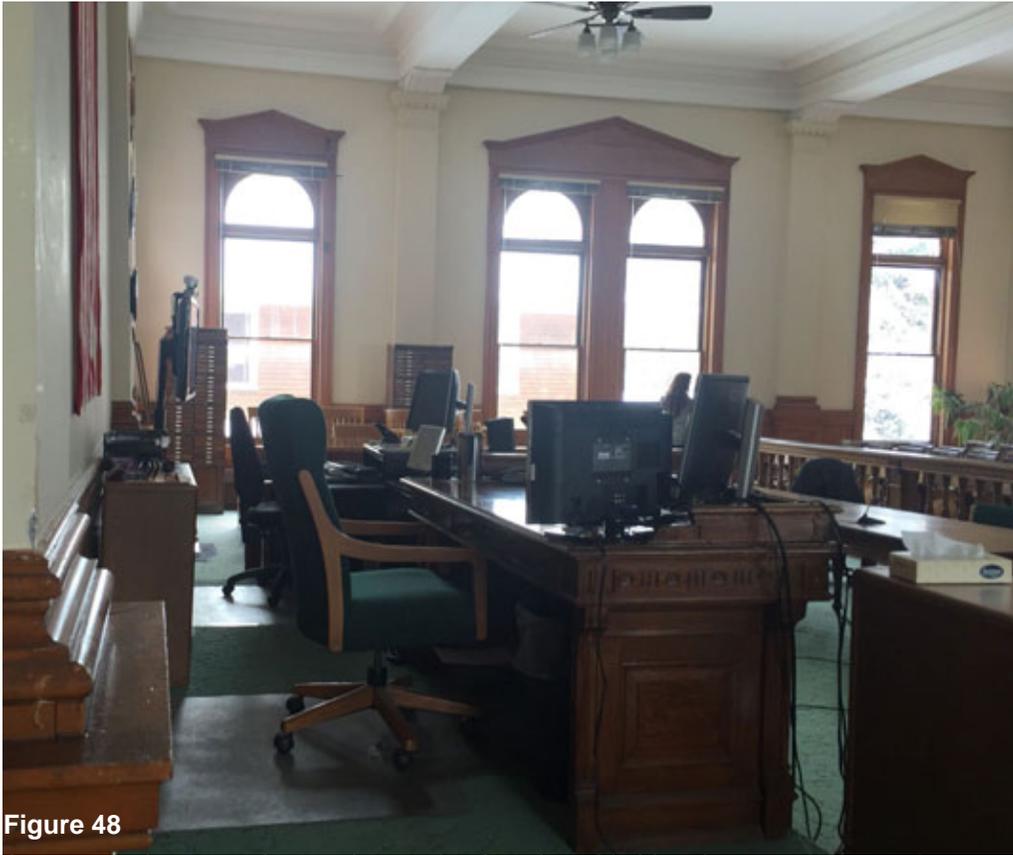
Figure 48

- The Judge's desk in the Courtroom is also original (Figure 48). The construction is as casework but sits independently in the room like a piece of furniture. The dais upon which the desk currently sits is not original. The desk is dark stained oak with the original finish and original hardware. It is in excellent condition and is still in regular use.

Attempts at incorporating modern technology into this historic space are seen here. Much of the original furniture remains.

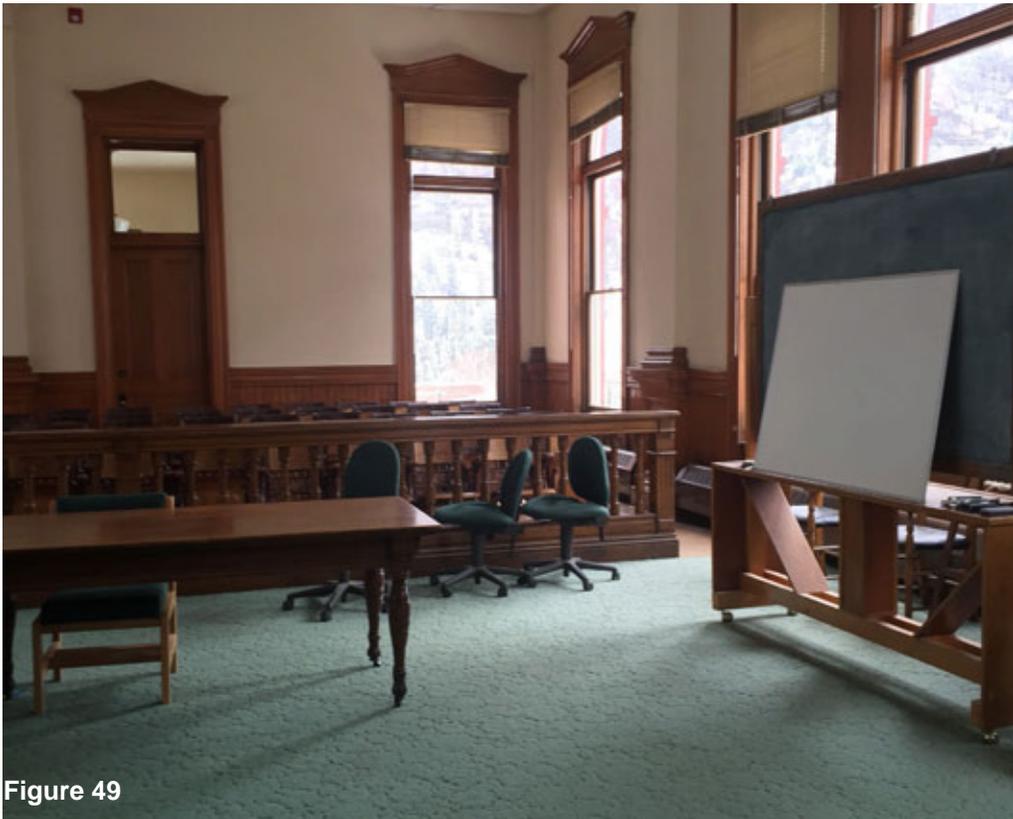
Figure 49

- The Courtroom accessory furniture, including attorney's tables and chairs, are also at least partly original. The tables of dark stained oak may have received new tops at some point, but the legs and hardware are identical to those in the oldest photographs. The chairs are also original frames but the leatherette seats may have been replaced. Both pieces are in excellent condition and still in regular use (Figures 47, 48, 49).

Inside of the Courtroom looking towards the original seating area. Carpet has been installed in the space where the public doesn't sit.

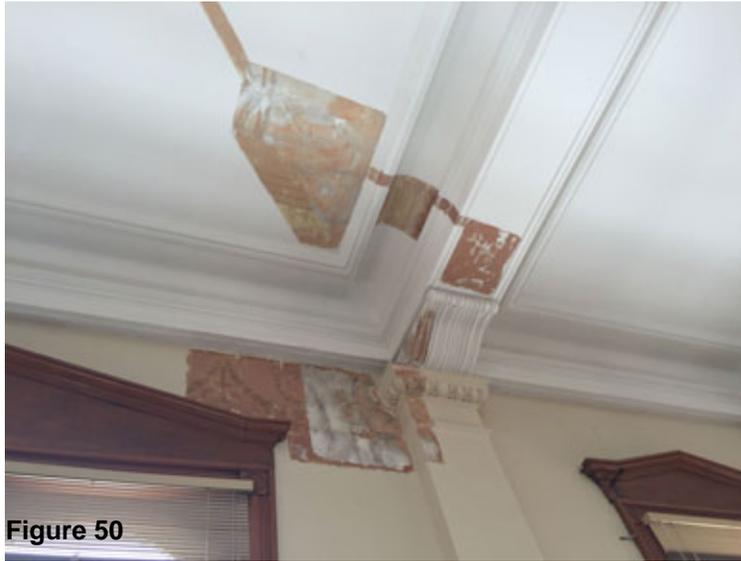
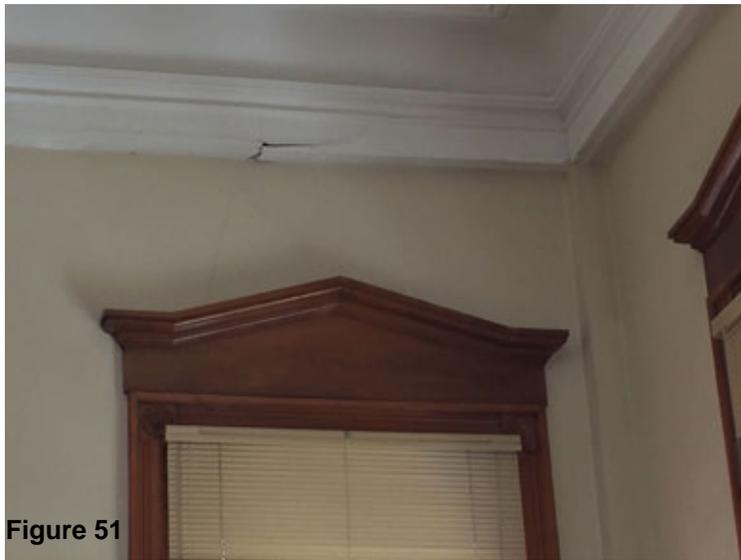
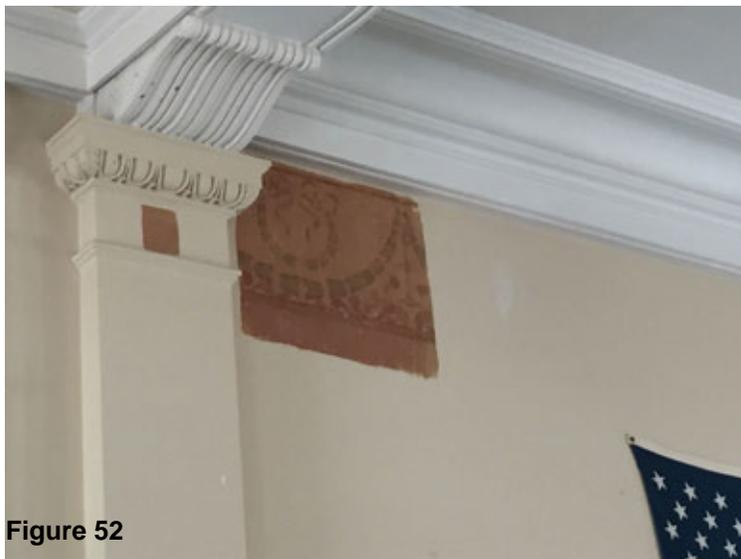
areas (main hall, foyer and courtroom) show no signs of wall paper coverings which were common at the time the Courthouse was constructed. However, historical photos suggest that most of the office spaces had their plaster covered with wall paper. Indeed, in some rooms the paper still exists under several coats of paint. Historical references suggest wall paintings in the courtroom around 1898. Multiple layers of paint cover all plaster surfaces. The historic finish analysis conducted by Evergreene Architectural Arts in 2006 reveals the historical information, location of the frescoes and stenciling, and possible artist responsible for the work. A detailed report can be found in Appendix F of this report. (Figures 50, 51, 52).

Revealed stenciling and details in the Courtroom by Evergreene in 2006.

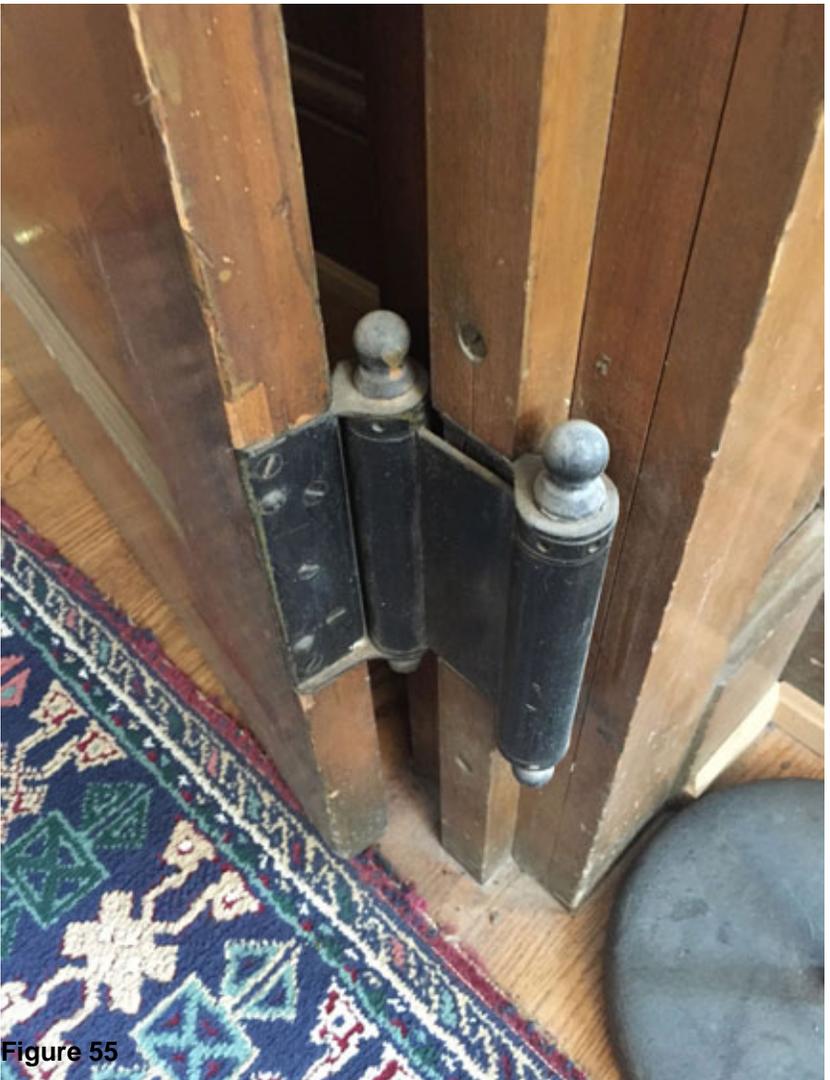
Figure 55

Main hallway in Courthouse with seating for the public who is waiting to see the County Clerk & Recorder. The original metal hardware and wood flooring is seen throughout the Courthouse.

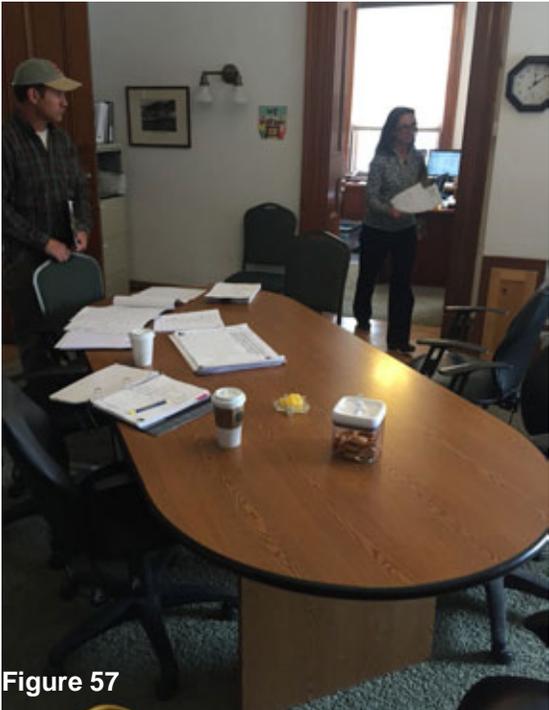
Figure 57

County Administrator's office and meeting room space. Original casework seen above.

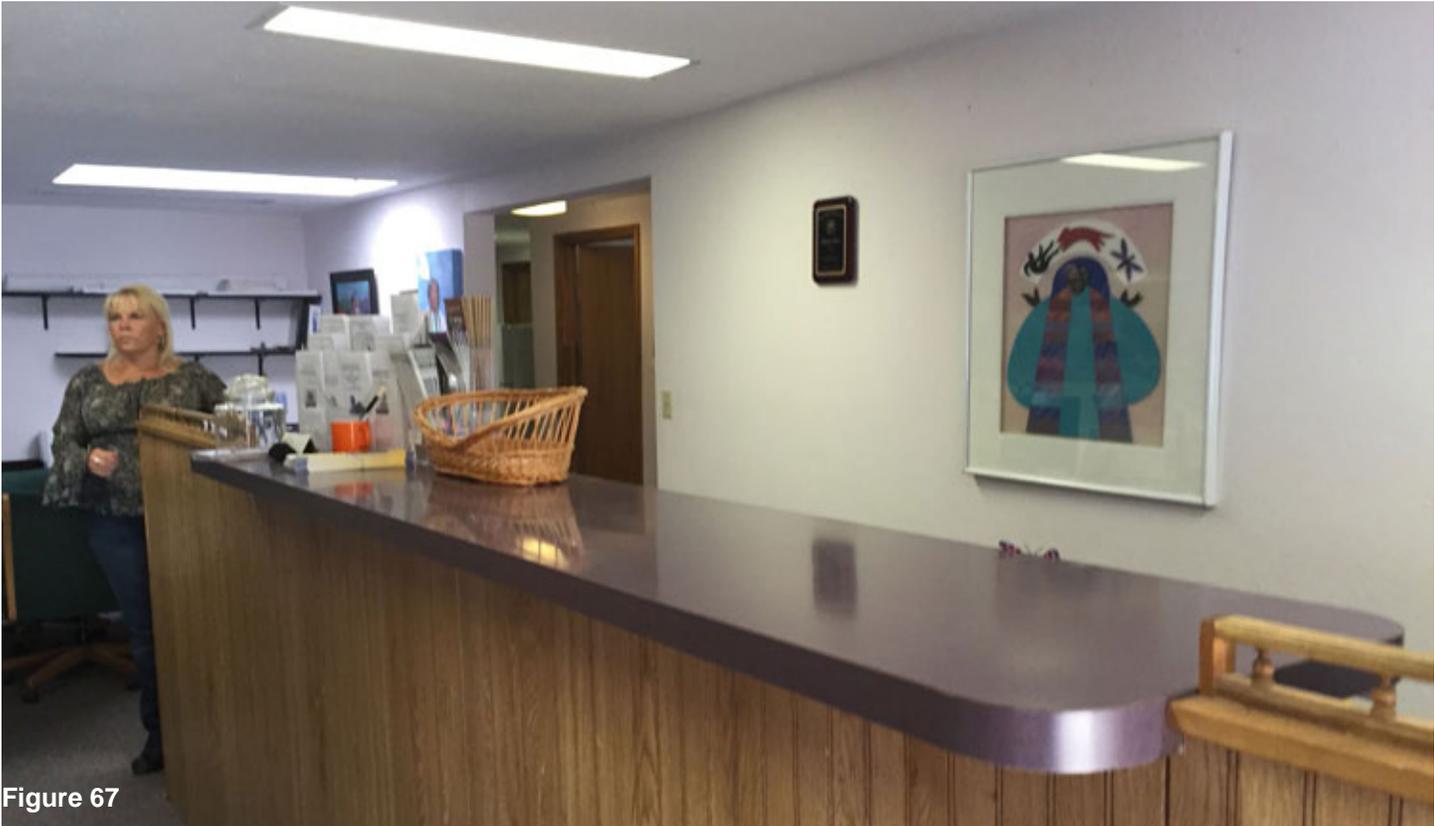
Figure 66

but some wood is chipped. Office desks and chairs are not historic in nature (Figure 66) and can remain or be replaced with pieces from a period more in line with the Courthouse's history. There is a general lack of storage space in the office for large format drawings and files that need to be retained for extended periods of time.

Office space in County Assessor's office.
