FEASIBILITY STUDY FOR THE OURAY COUNTY COURTHOUSE

OURAY, COLORADO

MARCH 2017

CHARLES CUNIFFE ARCHITECTS

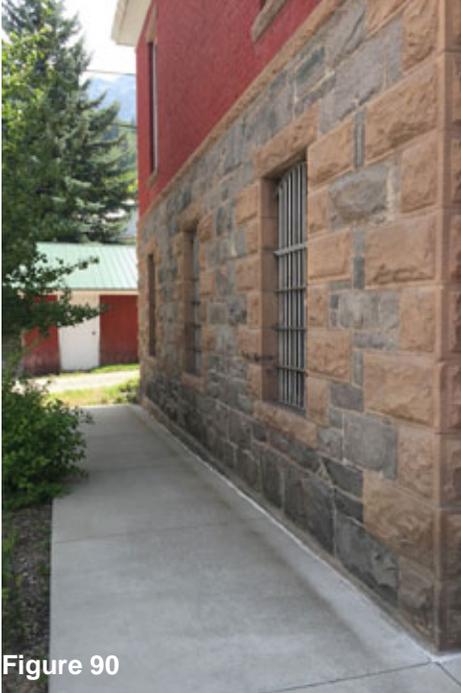
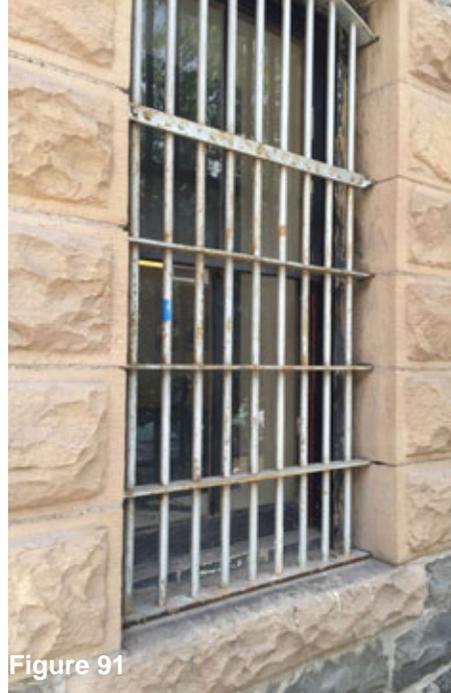
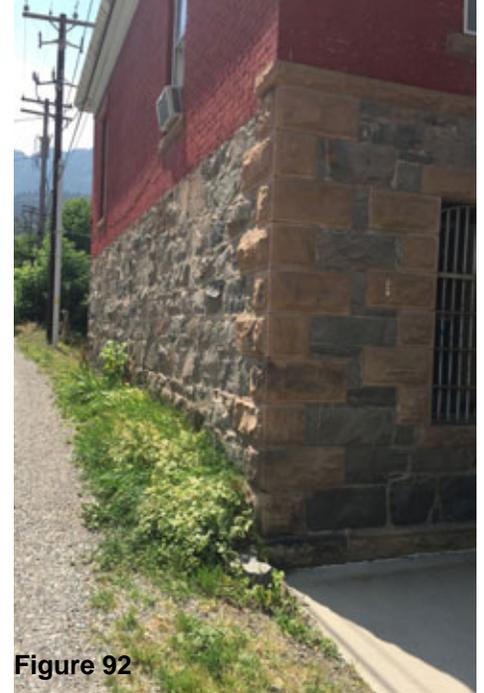
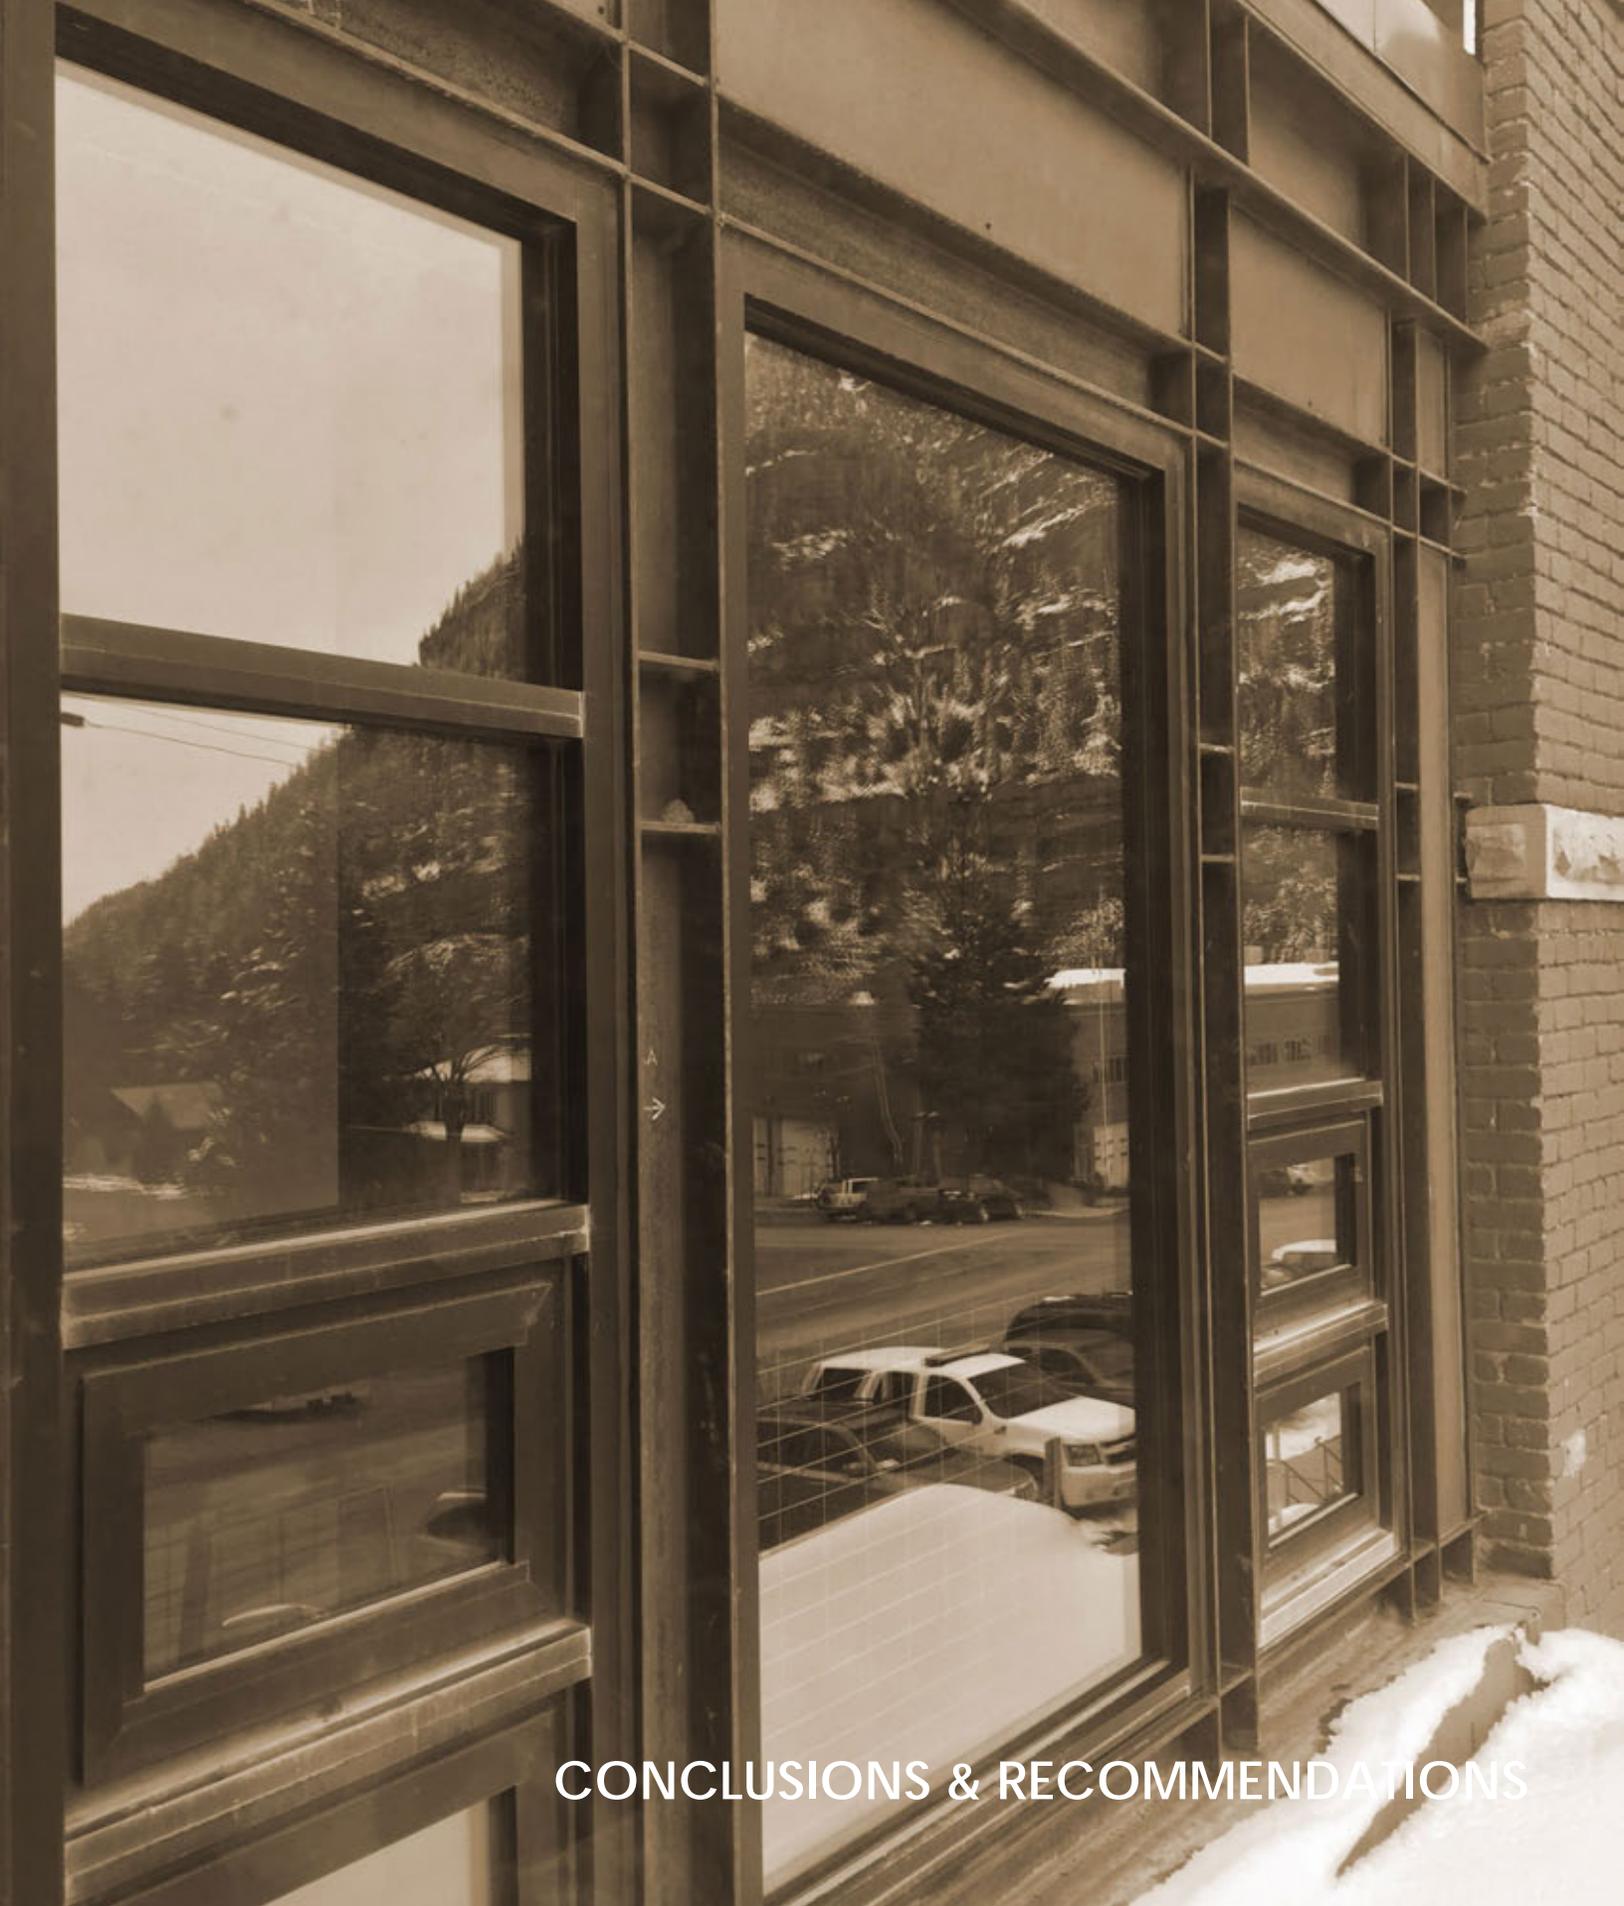
The Jail building (Figures 89, 90, 91, 92), a satellite building to the east which is now connected to the Courthouse on the interior through the 2008 addition, is also a masonry bearing wall structure. The main floor elevation varies from grade to 2 feet below

The Jail building is seen to the right of this image connected on the interior to the Courthouse building by the 2008 addition.

The Jail building as seen from the ADA ramp.

A detail of the original Jail cell windows.

The east side of the Jail building on the alley.

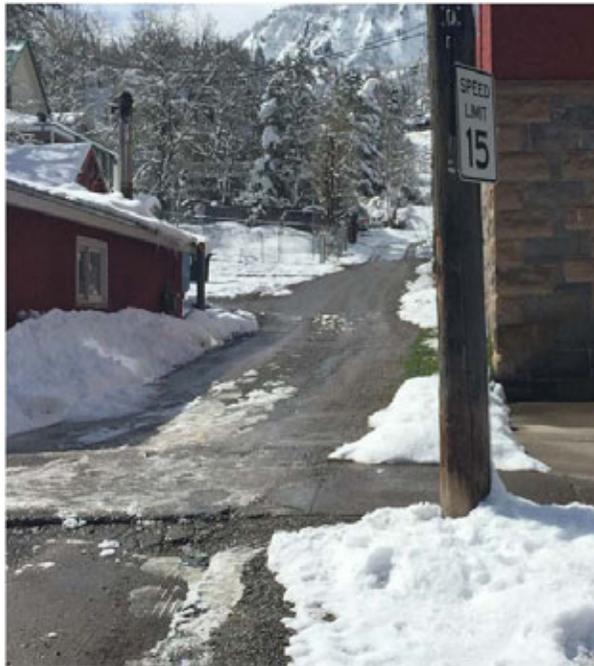
- There is an icing issue where the alley meets 6th Ave. The proposed solution is to extend the storm pipe up 6th Ave. and install an inlet near the alley. An additional inlet may also be added further into the alley. These inlets would collect runoff before it reaches 6th Ave. and freezes, eliminating the ice damming issue. Runoff from the snow melted walkways around the building also contribute to the ice damming problem. Inlets would be a concrete valley pan style with a grated lid similar to what is installed on surrounding streets. 170' of 15" ADS (plastic) pipe will be needed to connect the proposed inlet near the alley to the existing storm system.

End of Alley, location of proposed inlet.

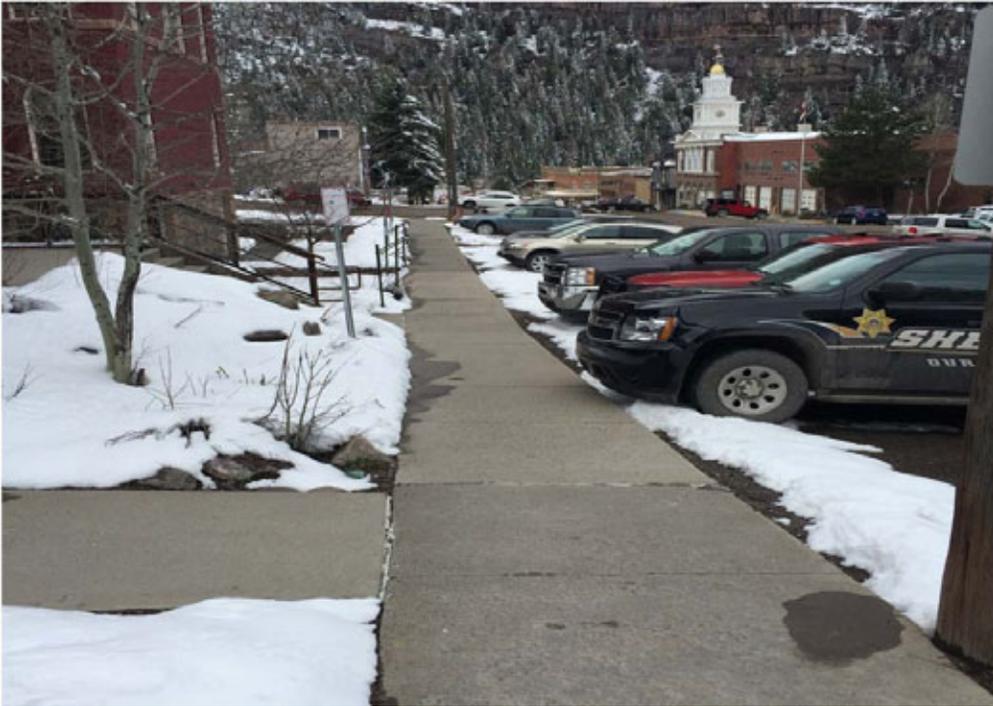
- The sidewalk along 6th Ave. is not ADA compliant and exceeds the maximum grades set forth in the ADA code. The project will remove the existing sidewalk and replace it with snow melted sidewalk that is ADA compliant. A grade compliant connection from assigned parking spaces to the current mid building access is also proposed.

Sidewalk and potential concrete parking on 6th Avenue

- A possibility, if the budget would allow, is to create concrete parking spaces on 6th Ave. with a curb and gutter. Currently the sidewalk is flush with the road base surface of the streets. This was done to facilitate the plowing of the streets and sidewalks.
- The main entrance to the building is accessed by way of steps. The proposed condition is to create an ADA compliant access off 4th St. The proposed 4' wide concrete ramp would run south and then turn west, with a total length 50'. Two parking spaces would be assigned and a curb ramp required.

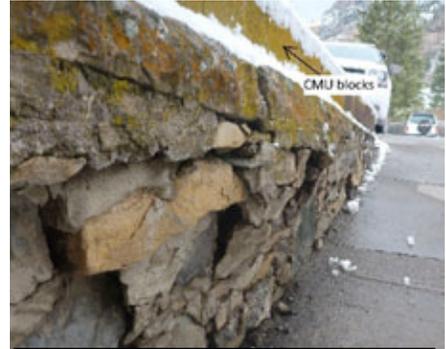
There is a retaining wall extending to the North from the concrete stairs at the front entrance (Figure 3.2.5). The wall provides for a commonly-used exit from the building's basement. It is approximately five feet tall at one end and tapers to ground level as the sidewalk below slopes upward. It's built of varying shapes and sizes of stones surrounded by lime mortar which at some time was partially repaired with Portland cement. It is topped with CMU blocks in an attempt to increase snow retainage. The wall is bulging massively at the center of its height as shown in the photo at right (Figure 3.2.4), and is on the verge of collapse.

Figure 3.2.4 – the retaining wall is in critical condition

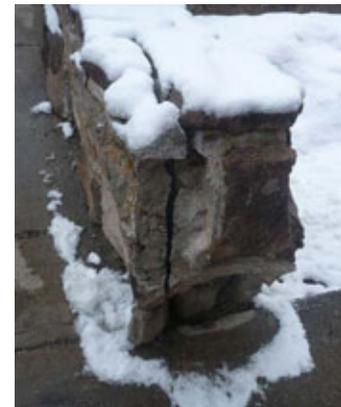
Stone and mortar planters exist on the North side of the building which are approximately 3 feet tall and surround the North courtyard as shown in Figure 3.2.1. There is a central foundation (likely stone masonry) overlain by flat stones and mortar. The façade of these planters is peeling away in places (Figure 3.2.6), specifically on their West side, but the underlying foundation seems structurally sound and could be restored by simply repairing the stone and mortar façade.

Figure 3.2.6 – peeling planter façade

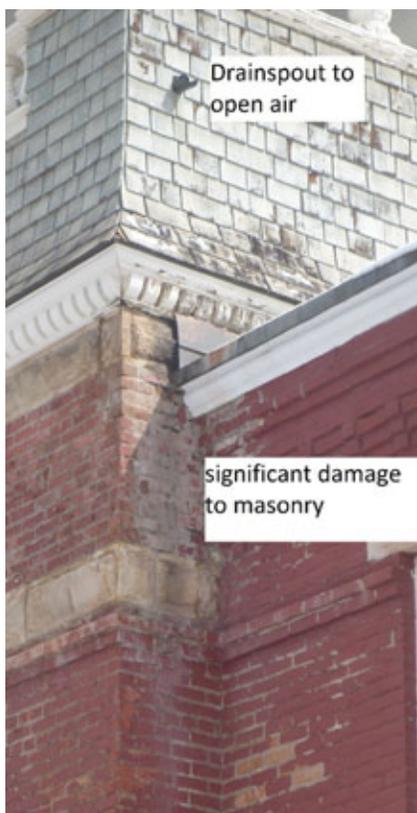
This failed system has caused regular periods of standing water in the cupola (Figure 3.3.2), which is open to weather and gathers both snow and rain. This precipitation cannot drain out as it should, and water damage to the floor system (Figure 3.3.4), underlying brick, and internal wall finishes has resulted as water has penetrated deep into the courthouse top floor (Figure 3.3.5). The partially-effective drain pipe dumps water onto the outside brick wall as seen in Figure 3.3.3, and is causing efflorescence and deterioration of the lime mortar in that area of the wall.

Figure 3.3.3 – water damage from cupola

The current condition of the support structures is fair, as damage exists but in its current state it is quite structurally sound. However, the overall condition will rapidly deteriorate to poor and unsafe unless an effective drainage system is installed because rot of the supporting wood and deterioration of the brick mortar will likely continue. One possible treatment of the water drainage issue is to “bathtub” the entire floor of the cupola with an EPDM

failed drain in the Southwest corner (Figure 3.3.2). The drain should be well repaired or replaced with a watertight pipe that flows to the gutters of the structure and follows a designated channel all the way to the ground instead of pouring out into the open air. Also, a clear Plexiglas™ could be inconspicuously installed between the cupola railing and the floor to partially prevent moisture from entering the room at that level. Of course, this Plexiglas™ could be continued to the ceiling in order to completely close in the room, but that would likely take away from the historic feel of the courthouse.

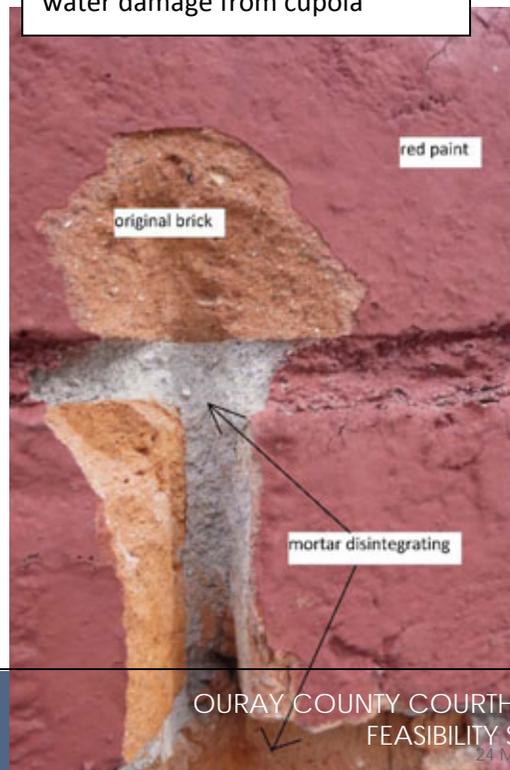
Figure 3.3.5 – internal wall finish water damage from cupola

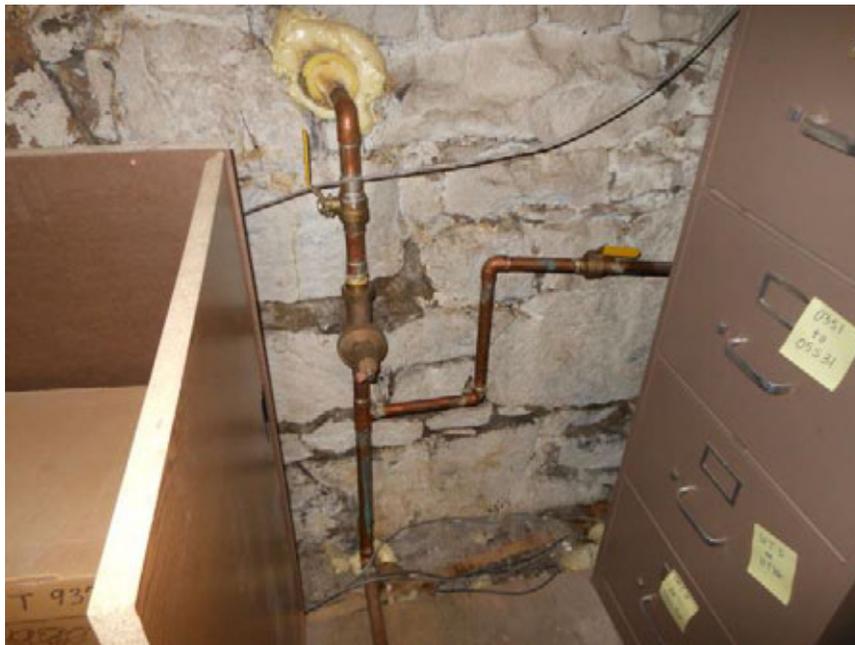
The domestic water entry is located in the basement on the north side of the building (photo #2) and is composed of a 1" copper line from the curb stop, an isolation ball valve and a pressure reducing valve (prv). There is no backflow preventer.

Photo #2 : Water entry.

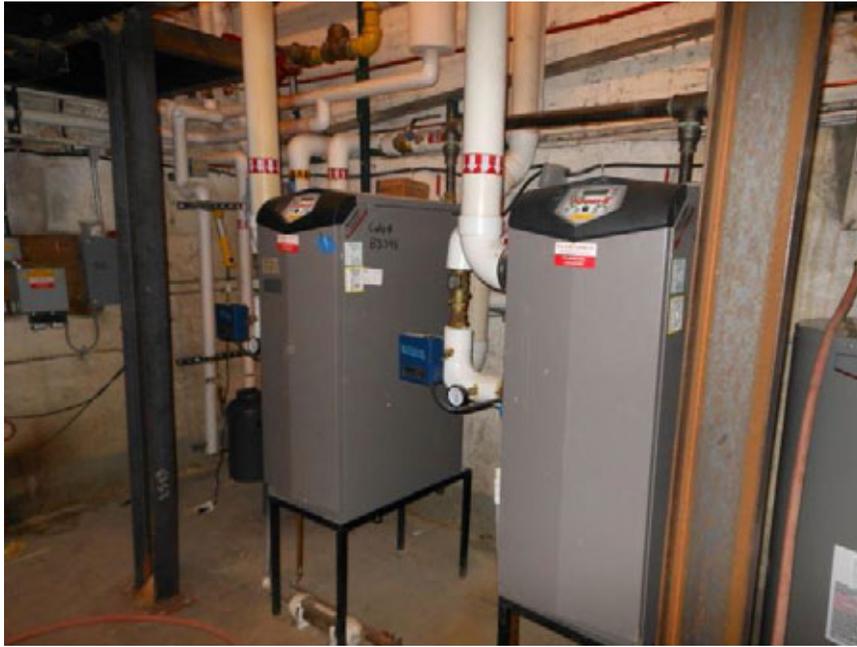
The boilers (photo #3) are Lochinvar Knight model KBN399 with an input of 399 mbh each. The boilers are piped in a primary/secondary arrangement using existing primary pumps (photo #4) and piping to circulate heating water thru the piping system. The boilers were installed in 2008. The age of the existing pumps and piping system is

Photo #3 : Boiler system.

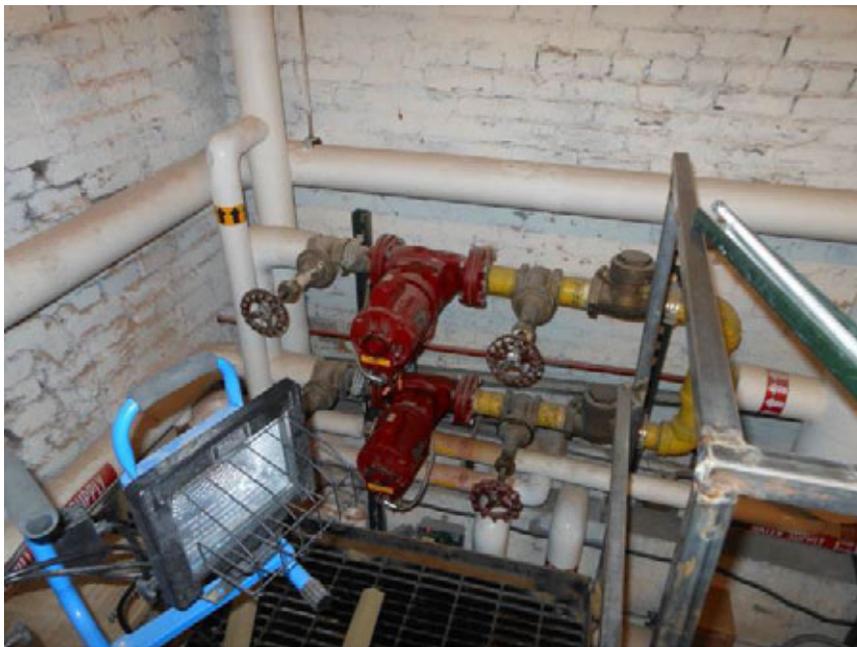
Photo #4 : Primary heating pumps.

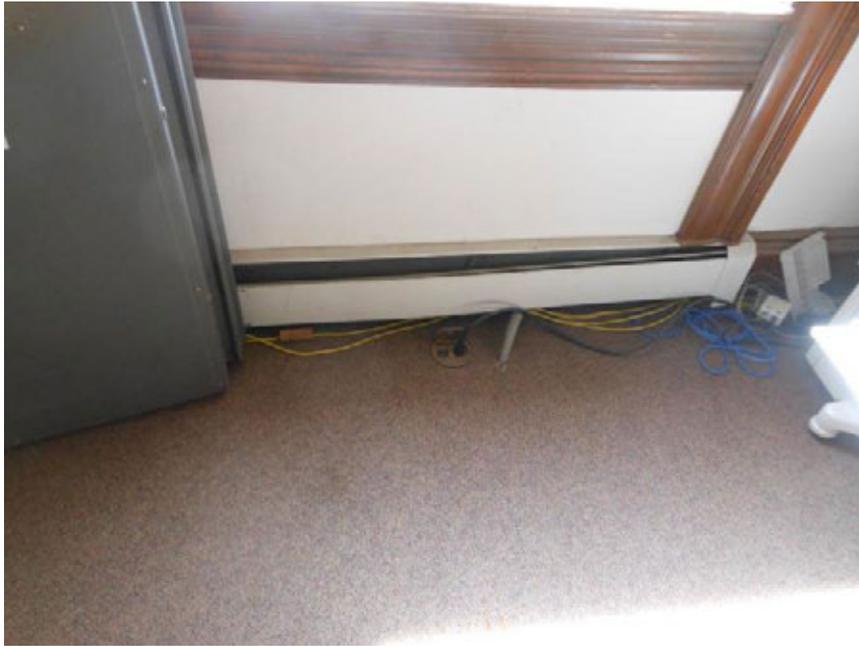
The baseboard radiation heating elements (photo #5) around the perimeter of the building provide heating from the boiler plant. These units are in various states of repair and their age is unknown. Some of the units are residential quality and are in poor shape. Some of the units located on the stair landings and public areas are a more commercial quality and are in fair shape.

Photo #5 : Baseboard radiation element.

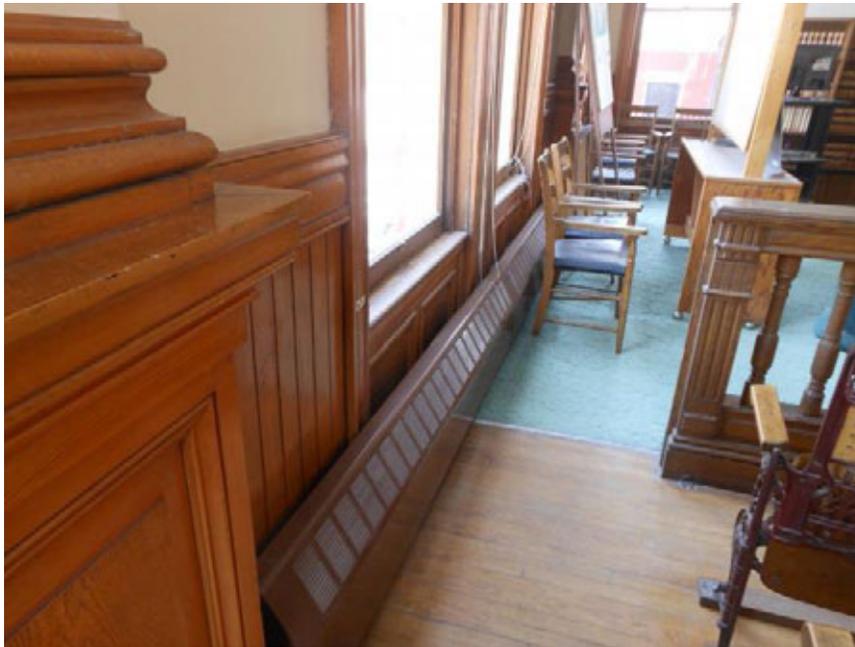
There is no active air-conditioning or ventilation in the other parts of the building not mentioned above. Operable windows are used as needed. The courtroom does have ceiling mounted fans to allow some air movement (photo #7).

Photo #7 : Courtroom fans.

1. The building should be considered for an upgrade with a new mechanical system. The building has no active ventilation or air-conditioning systems. The IMC and IBC require specific ventilation rates for building occupants to ensure good air quality. Also, given the high occupancy of some areas of the building (commissioner's meeting room), it is probable that air quality standards are not met. There are also areas in the building that require air conditioning (the server room) and other areas that have been known to overheat at times and, thus, would benefit from air-conditioning. A recommended system type might be what is known as VRF (variable refrigerant flow). This system incorporates air-air heat pumps with a heat recovery feature. The defining characteristic of this system is the variable speed compressor technology and, along with the heat recovery feature, makes this system very efficient for heating and cooling. This system is easily integrated into existing, older construction; requires minimal ductwork; is extremely quiet; and offers flexible zoning.

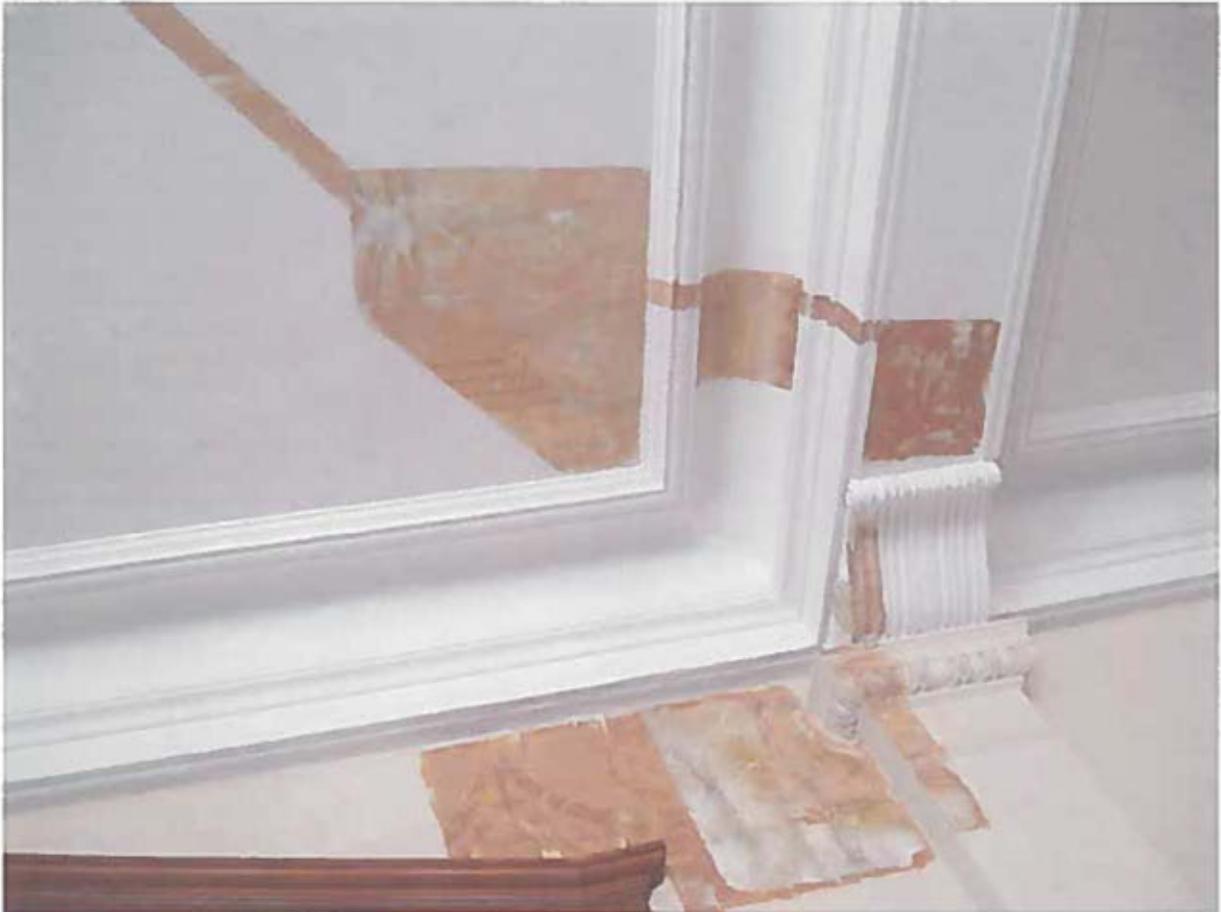
This general view shows the arrangement of the bulk of the exposure work conducted along the north wall of the courtroom in the center bay.

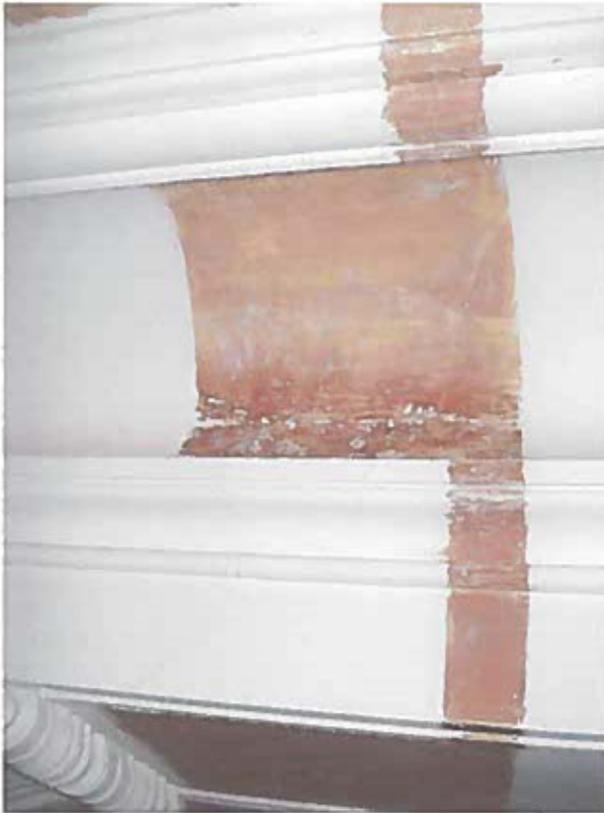
This photo exhibits the cornice/beam exposure that clearly shows the gradient of reddish brown applied in the lower part of the cove.

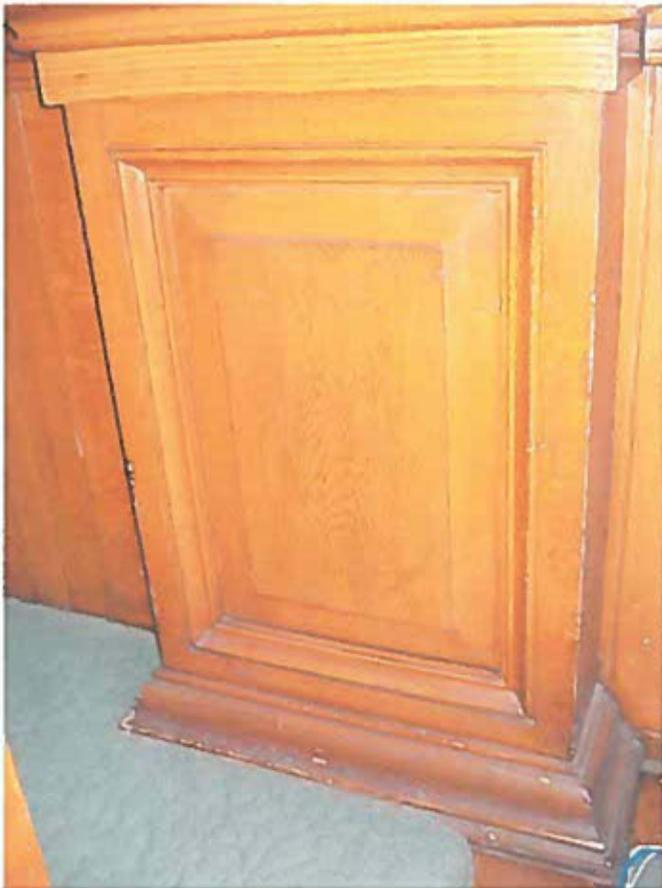
Typical view of the high quality wood graining on the secondary scheme in the courtroom. The original finish was a stain and varnish finish of a similar tonality.
