Ouray County Courthouse & Jail

Historic Structure Assessment & Restoration Plan

Issued: December 19, 1999

Prepared by:
CHARLES CUNIFFE ARCHITECTS

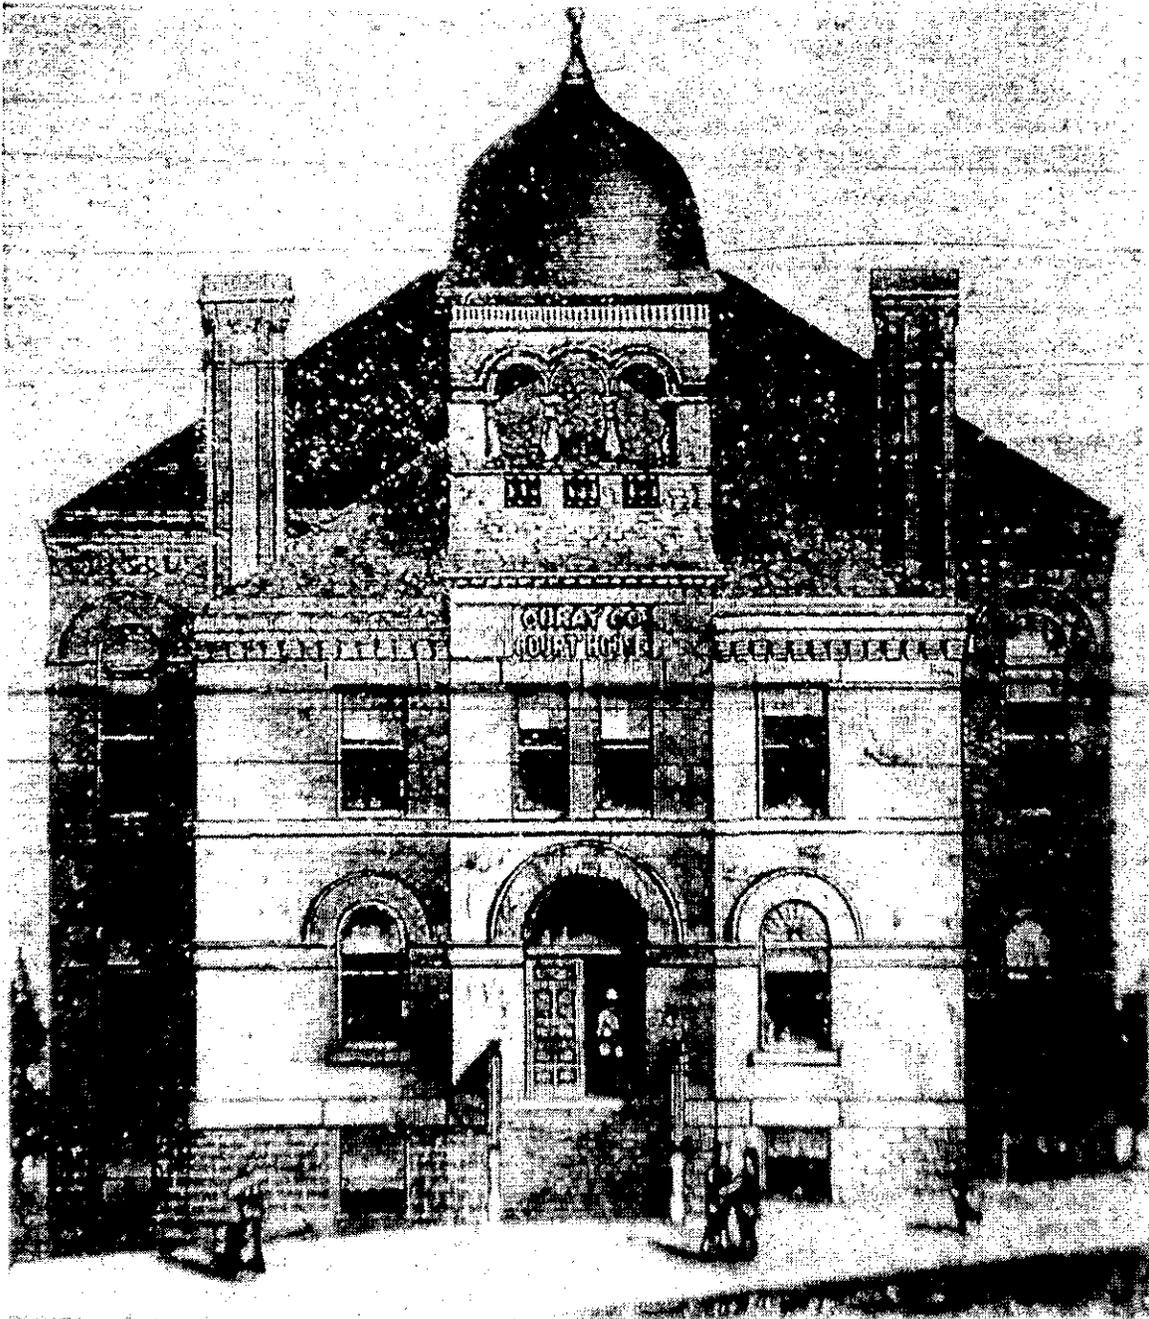
A - Engraving of West Elevation of Courthouse

This engraving was published in the local papers prior to construction in 1888. Note the absence of an entry portico. Also of note is the existence of two chimneys that were not constructed.

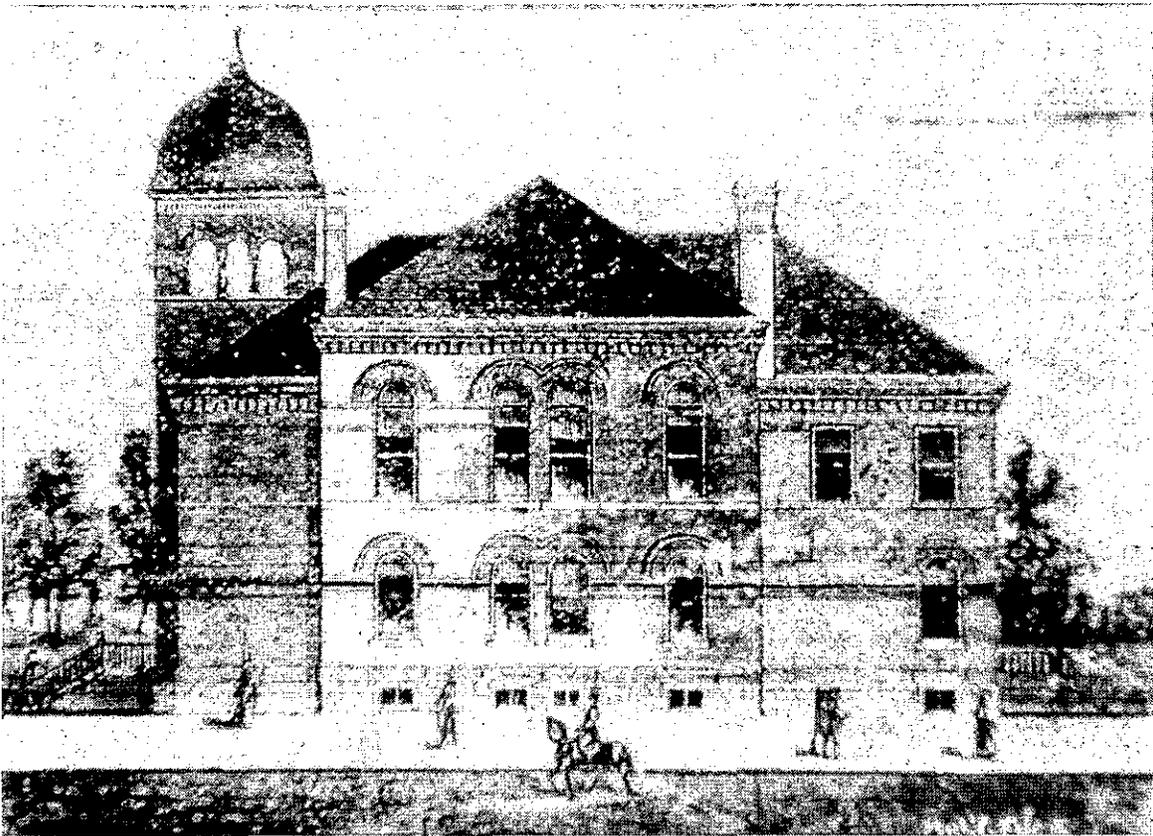
B - Engraving of South Elevation of Courthouse

This engraving was published in the local papers prior to construction in 1888. This engraving erroneously shows a street on this side of the building.

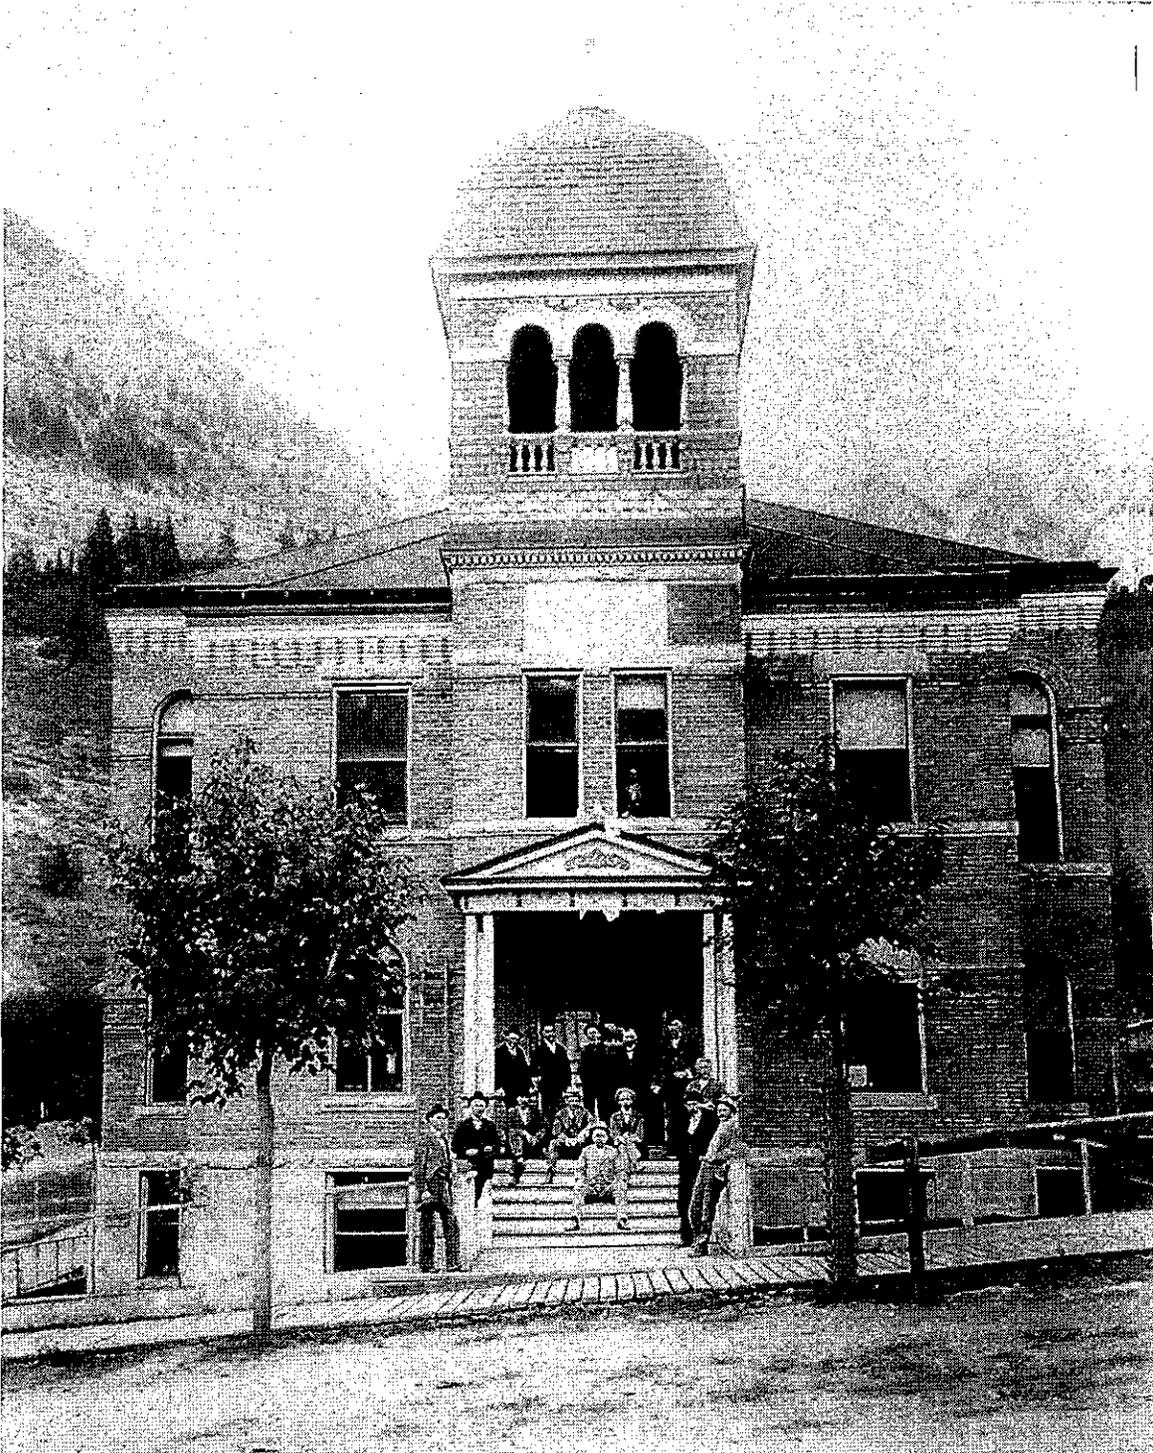
C - Earliest Photograph of Courthouse

This is the earliest known photograph of the Courthouse and was probably taken soon after its completion in 1889. Note the portico and wooden front steps. Also of note is the unpainted brick except at the cornice. Patterns of some type can be seen stenciled on the shingles of the cupula.

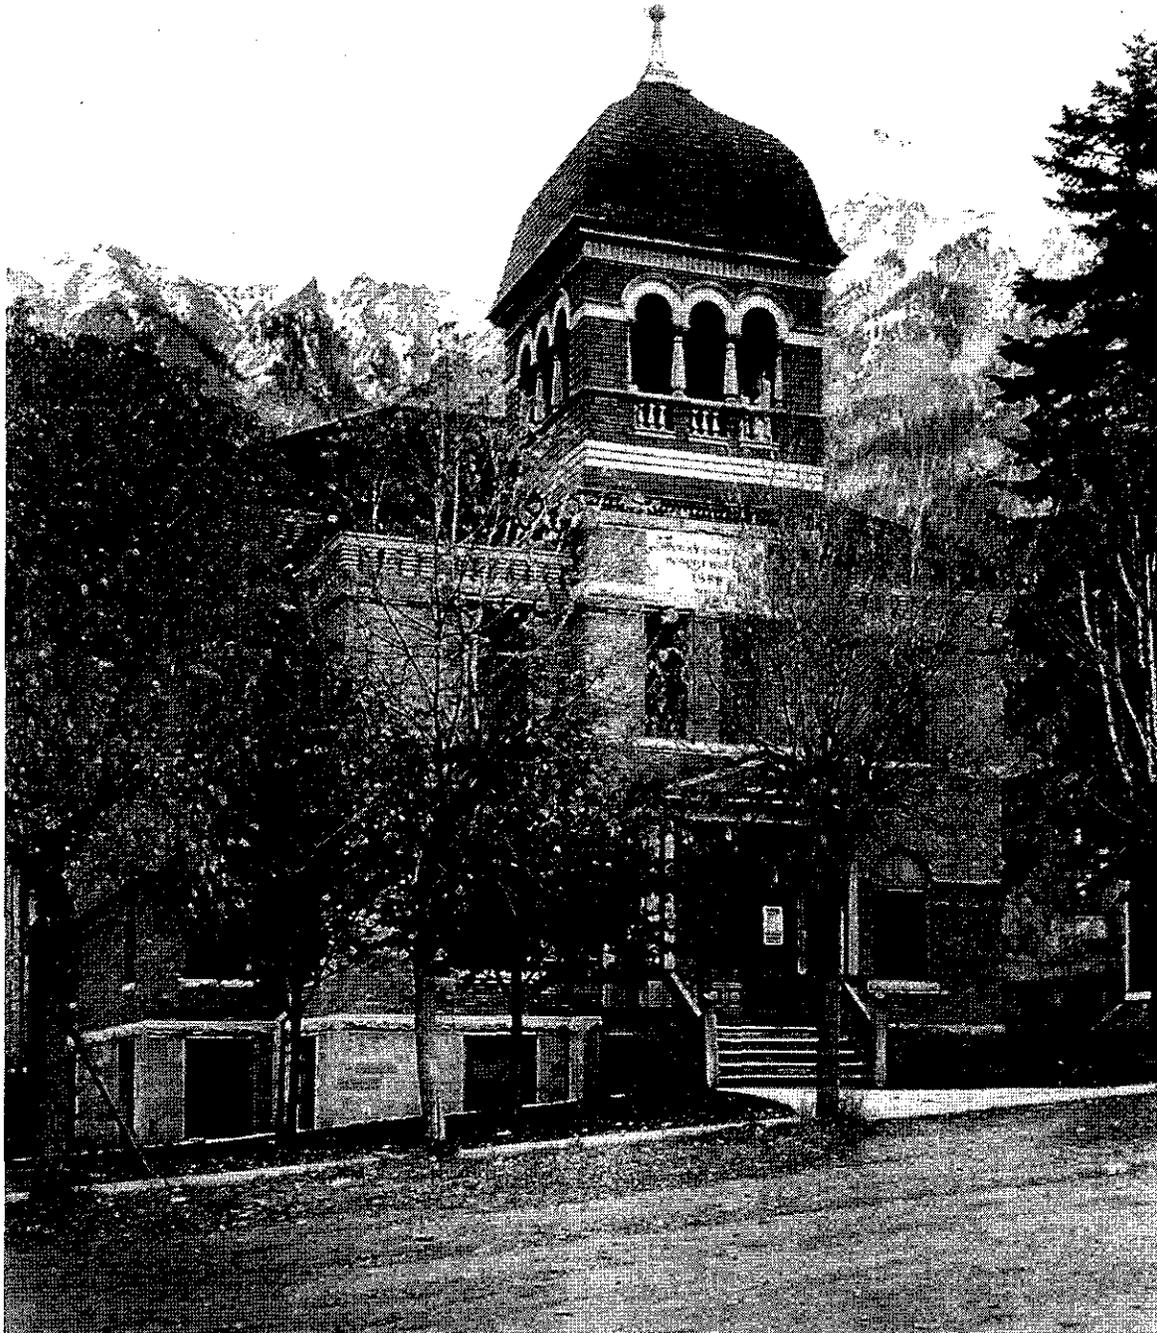
D - Early Photograph of Courthouse

This photograph, taken some time after 1908, indicates little change over the first few decades. The sidewalks have been changed to concrete but the wooden steps remain. Note that the brick is still unpainted but the decorative patterns on the cupola have been painted over.

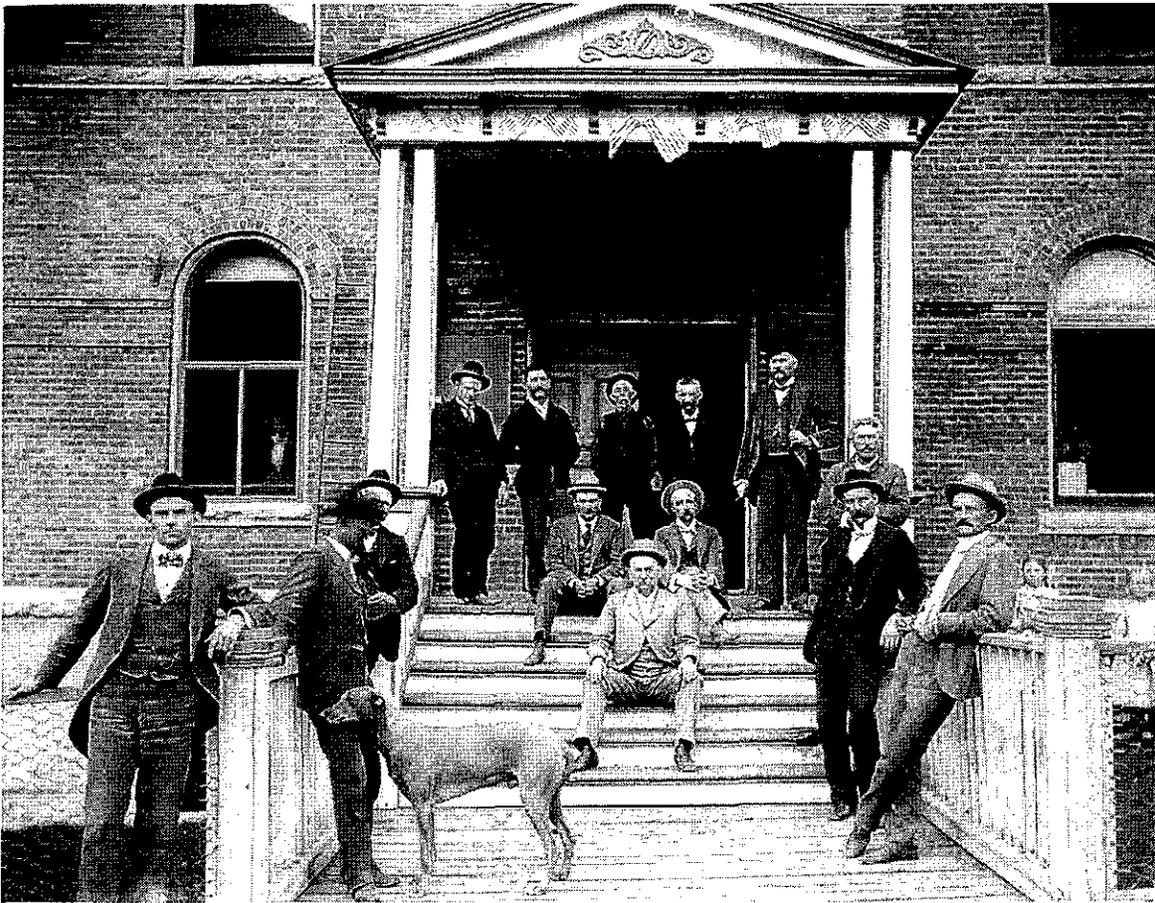
E - Early Photograph of Courthouse

This photograph, probably taken the same day as Photograph C, shows a close view of the original detailing of the front entry and missing handrails.

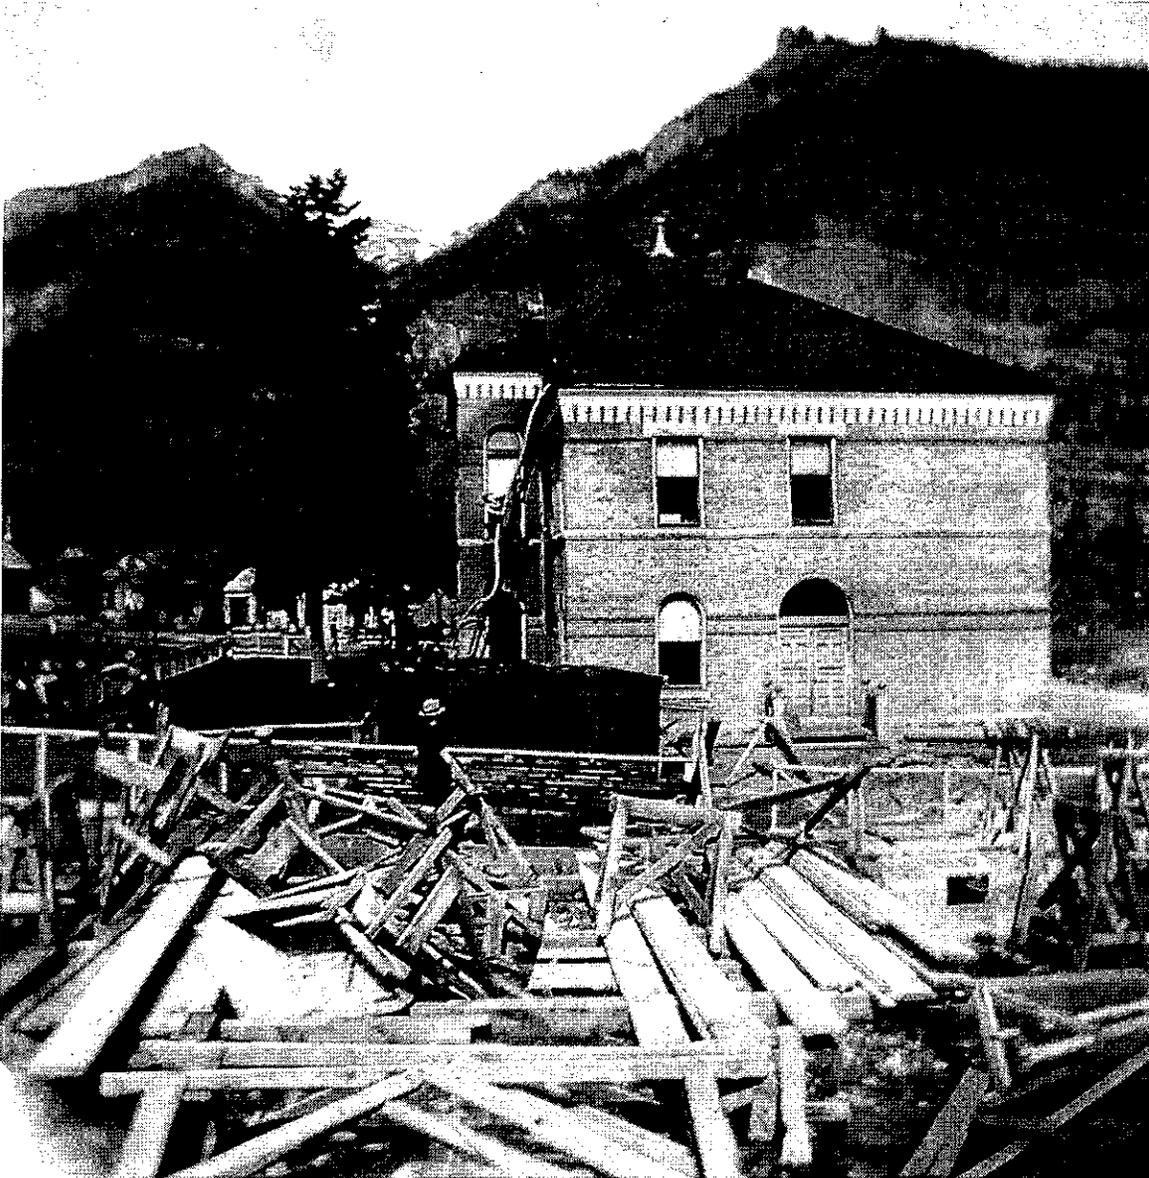
F - Photograph of Rear of Courthouse

This the only known photograph of the back side of the Courthouse. Due to the activity shown, this photograph was no doubt taken in May of 1898 during the small fire in the Courthouse attic. Note the relatively lower ground level of adjacent properties. The Jail building has yet to be constructed.

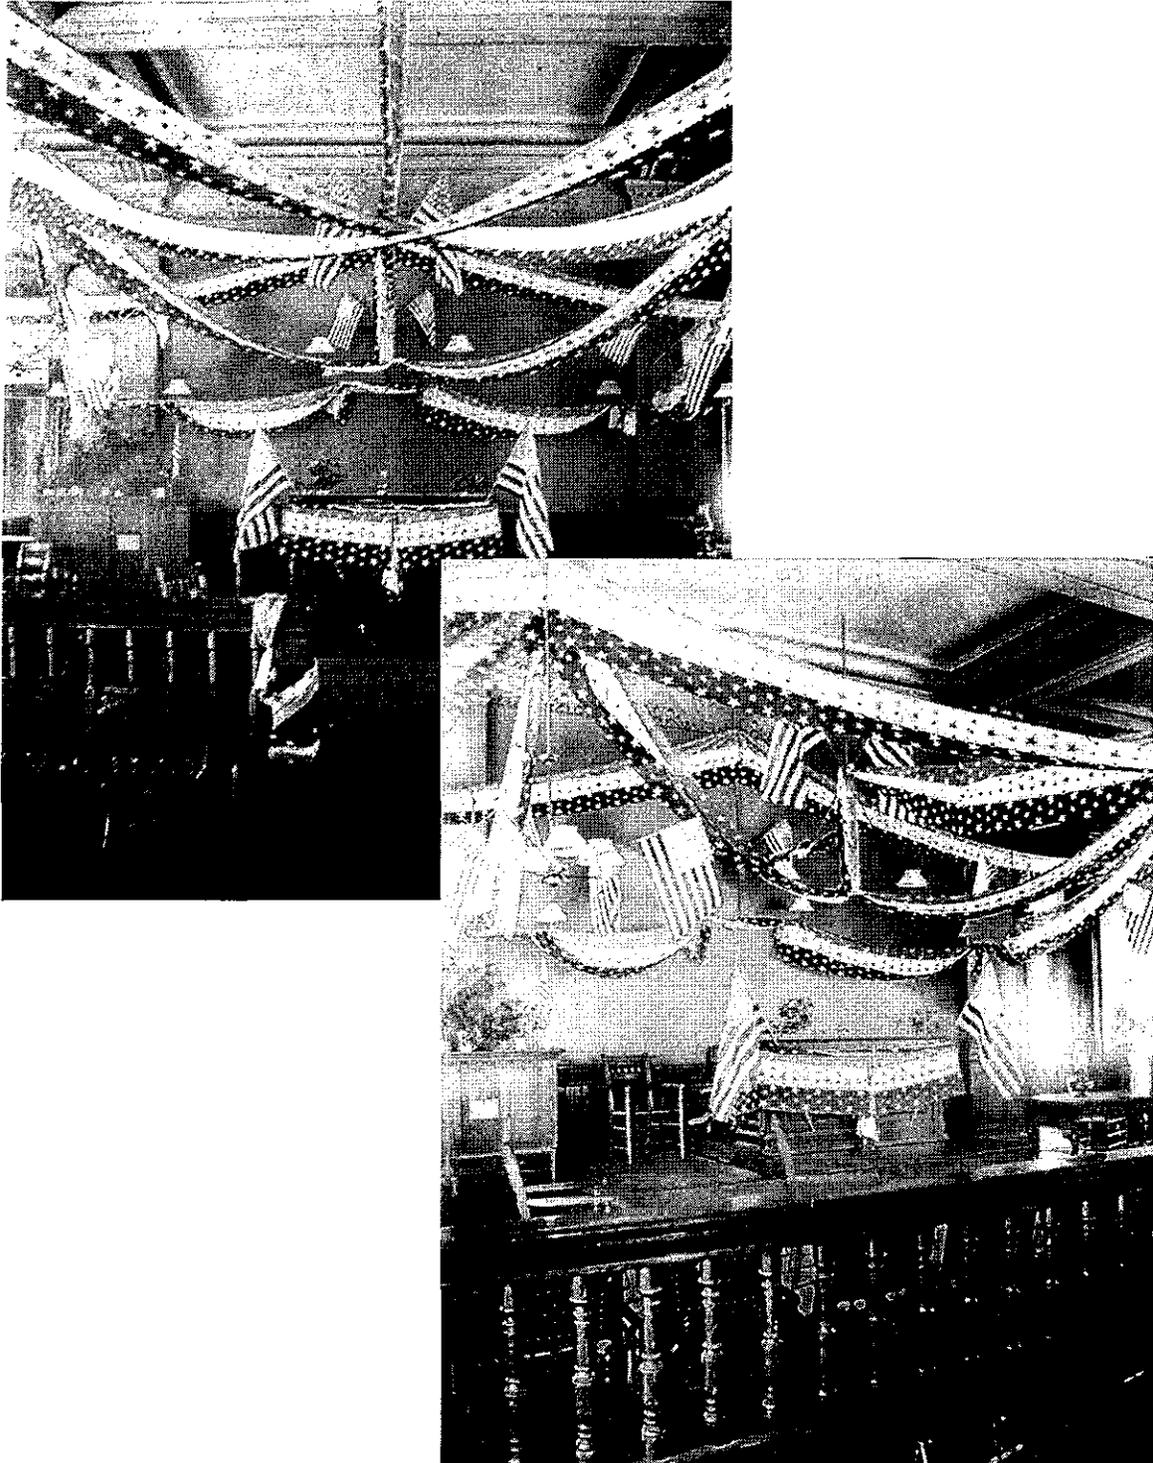
G - Photograph of Courtroom Interior

This the only known photograph of the Courtroom Interior. The date is not known but there is reason to believe the photograph was taken some time between 1898 and 1910. Of particular note is the furniture still in use including the judge's desk, tables, chairs and public seating. Also visible is the decorative stenciled frieze on the walls just beneath the ceiling. The early light fixtures are also visible.

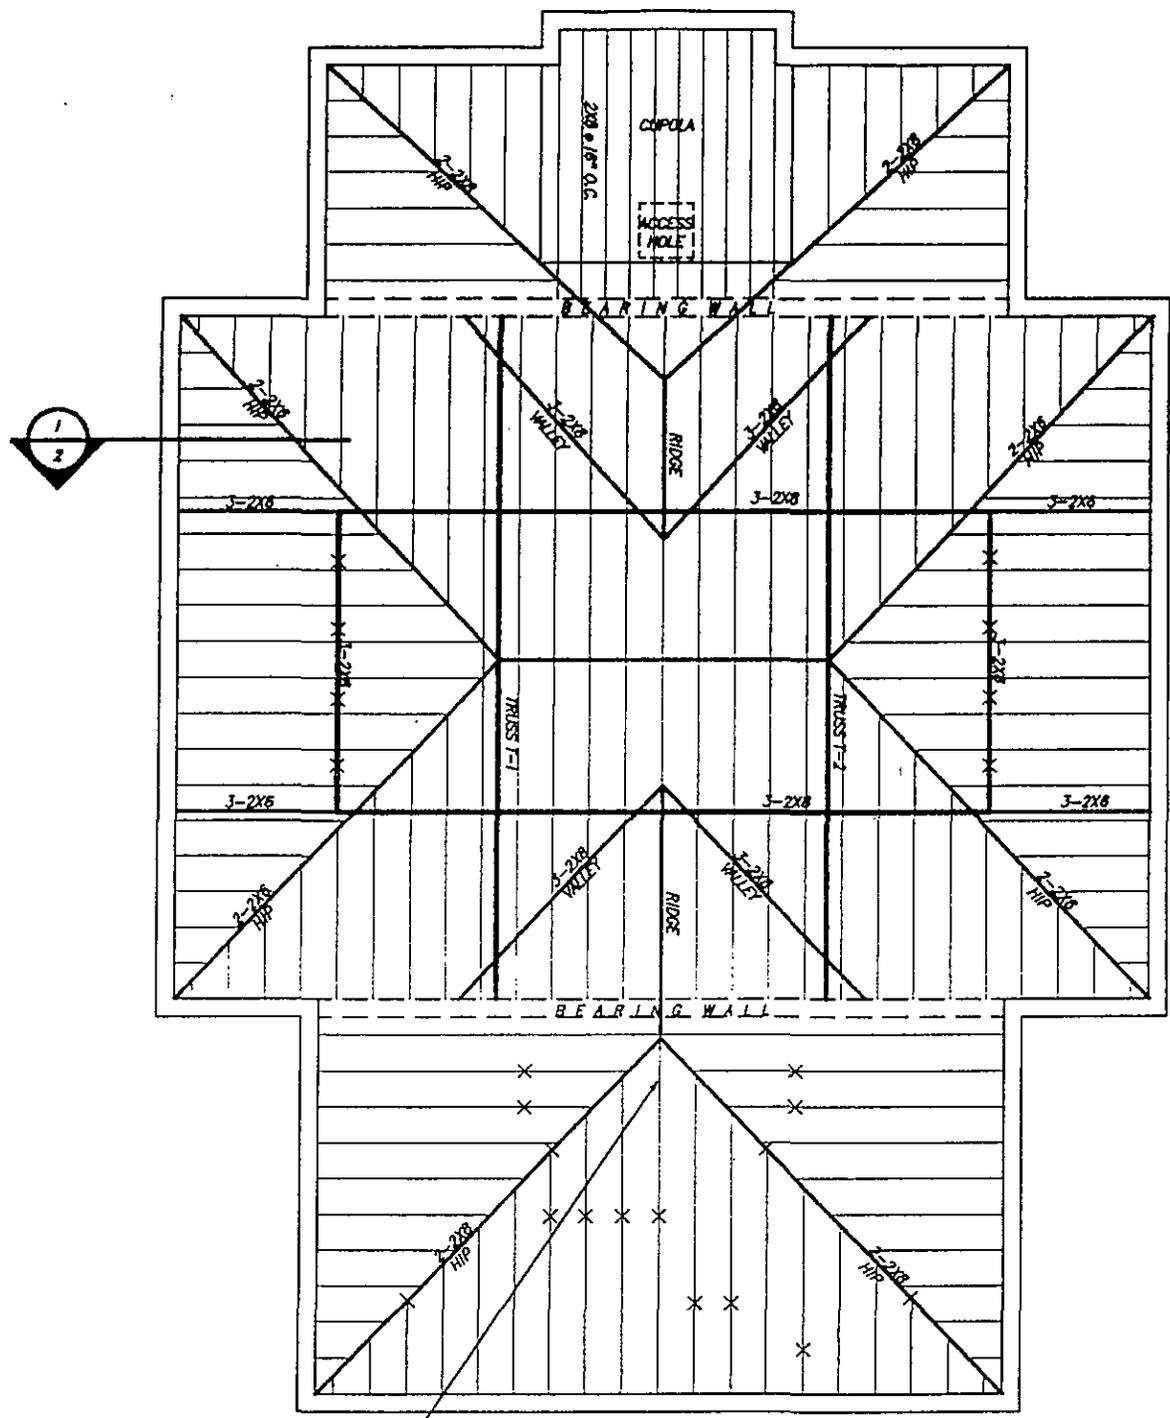
BLACK SMOKE INDICATION NEAR TO RIDGE

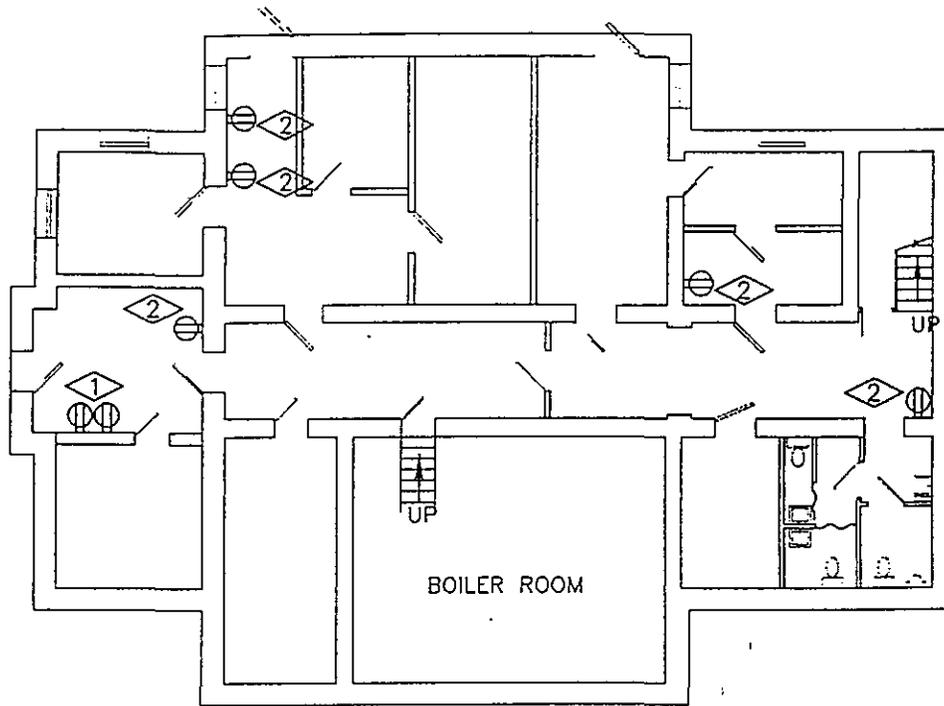
LOWER FLOOR RECEPTACLE PLAN

- ① OPEN GROUND
- ② REVERSED POLARITY
- ③ NON GROUNDED (REPLACE WITH GROUNDING RECEPTACLE)

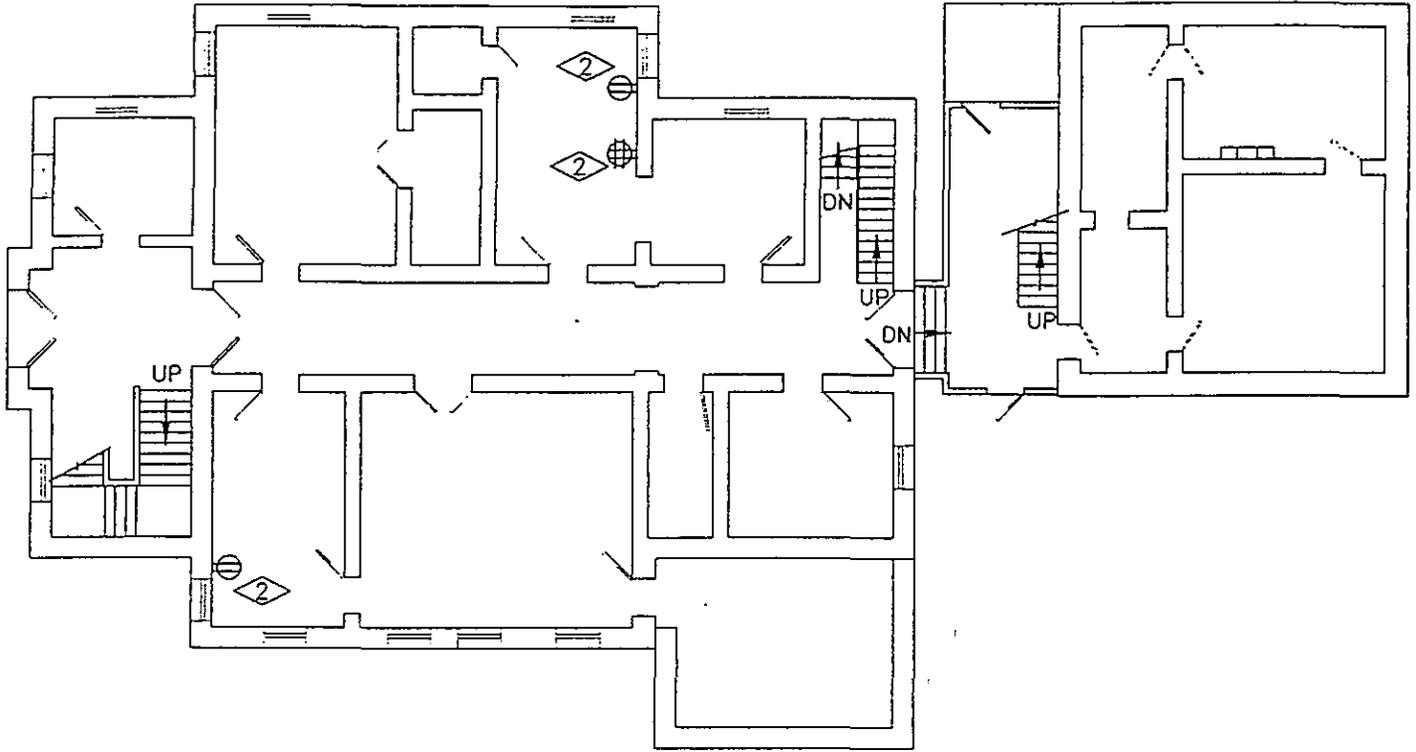
MAIN FLOOR RECEPTACLE PLAN

- ① OPEN GROUND
- ② REVERSED POLARITY
- ③ NON GROUNDED (REPLACE WITH GROUNDING RECEPTACLE)

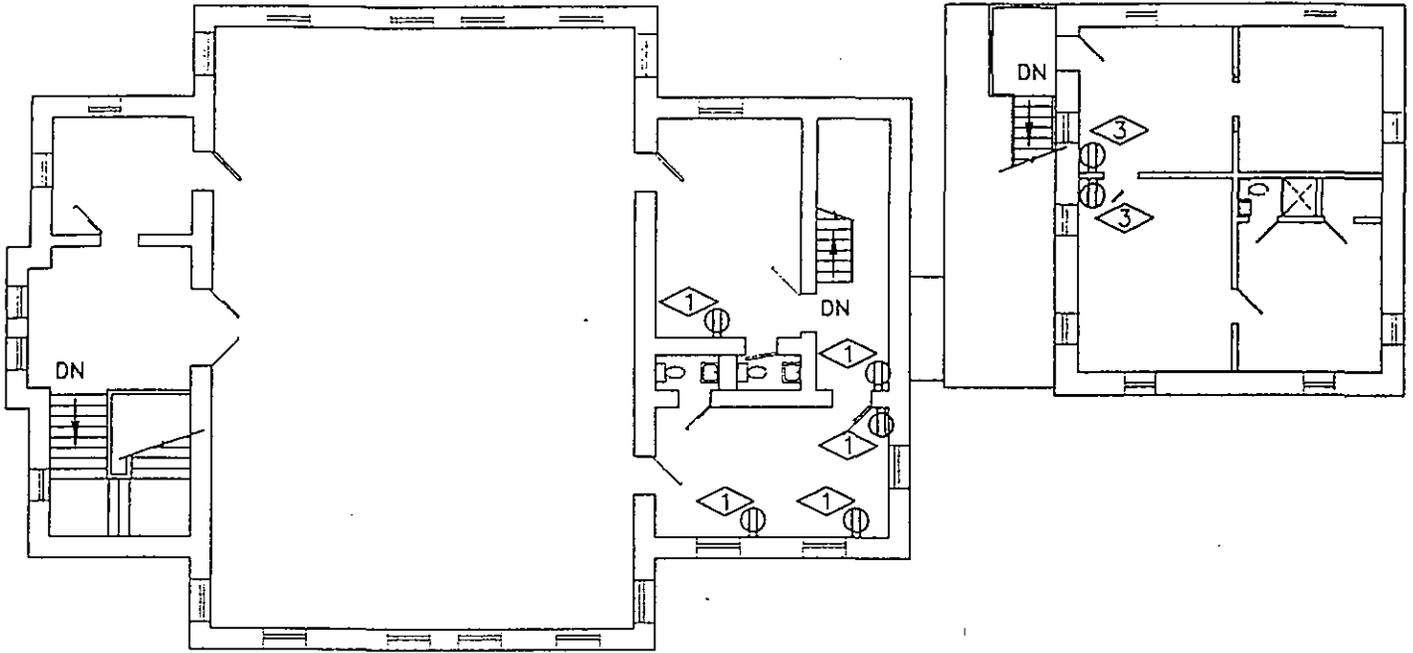
UPPER FLOOR RECEPTACLE PLAN

- ① OPEN GROUND
- ② REVERSED POLARITY
- ③ NON GROUNDED (REPLACE WITH GROUNDING RECEPTACLE)
